Annex H2

Transplanted Plant Species of Conservation Importance Monitoring

TUNG CHUNG NEW TOWN EXTENSION (EAST) -DESIGN AND CONSTRUCTION

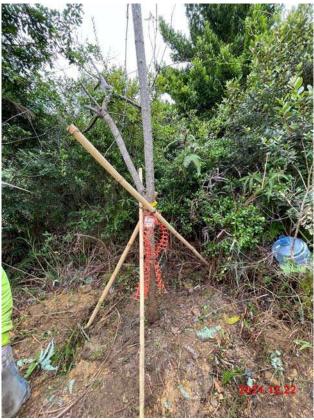
1st Root Prunning for G62RT07

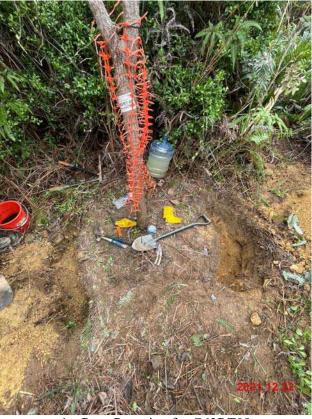
1st Root Prunning for G62RT08

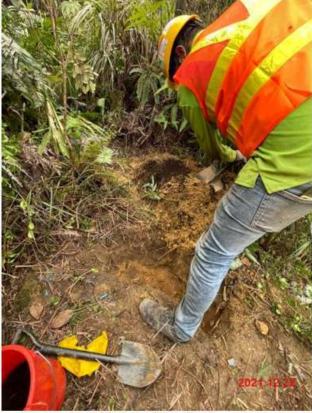
Backfilled with soil mix-A

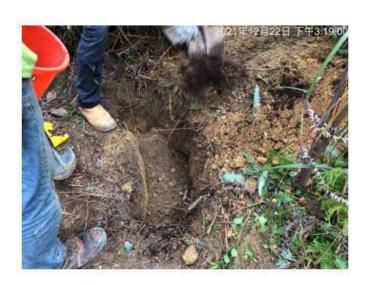
Backfilled with soil mix-B

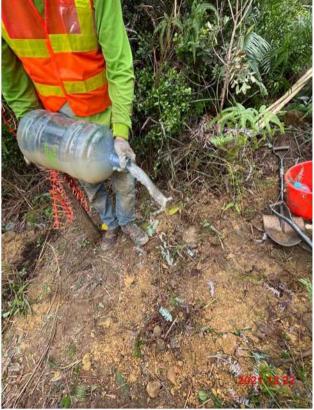
Watering-A

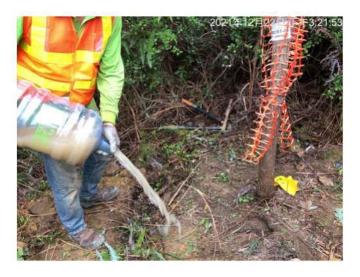
Watering-B

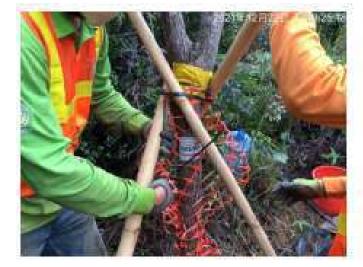
Fixing Bamboo Stakes-A

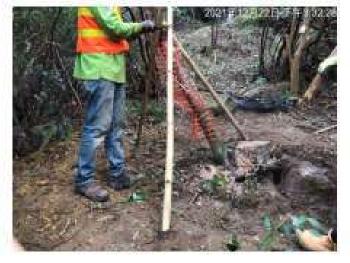
Fixing Bamboo Stakes-B

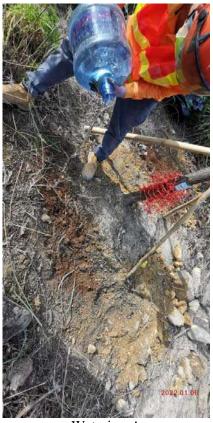
Watering-A

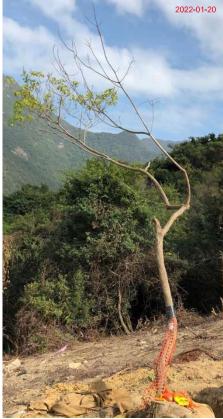
3rd Root Prunning for G62RT07

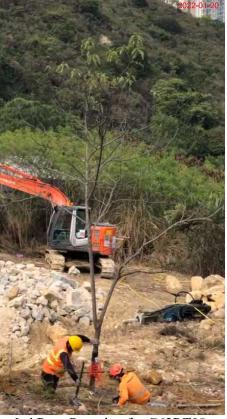
3rd Root Prunning for G62RT08

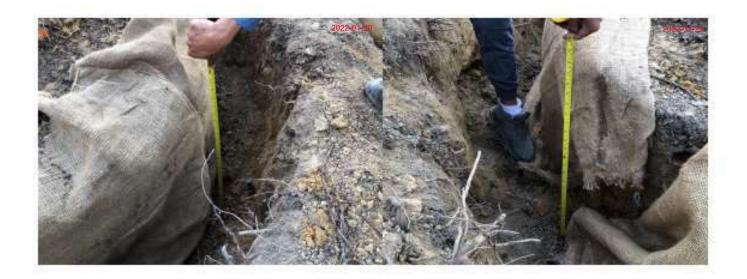
Depth of rootball for G62RT07

Depth of rootball for G62RT08

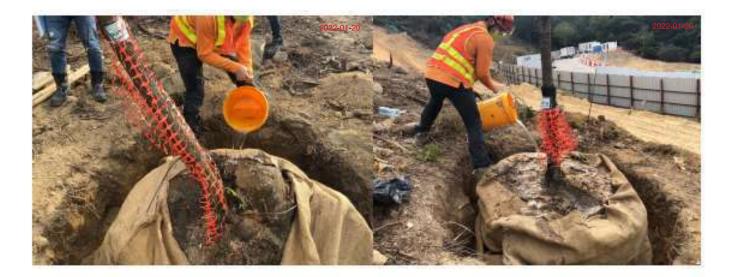
Watering-A

Watering-B

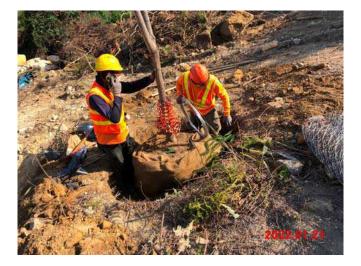
Tied with coir mat for root ball

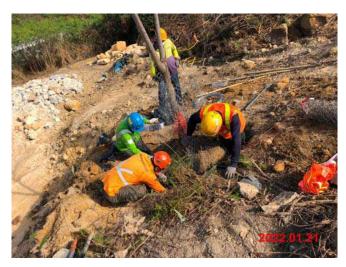
Tied with triple twist wire mesh

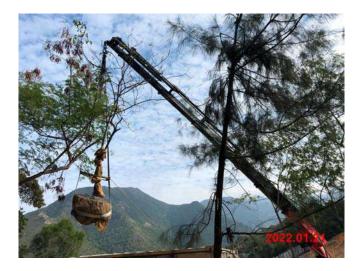
Lifing the tree-B

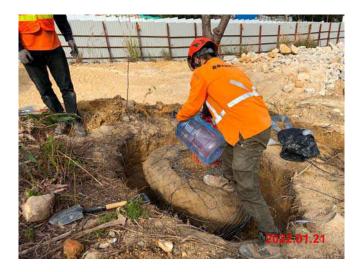
Tree planting in the final location-G62TR07

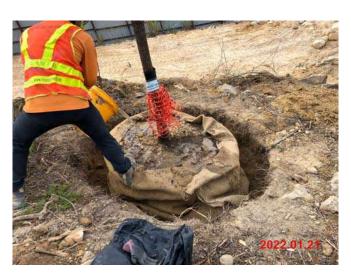
Tree planting in the final location-G62TR08
