Preserved/Transplanted
Plant Species of
Conservation Importance
Monitoring

Contract No.: NL/2020/02

Tung Chung New Town Extension - Salt Water Supply System

Monthly Report (15 May 2023) In-situ Plant Species of Conserva,on Importance - Photographic Records

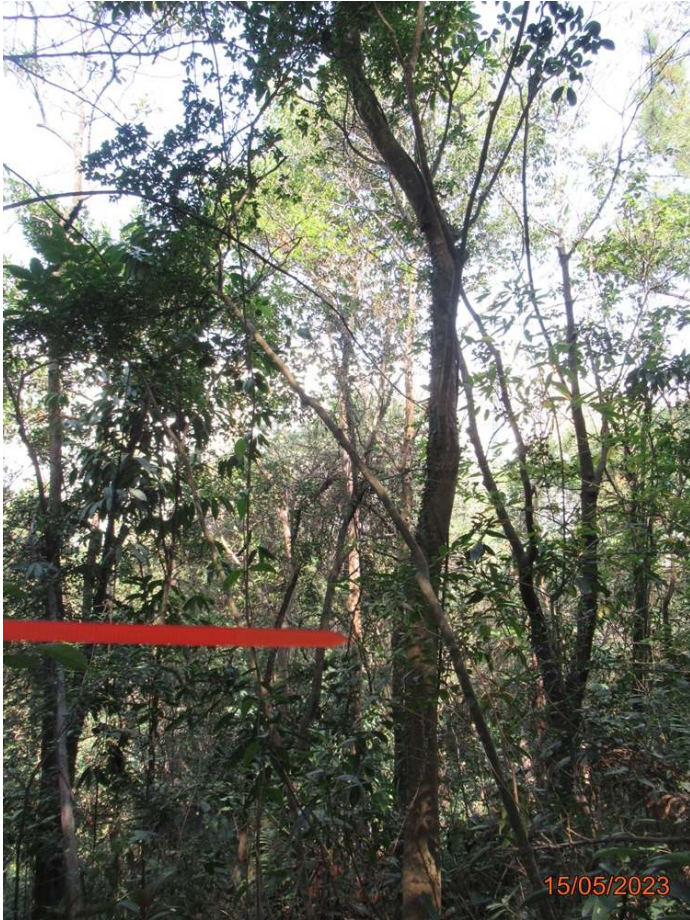
G01_30-R005

R005	<i>Aquilaria sinensis</i>	土沉香	8	130	3	Good	Fair	Fair	Fair	Yes	Retain	-	On slope
		R006	<i>Aquilaria sinensis</i>	土沉香	-	-	-	-	-	-	-	Yes	Retain	-	Missing
	G02/29	R007	<i>Gmelina chinensis</i>	石梓	10	170	5	Good	Poor	Fair	Fair	Yes	Retain	-	On slope, Co-dominant Branches with Included Bark Crossed Branches, Old termite tracks on trunk
		R013	<i>Gmelina chinensis</i>	石梓	8	150	7	Good	Poor	Fair	Fair	Yes	Retain	-	On slope, Co-dominant Branches, Epicormics at Branch Broken Leader with Epiphyte
	G03/44	R014	<i>Gmelina chinensis</i>	石梓	7	160	5	Good	Poor	Fair	Fair	Yes	Retain	-	On slope, Co-dominant Branches
		R015	<i>Gmelina chinensis</i>	石梓	6	110	2	Good	Poor	Poor	Fair	Yes	Retain	-	On slope, Broken Leader, Epiphytes
		R016	<i>Gmelina chinensis</i>	石梓	-	-	-	-	-	-	-	Yes	Retain	-	Missing
	G04/45	R017	<i>Gmelina chinensis</i>	石梓	8	130	4	Good	Poor	Fair	Fair	Yes	Retain	-	On slope, Broken Leader with Epicormics

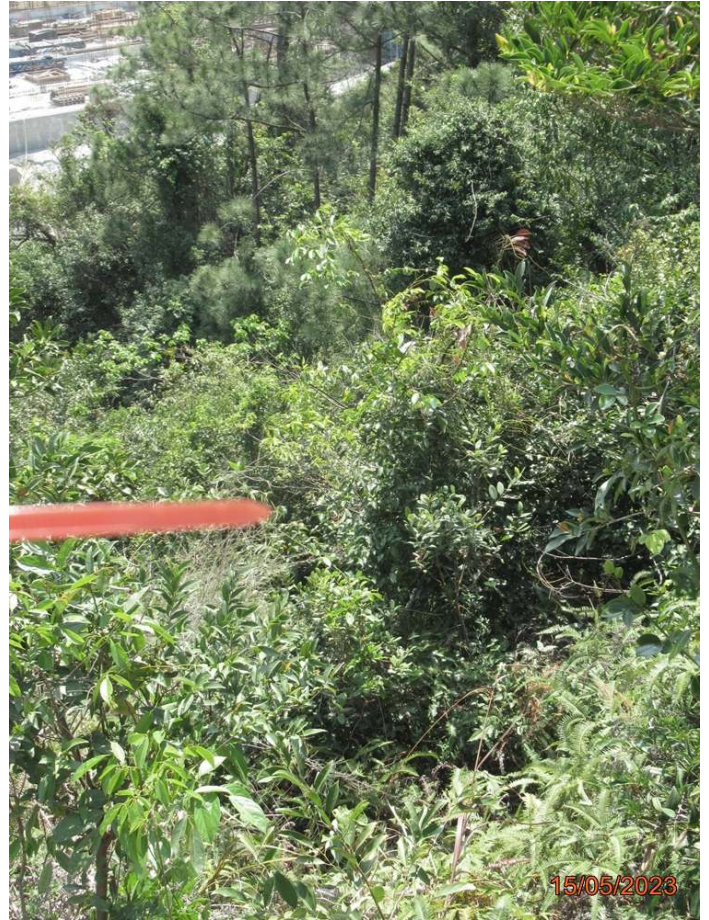
G01_39-R01_Inaccessible

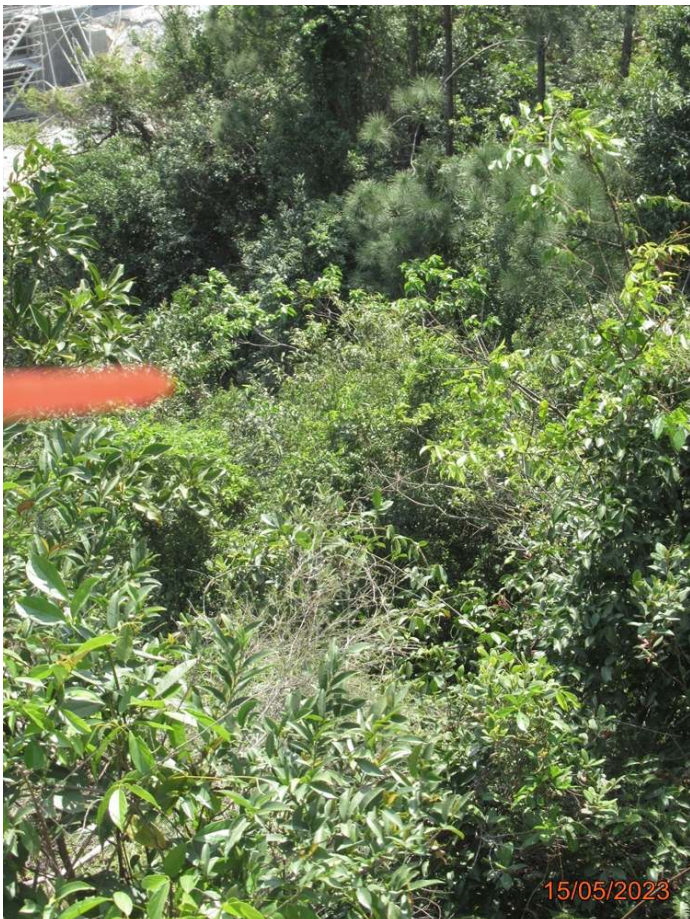
G01_39-R02_Inaccessible

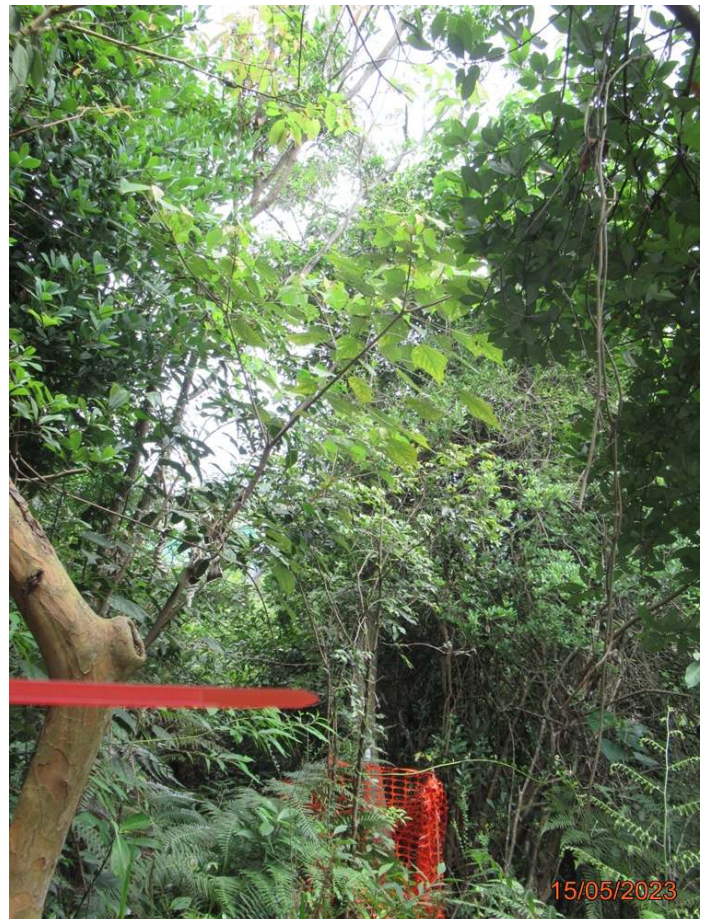
G01_81-RT-01

Drawing no.	Tree group no.	Tree No.	Botanical Name	Chinese Name	SIZE			Amenity Value	Form	Health	Structural Condition	Conservation Status	Recommendation in Detailed Preservation and/or Translocation Plan for Plant Species of Conservation Importance for Tung Chung East (Retain/ Transplant/ Fell)	Justification	Remarks
					Height (m)	DBH (mm)	Spread (m)								
60507694/C2/1721	G01/39	R01	<i>Gmelina chinensis</i>	石梓	-	-	-	-	-	-	-	Yes	Retain	-	On Slope, Inaccessible
		R02	<i>Gmelina chinensis</i>	石梓	-	-	-	-	-	-	-	Yes	Retain	-	On Slope, Inaccessible
	G06/59	R018	<i>Gmelina chinensis</i>	石梓	-	-	-	-	-	-	-	Yes	Retain	-	Missing
	G03/61	R019	<i>Gmelina chinensis</i>	石梓	-	-	-	-	-	-	-	Yes	Retain	-	Missing
	G05/62	RT06	<i>Gmelina chinensis</i>	石梓	-	-	-	-	-	-	-	Yes	Transplant	Direct conflict with proposed works	Missing
	G01/81	RT-01	<i>Gmelina chinensis</i>	石梓	5	160	3	Good	Poor	Fair	Fair	Yes	Retain	-	On slope, Strangled by Epiphytes

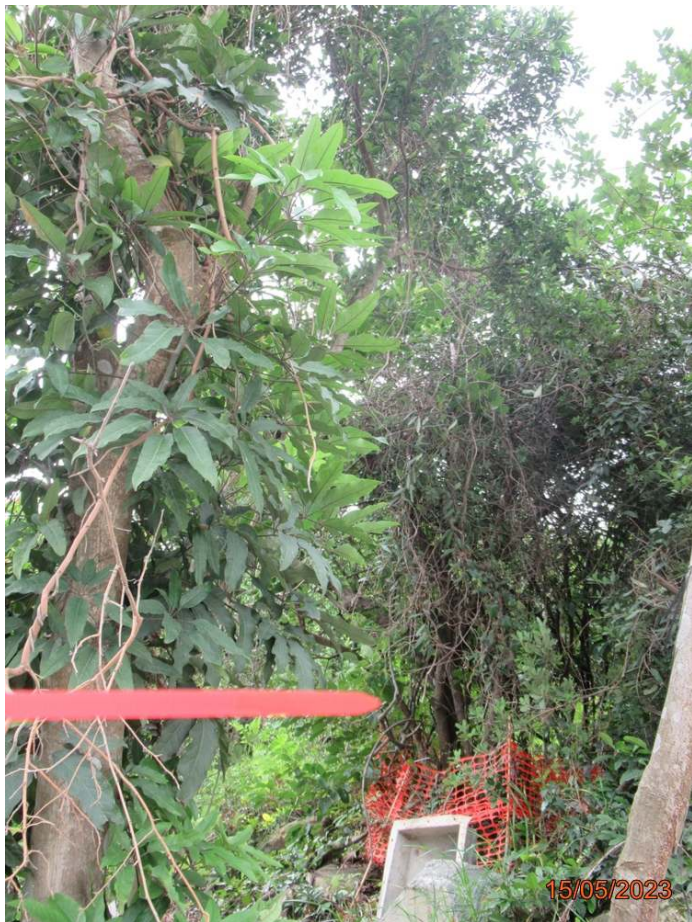
G01_81-RT-02 (T1535)

RT-02 (T1535)	<i>Gmelina chinensis</i>	石梓	8	110	3	Good	Poor	Fair	Fair	Yes	Retain	-	On slope, Co-dominant Branches, Strangled by Epiphytes
	G02/82	RT03	<i>Gmelina chinensis</i>	石梓	-	-	-	-	-	-	-	Yes	Transplant	Direct conflict with proposed works	Missing
	G04/83/84/85	R04 (T1788)	<i>Gmelina chinensis</i>	石梓	9	260	8	Good	Poor	Fair	Fair	Yes	Retain	-	On slope, Multiple Trunks
		R05 (T1572)	<i>Gmelina chinensis</i>	石梓	8	120	5	Good	Poor	Fair	Fair	Yes	Retain	-	On slope, Broken branch
		R05	<i>Gmelina chinensis</i>	石梓	-	-	-	-	-	-	-	Yes	Retain	-	Missing
		R06	<i>Gmelina chinensis</i>	石梓	5	100	3	Good	Fair	Fair	Fair	Yes	Retain	-	On slope
		R07	<i>Gmelina chinensis</i>	石梓	8	166	5	Good	Poor	Fair	Fair	Yes	Retain	-	On slope, Co-dominant Trunks
		R08	<i>Gmelina chinensis</i>	石梓	7	160	5	Good	Poor	Fair	Fair	Yes	Retain	-	On slope, Broken Leader, Epicormics, Imbalanced Crown
		R09	<i>Gmelina chinensis</i>	石梓	5	140	4	Good	Poor	Fair	Fair	Yes	Retain	-	On slope, Broken Leader with Epiphyte, Broken Leader with Epicormics

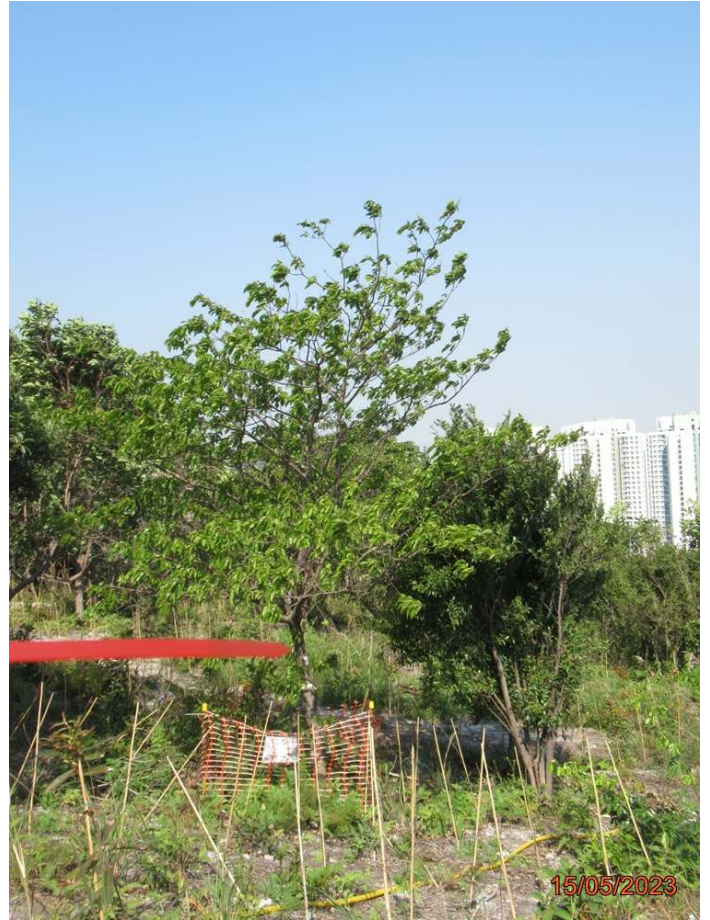
G05_67-R008

R010	<i>Gmelina chinensis</i>	石梓	-	-	-	-	-	-	-	Yes	Retain	-	Missing
		R011	<i>Gmelina chinensis</i>	石梓	8	140	7	Good	Poor	Fair	Fair	Yes	Retain	-	On slope, Co-dominant Branches
		R012	<i>Gmelina chinensis</i>	石梓	-	-	-	-	-	-	Yes	Retain	-	Missing	
G05/67	R008	<i>Gmelina chinensis</i>	石梓	6	120	4	Good	Fair	Fair	Fair	Yes	Retain	-	On slope	
G06/66	R009	<i>Gmelina chinensis</i>	石梓	7	120	5	Good	Poor	Fair	Fair	Yes	Retain	-	On slope, Epicormic at Broken Stump

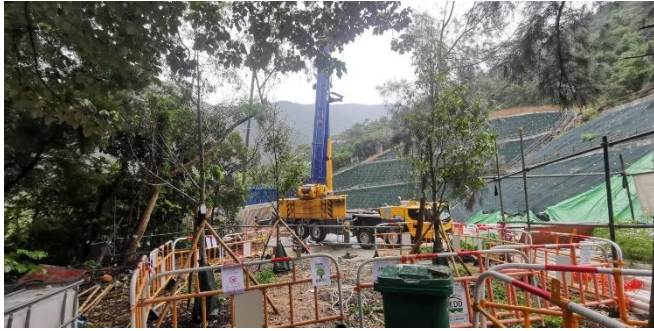
Photo 01: Whole view of 3nos. *Aquilaria Sinensis*

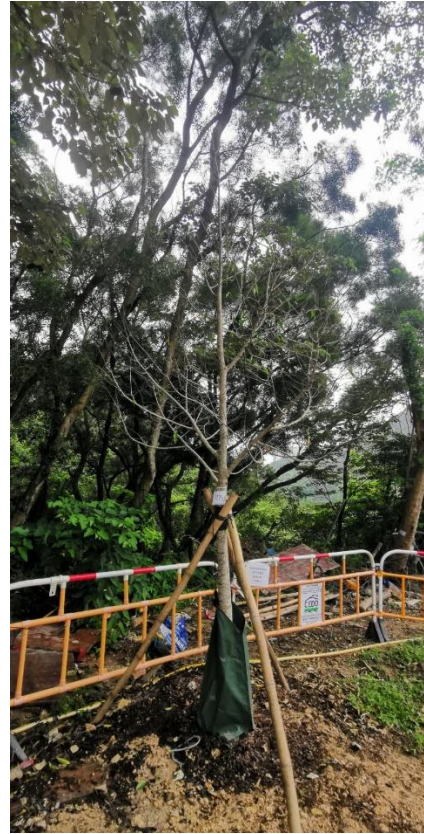
Photo 02: Whole view of RP01

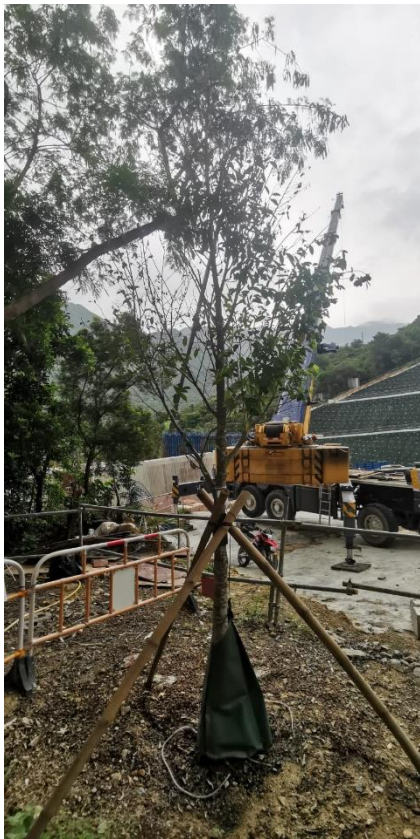
Photo 03: Whole view of RP02

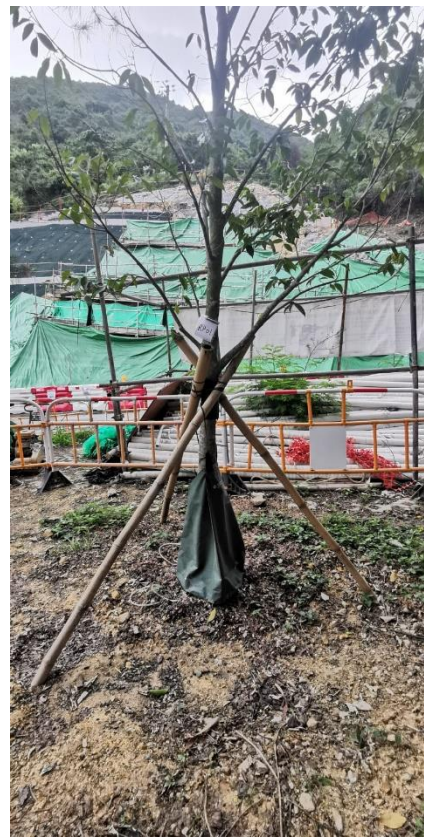
Photo 04: Whole view of RP03

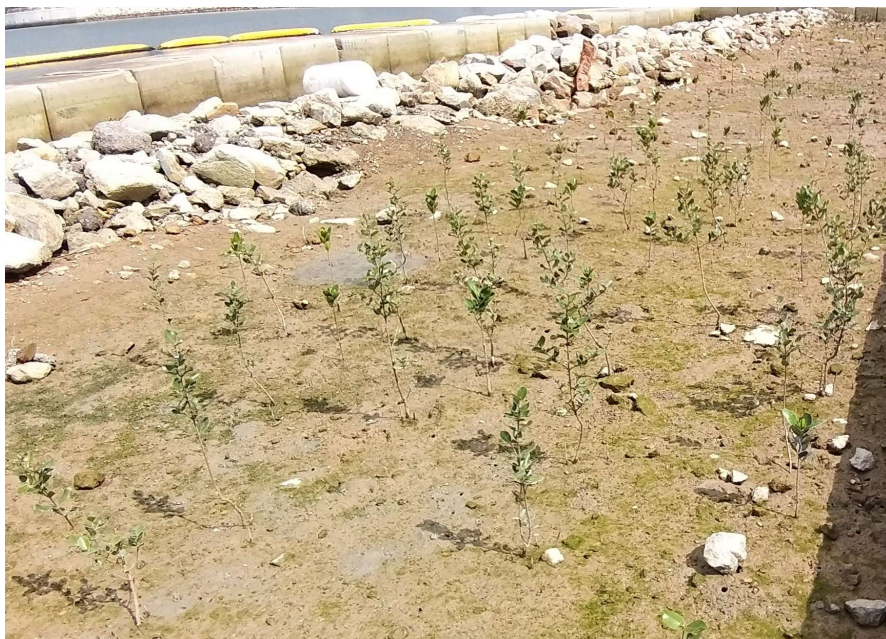
General View of Mangrove Eco-shoreline Upper Terrace

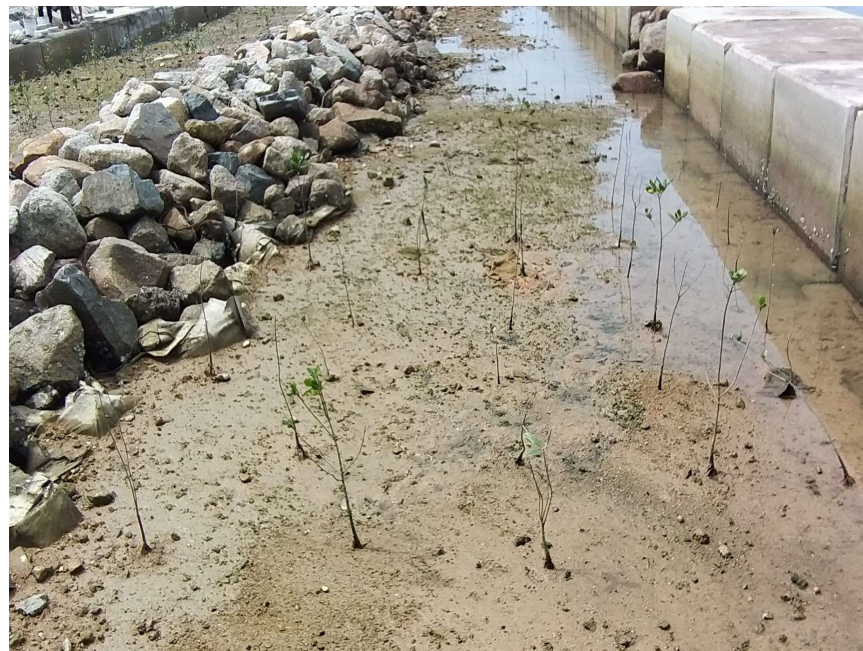
General View of Mangrove Eco-shoreline Lower Terrace

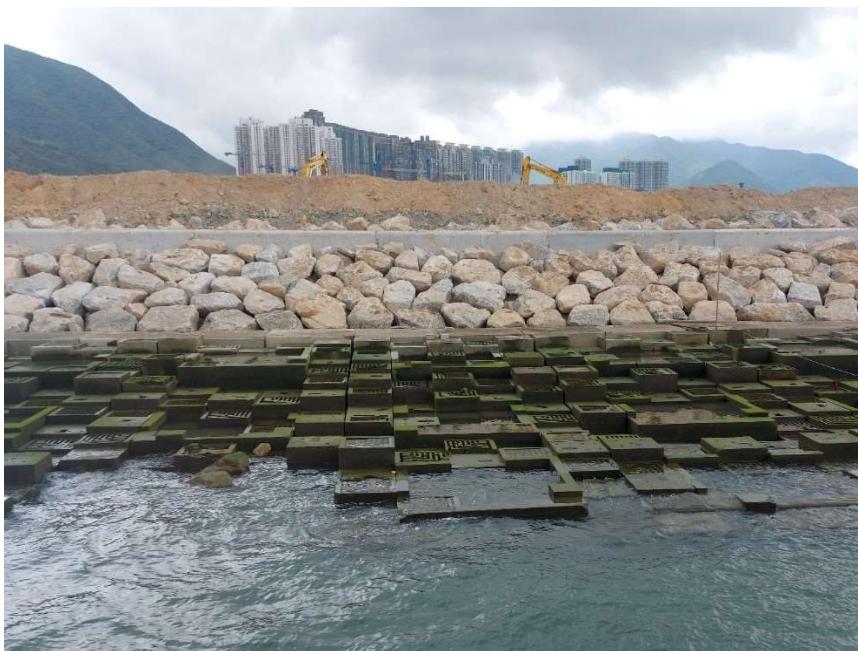
General View of Rocky Eco-shoreline

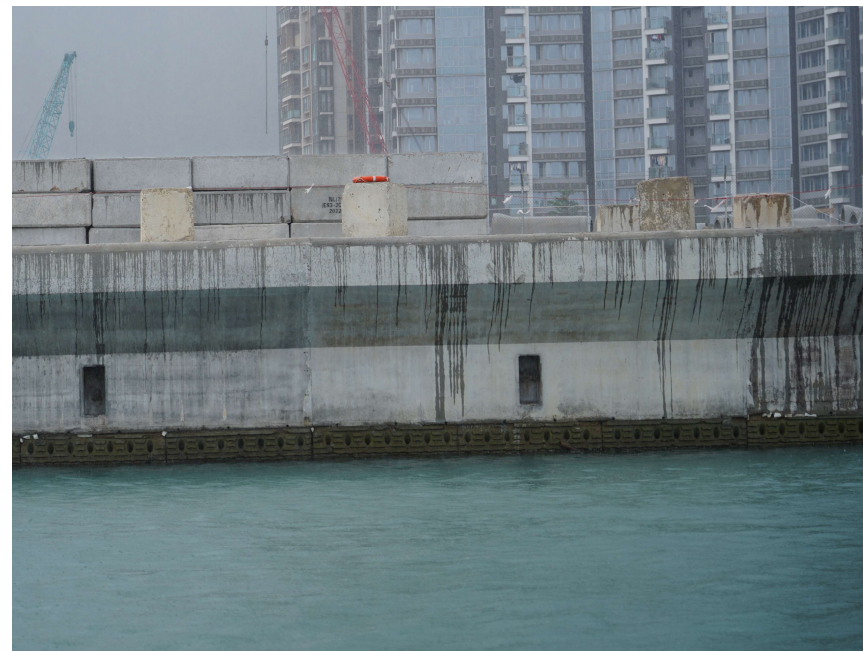
General View of Vertical Eco-shoreline
