**Civil Engineering and
Development Department**

Agreement No. CE 60/2017 (EP)

Environmental Team for Tung Chung New Town Extension (East) - Design and Construction

**Monthly Environmental Monitoring & Audit Report
for September 2022**

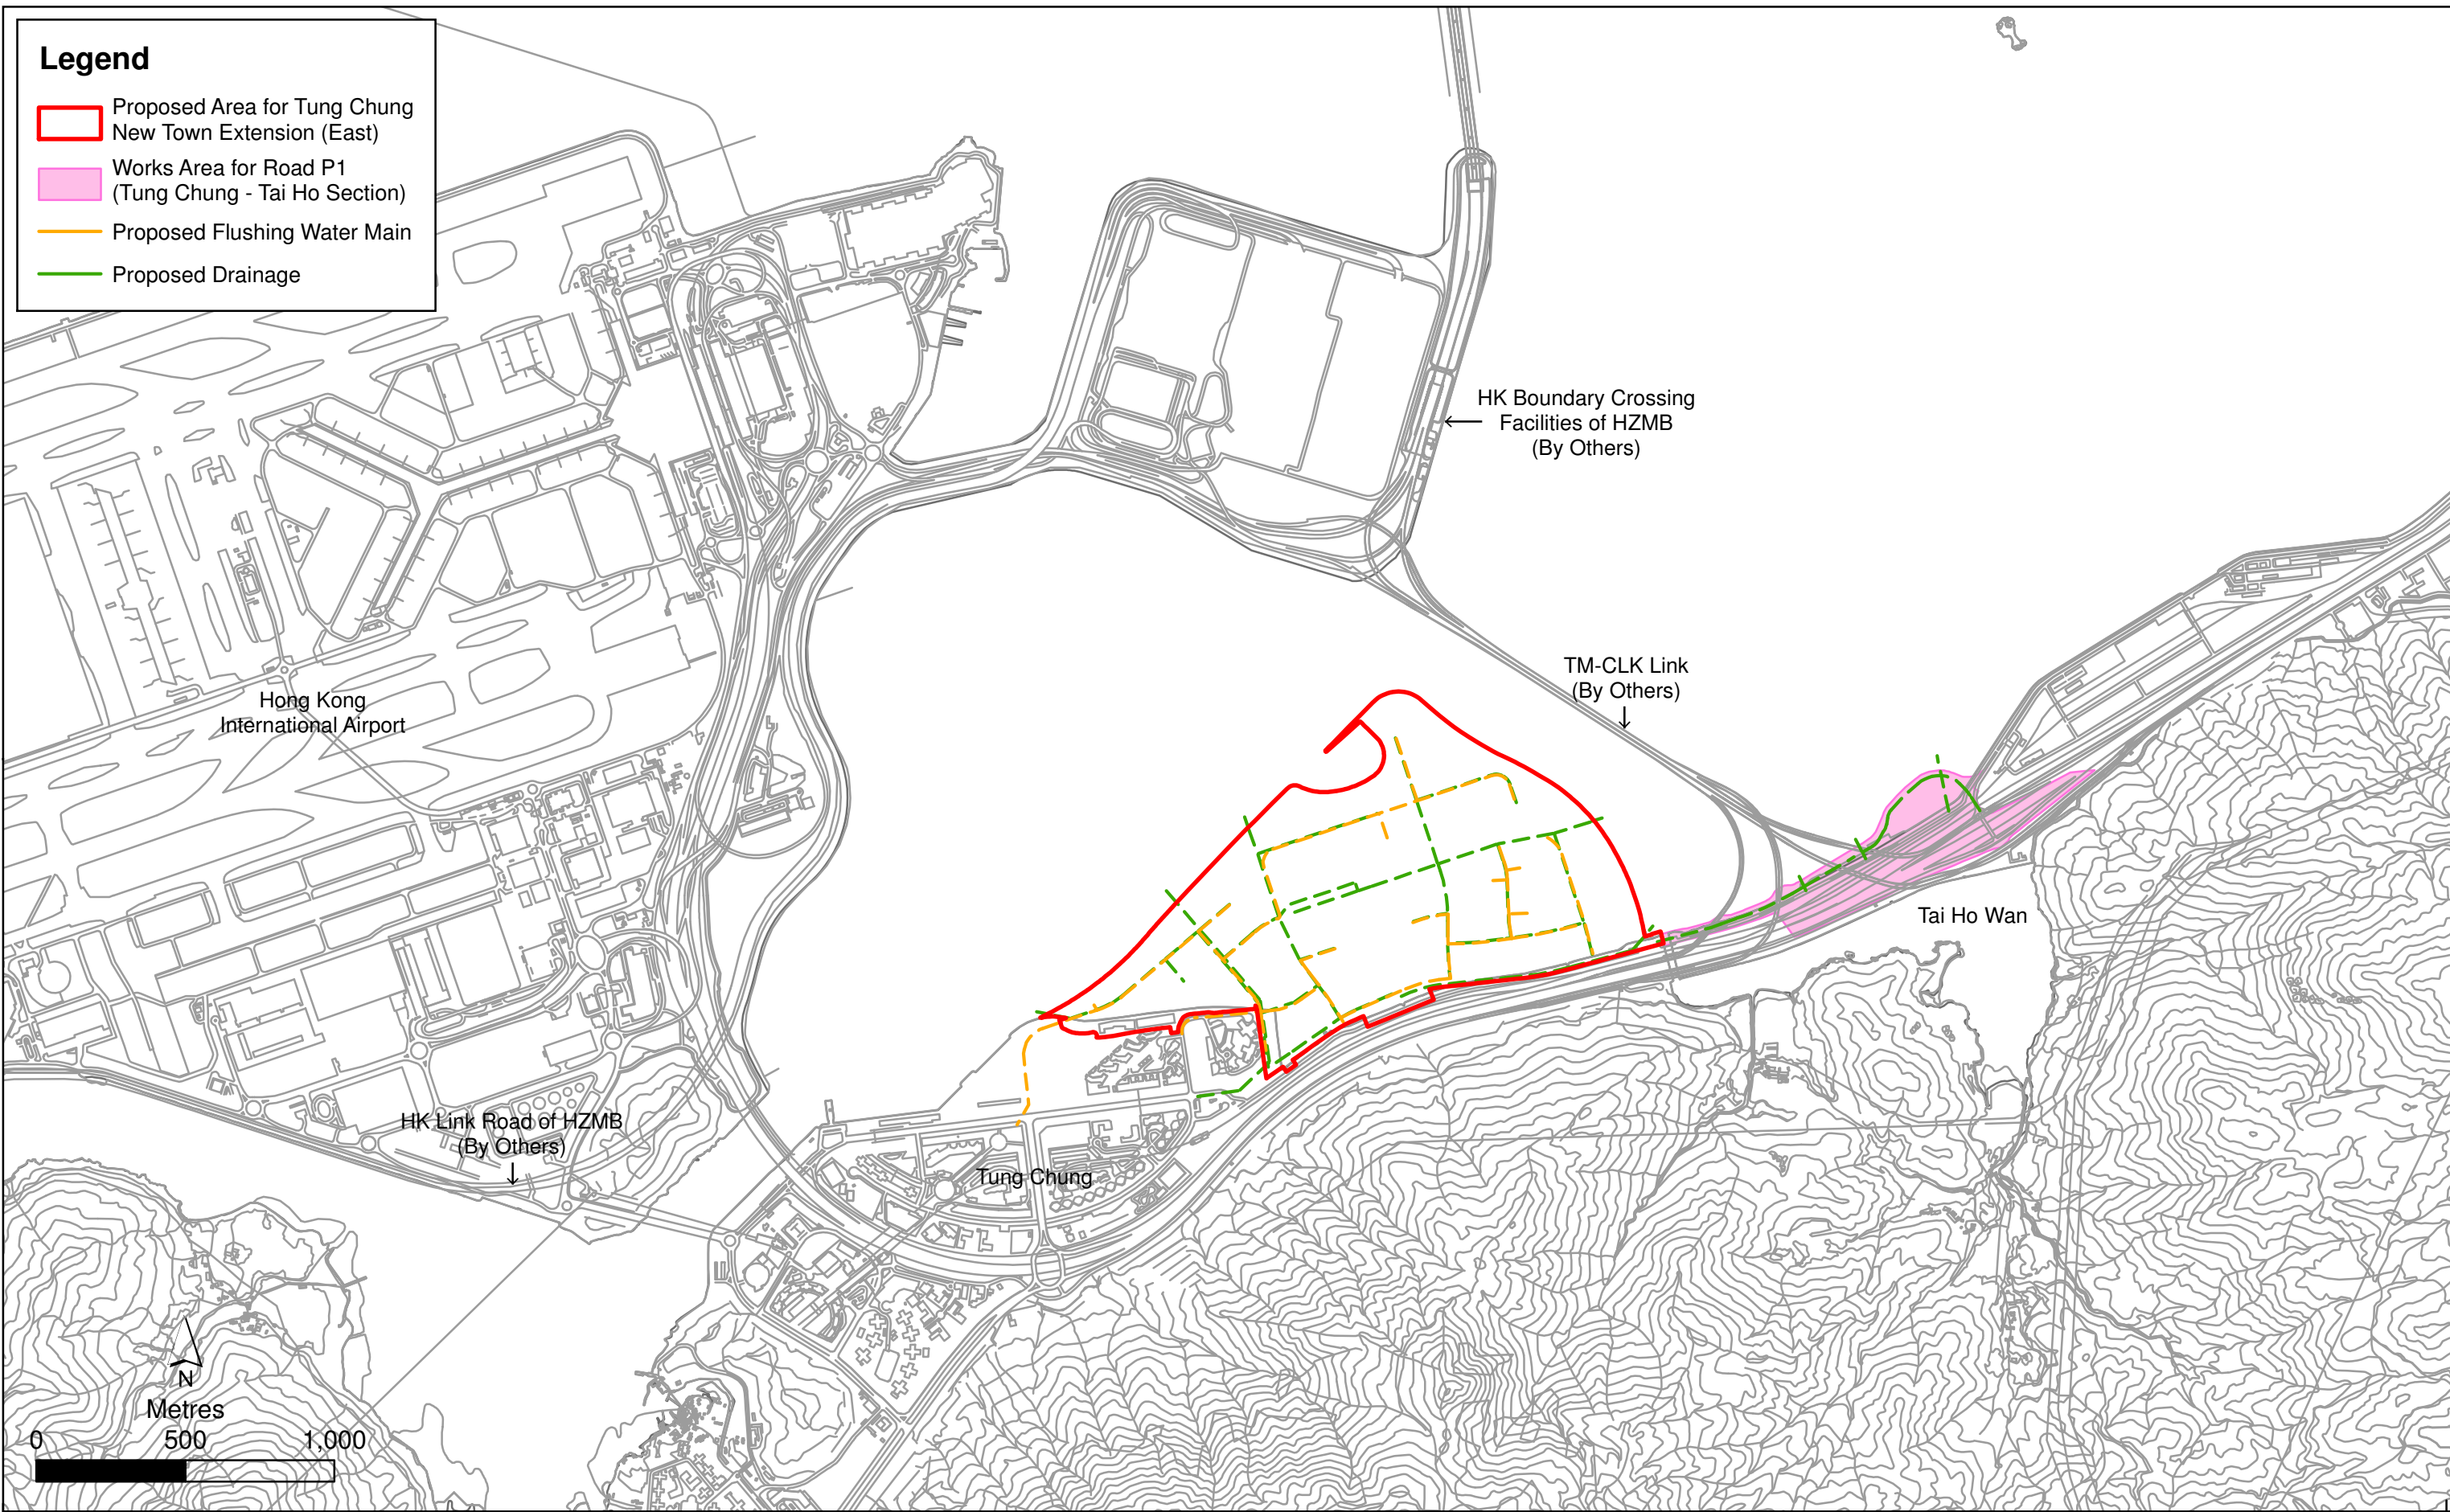
Figure 1.1

Location of Contract No. NL/2017/03 - Tung Chung New Town Extension - Reclamation and Advance Works (Contract 1)

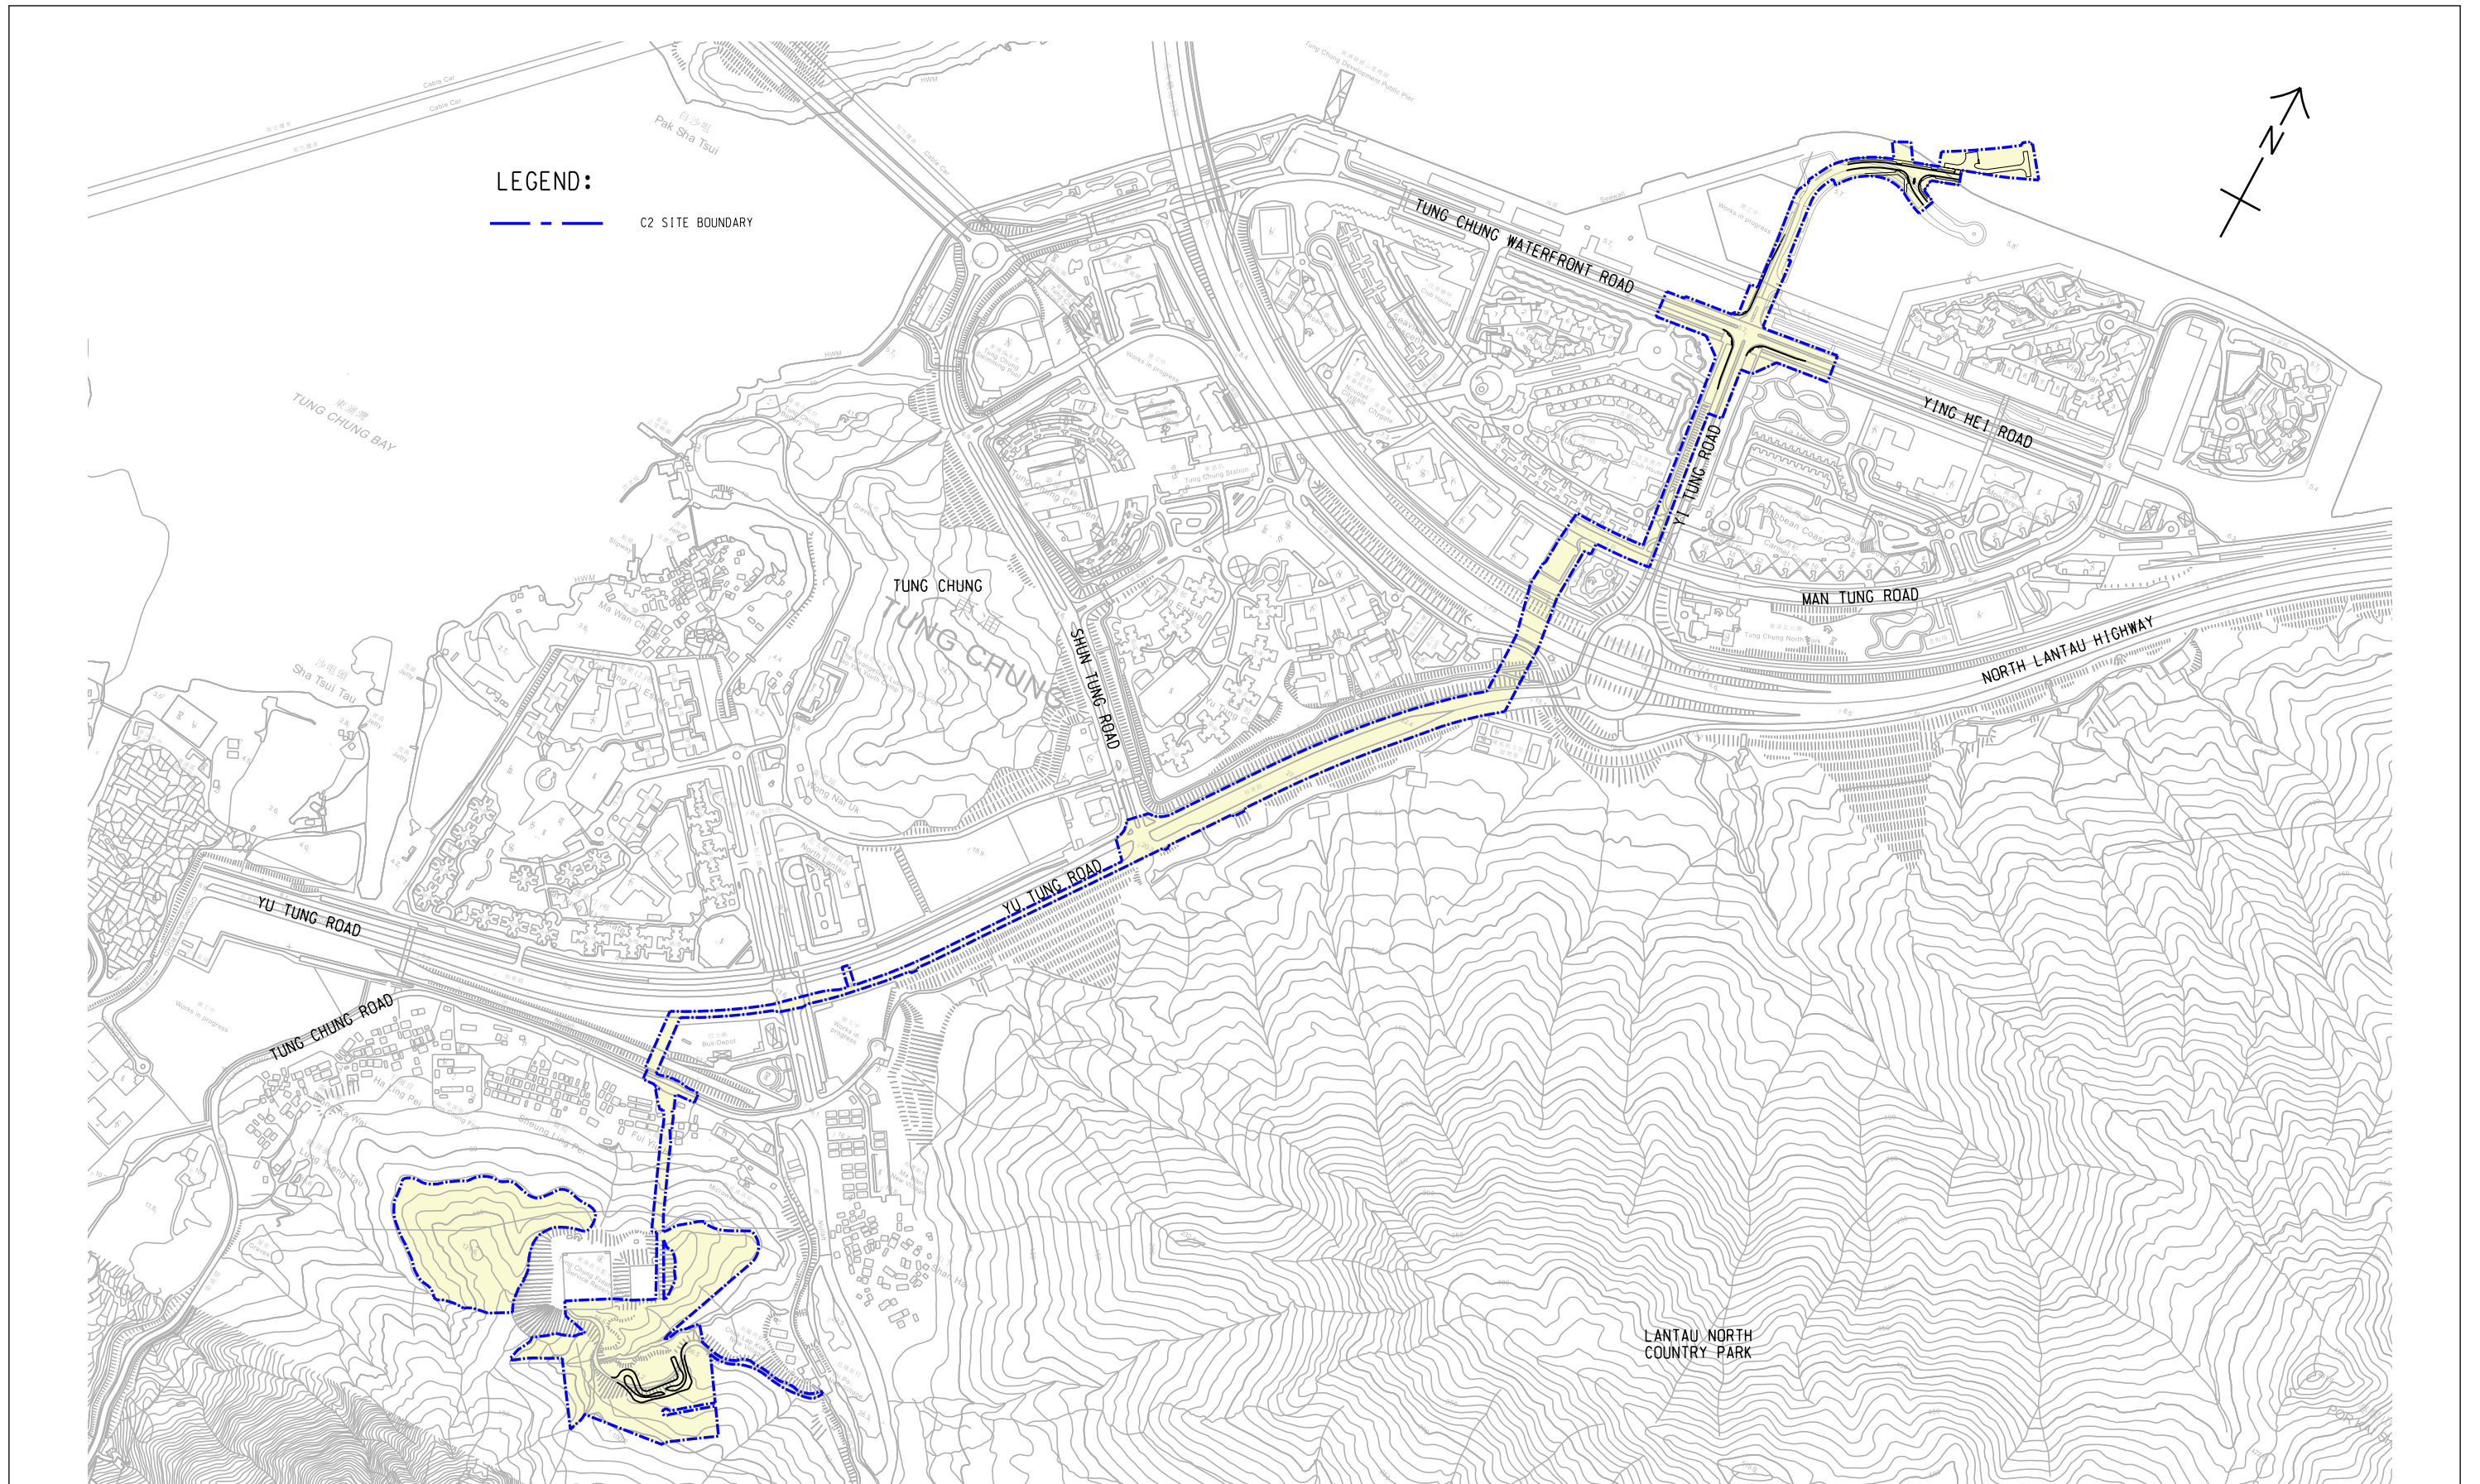
Figure 1.2 Location of Contract No. NL/2020/02 - Tung Chung New Town Extension – Salt Water Supply System (Contract 2)

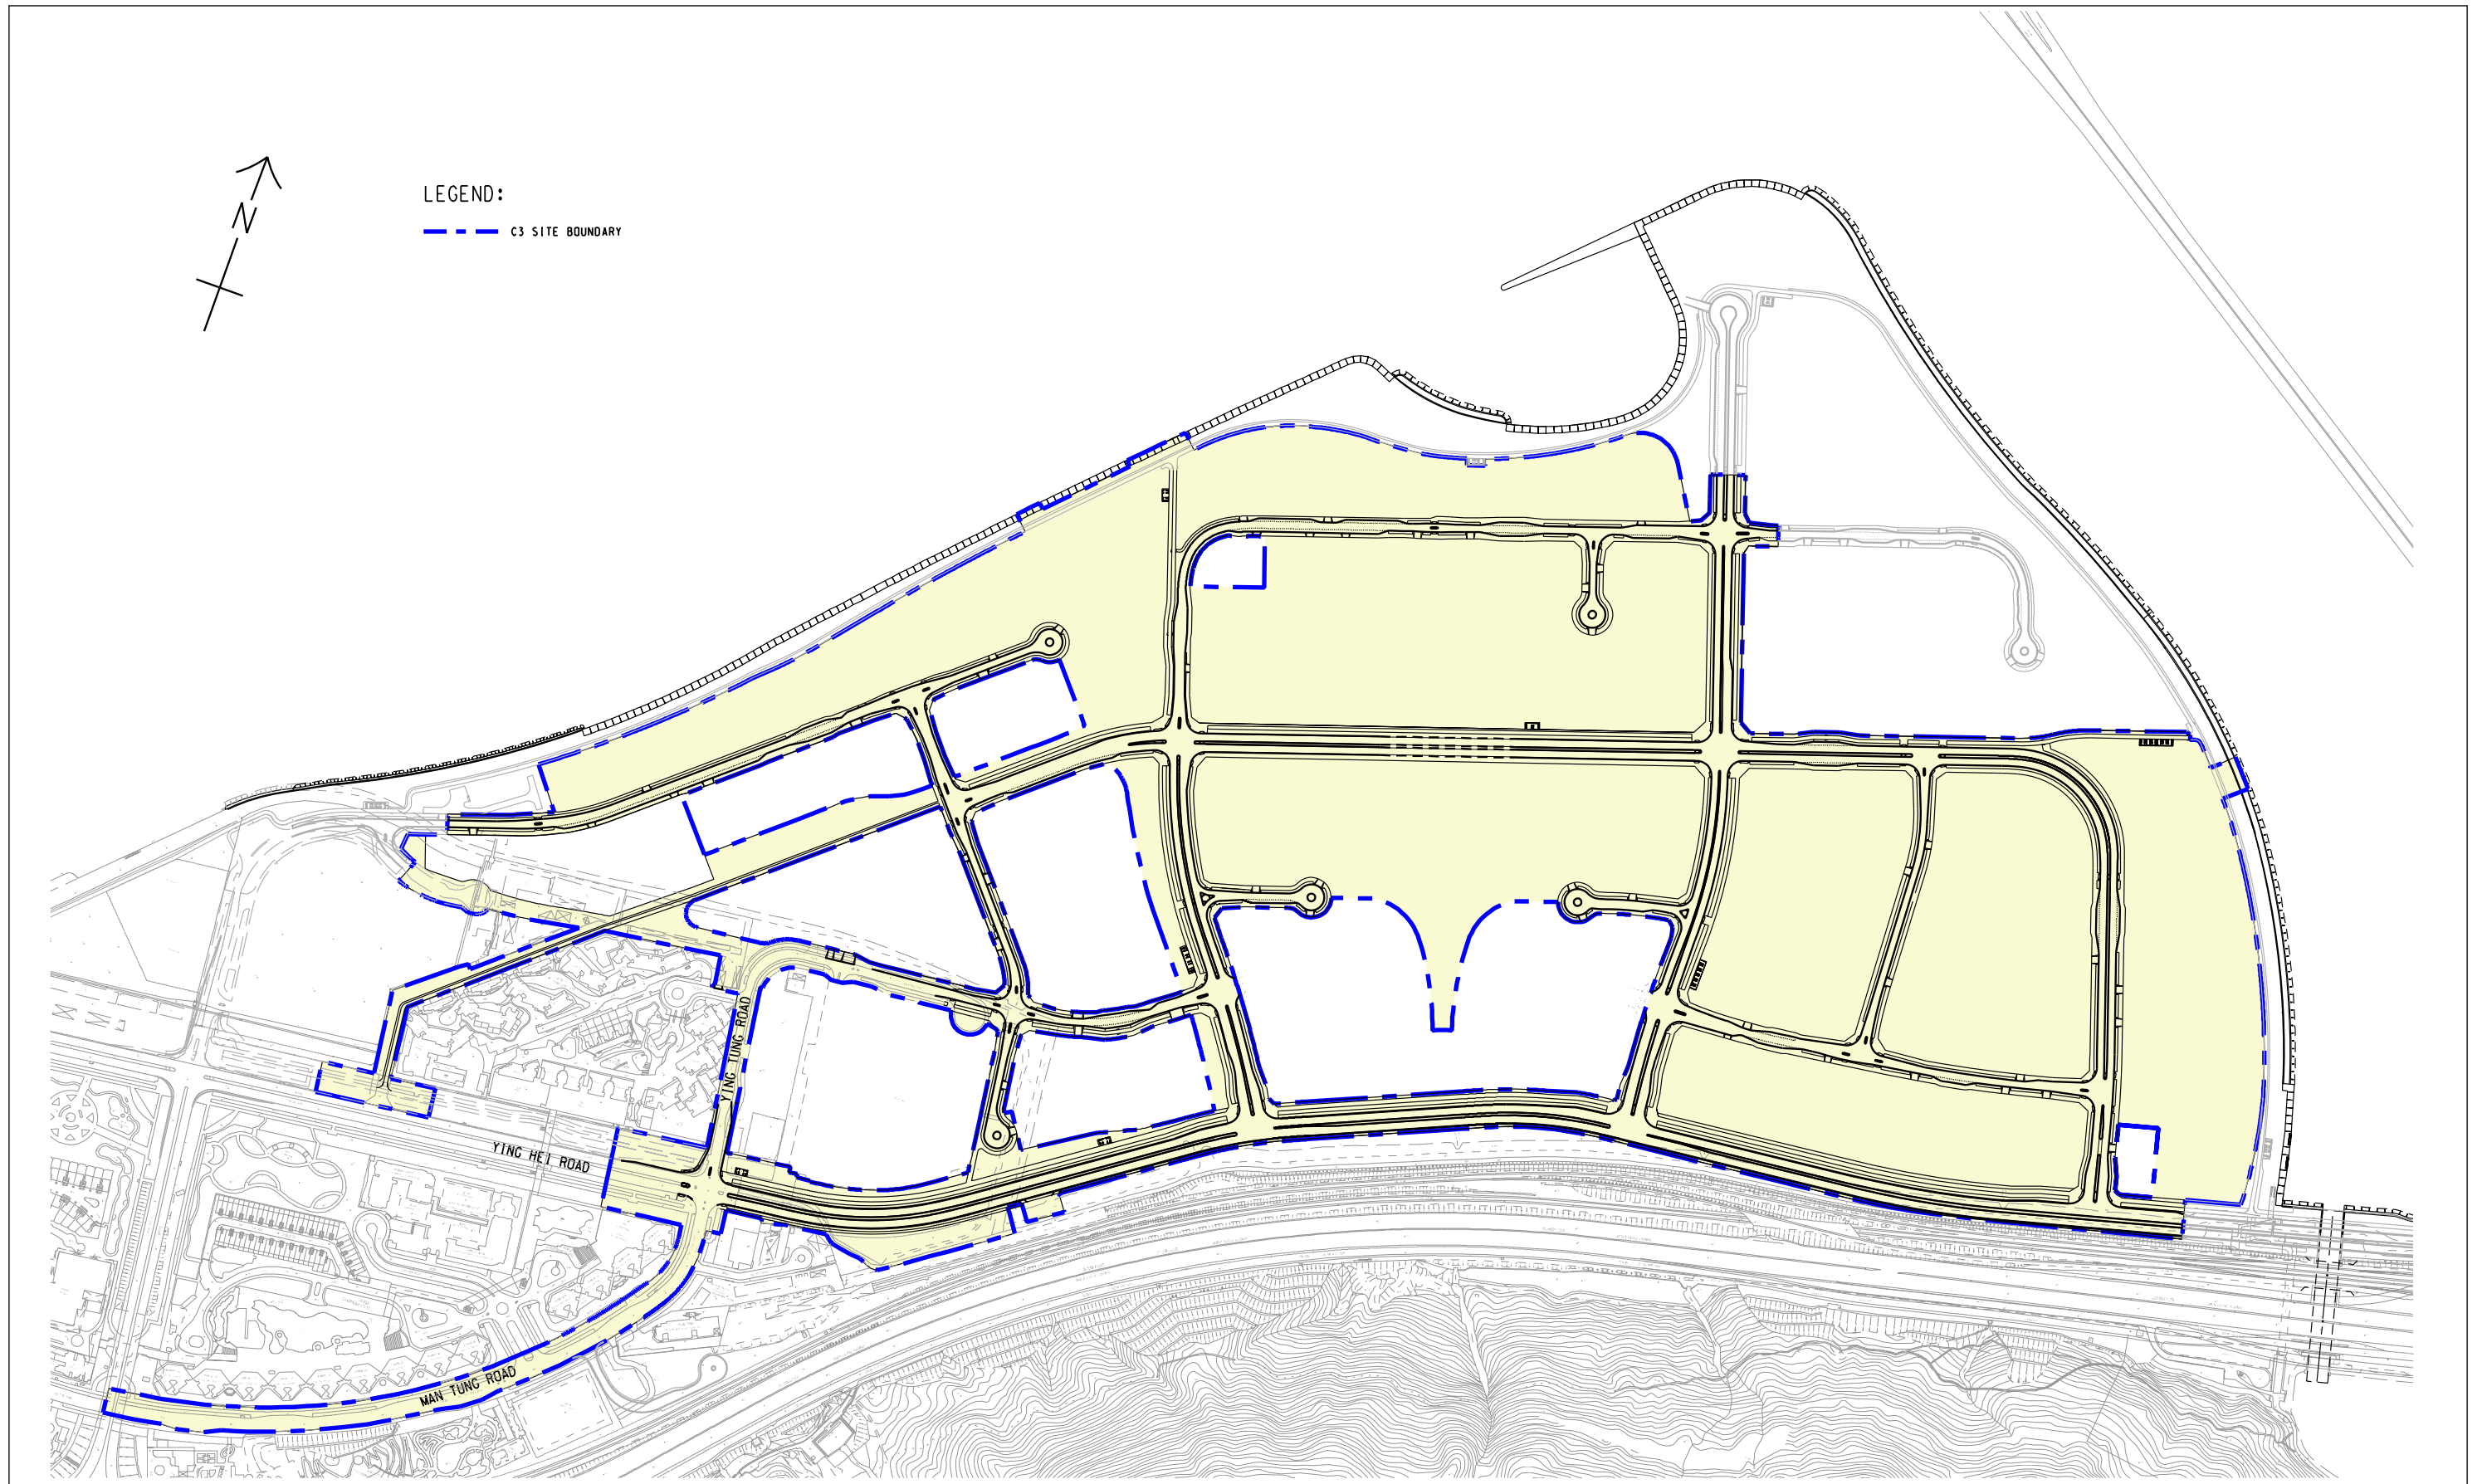
Figure 1.3

Location of Contract No. NL/2020/03 - Tung Chung New Town Extension – Major Infrastructure Works in Tung Chung East (Contract 3)

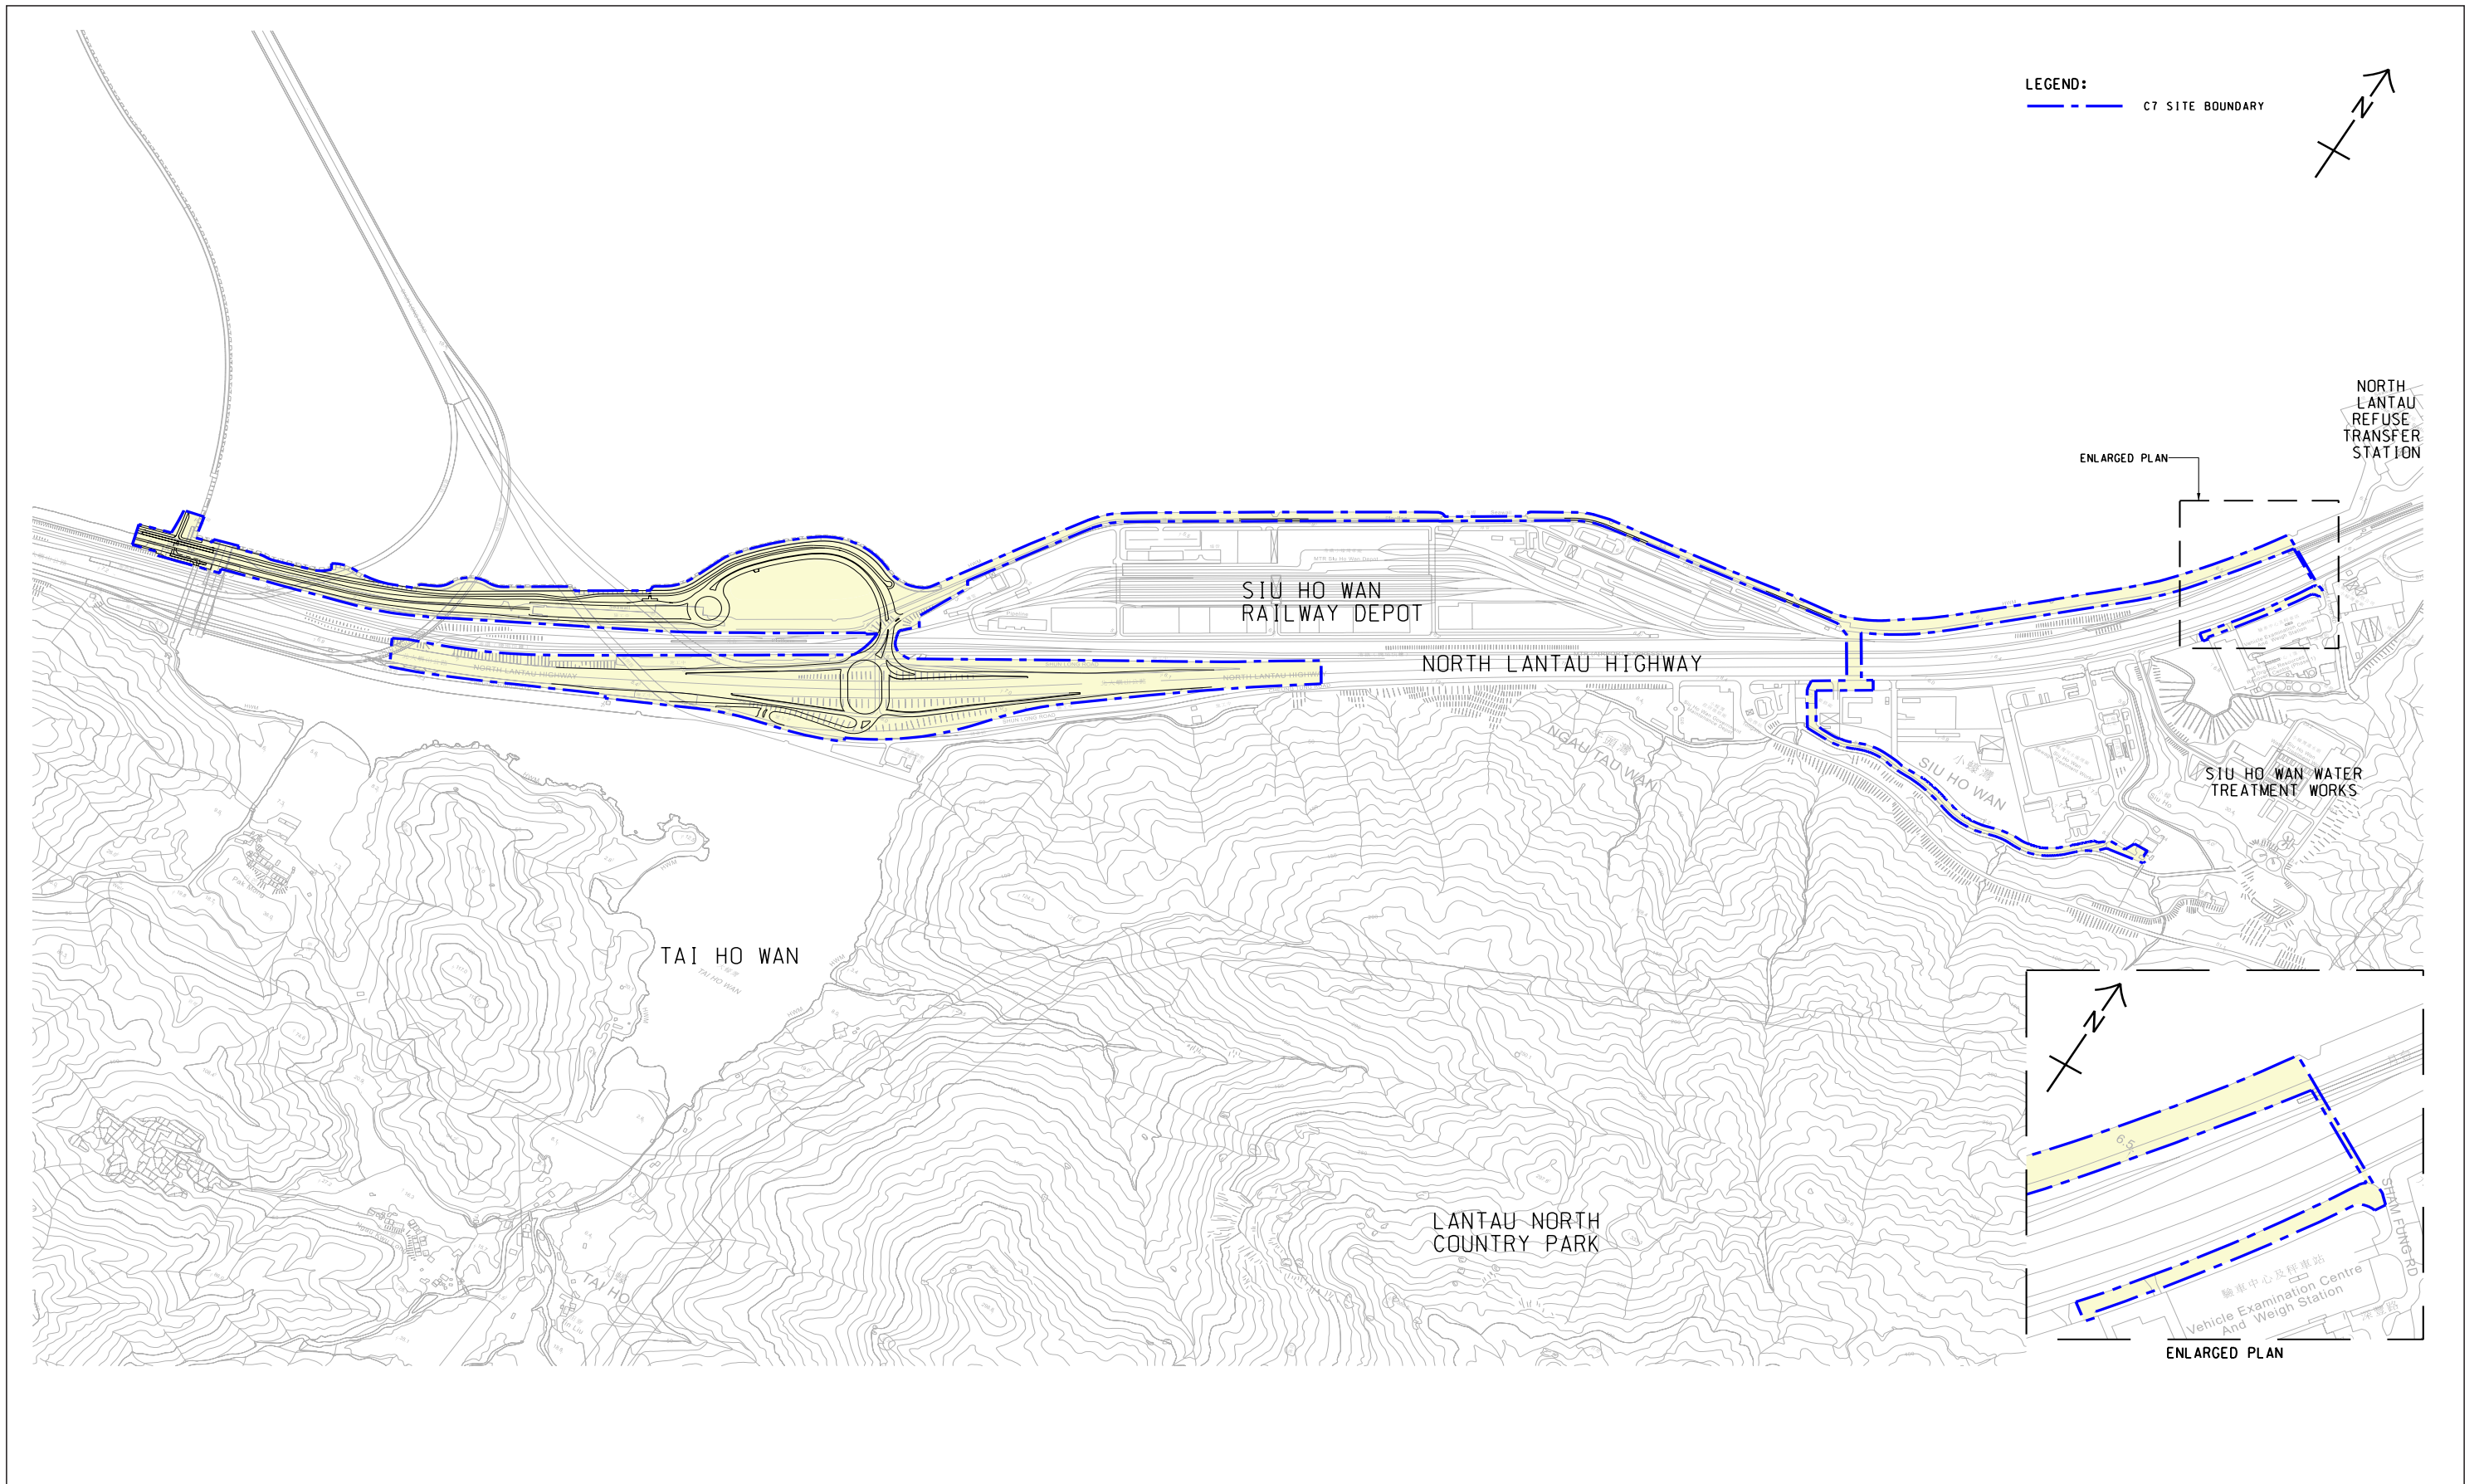
Figure 1.4 Location of Contract No. NL/2020/07 – Tung Chung New Town Extension – Tai Ho Interchange (Contract 7)

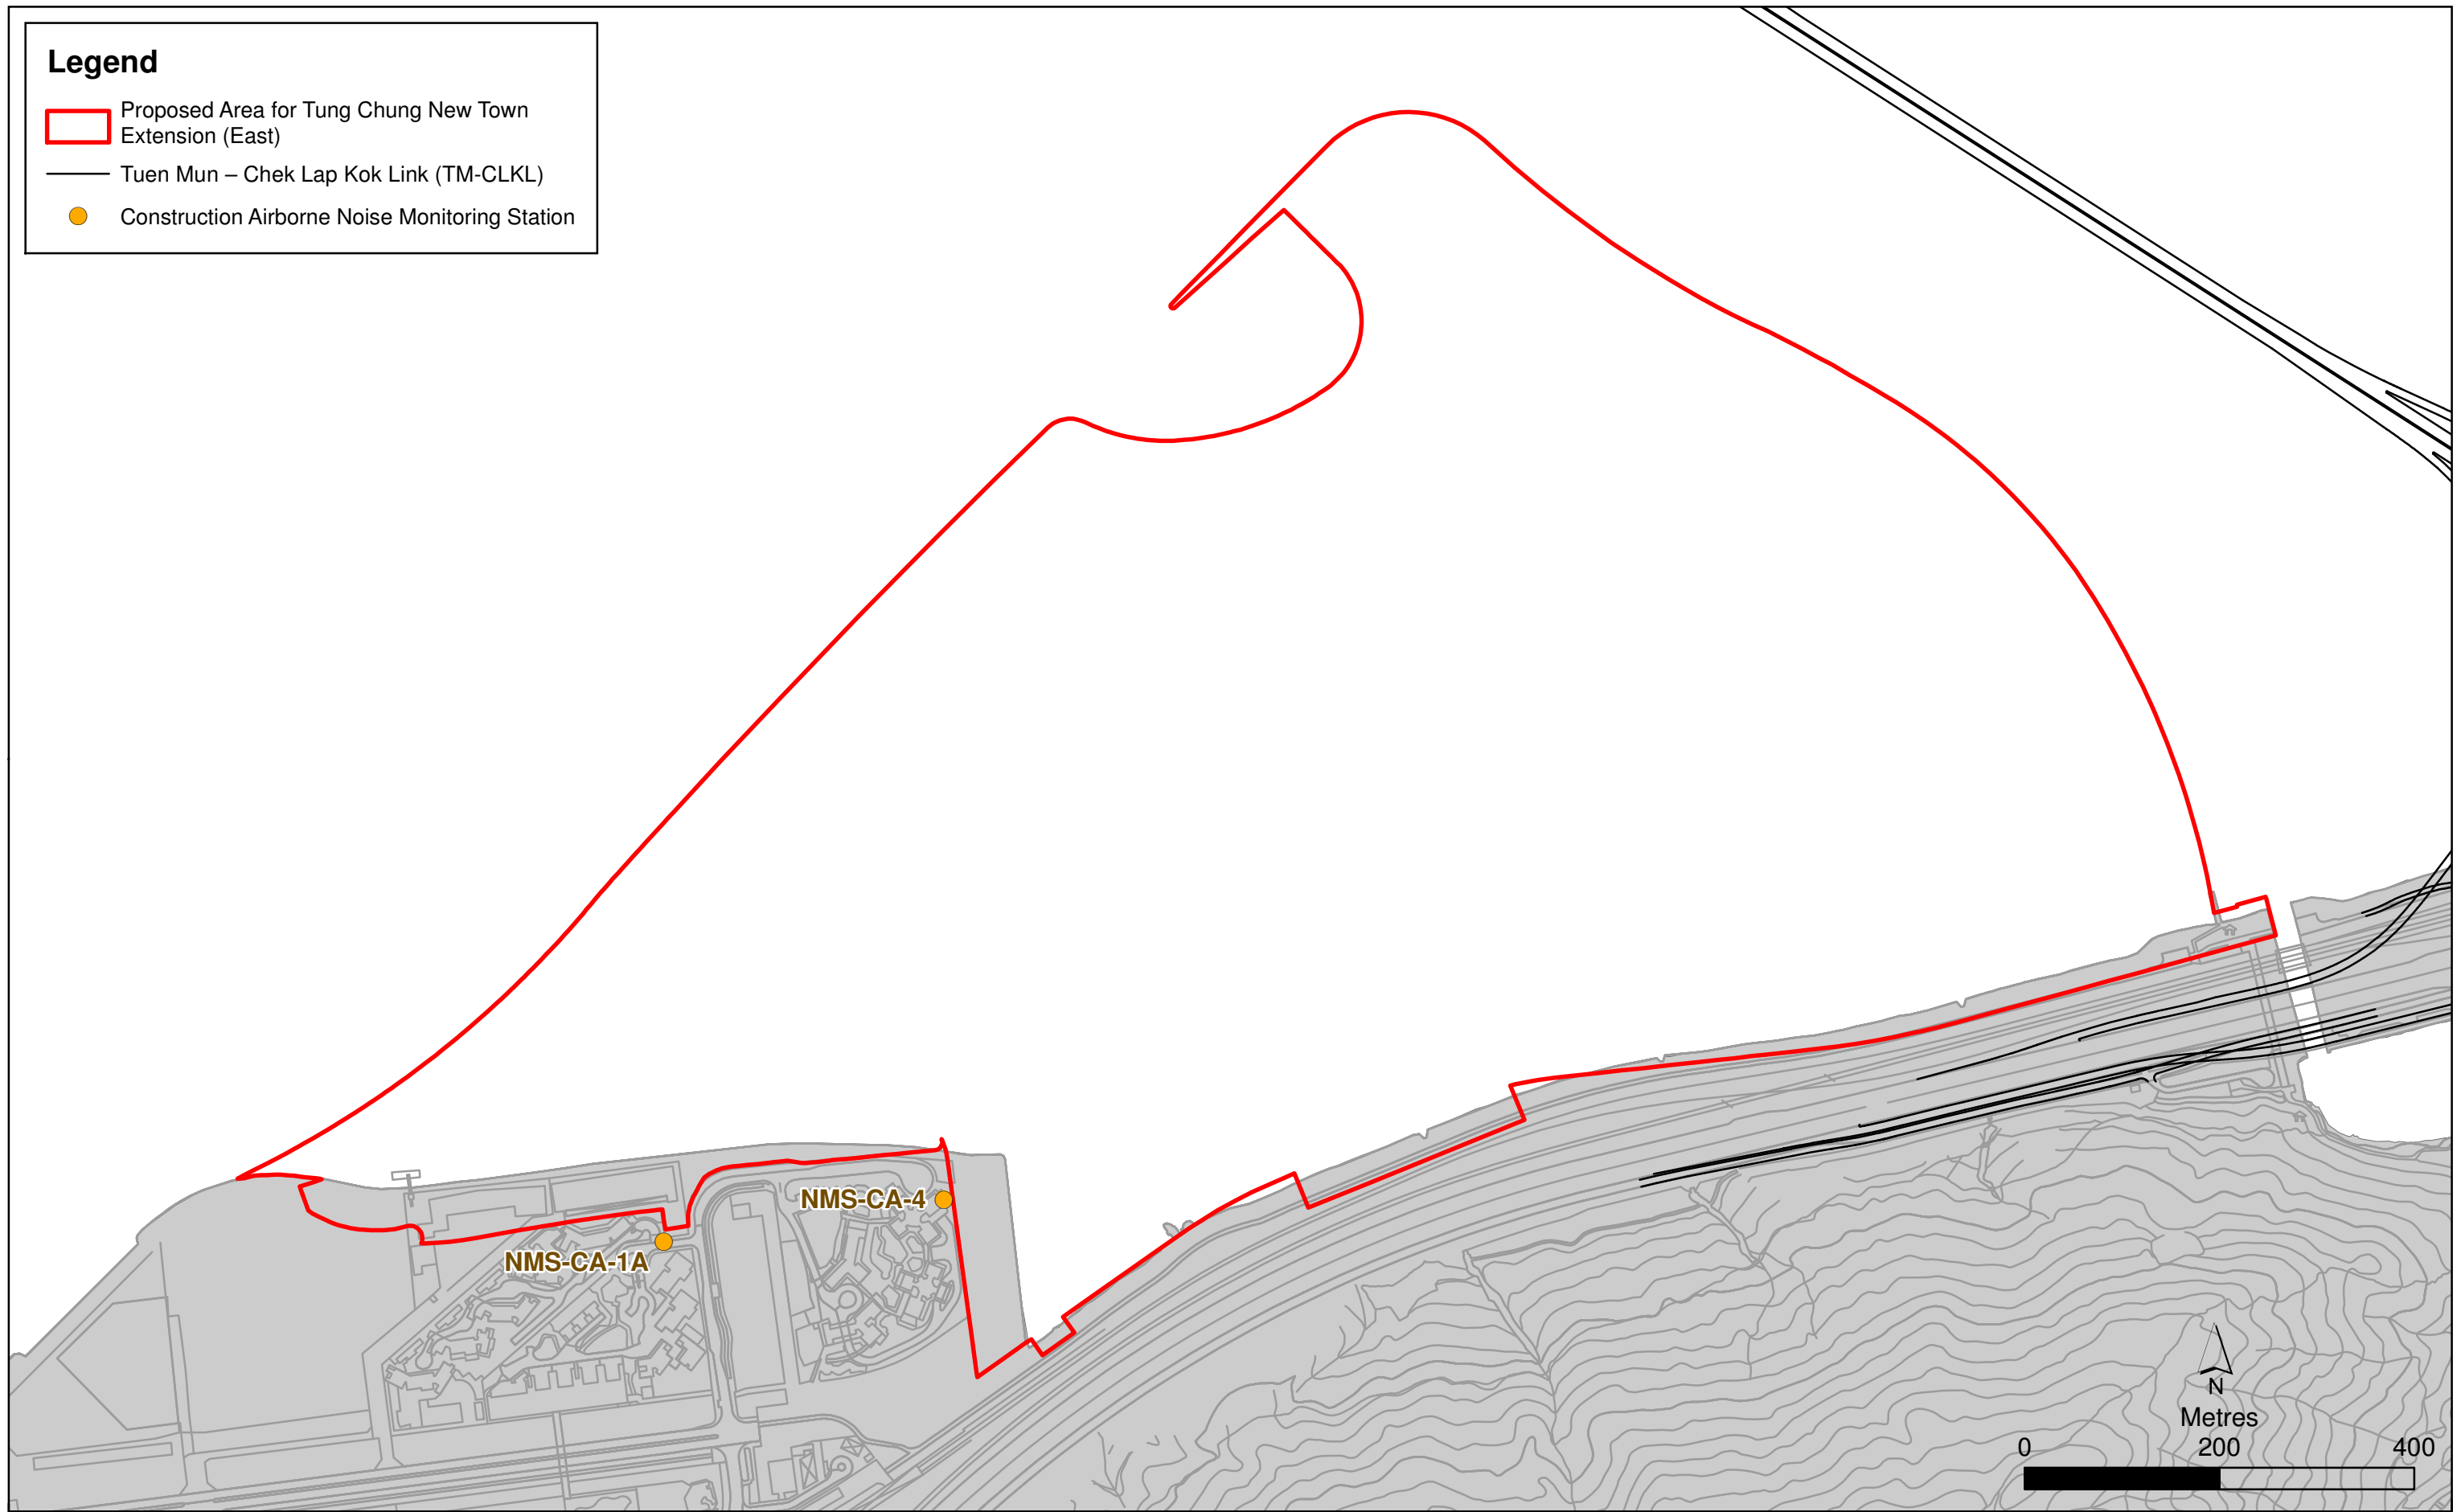
Figure 2.2

Construction Airborne Noise Monitoring Station Location

- (a) It should be noted that impact monitoring at other construction noise monitoring locations at TCE as stated in the Updated EM&A Manual will commence after the flat intake of residential premise in TCE (for Monitoring Station NMS-CA-1) and operation of schools (for Monitoring Stations NMS-CA-2 and NMS-CA-3).
- (b) Impact monitoring at monitoring station NMS-CA-1A commenced on 19 September 2018 in view of the close vicinity of the construction works near the residential area at Century Link.
- (c) Due to land handover issue, NMS-CA-1A was relocated to Ying Hong Road which is located 60m away from the original location. Proposal on the relocation of NMS-CA-1A was approved by IEC on 23 November 2018. Noise monitoring at the relocated location commenced since 24 November 2018.

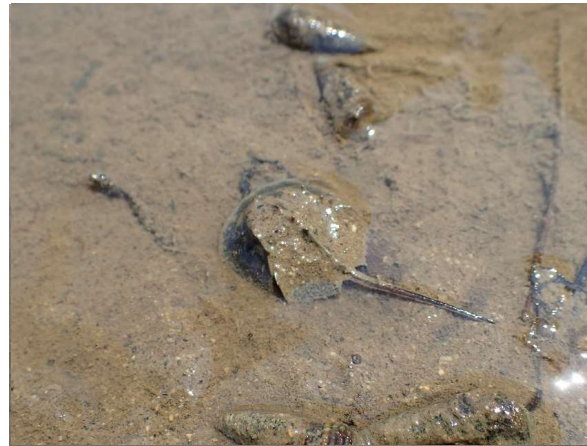
(e) Horseshoe crabs *Tachypleus tridentatus* recorded at THW during the Qualitative Walk-through Survey

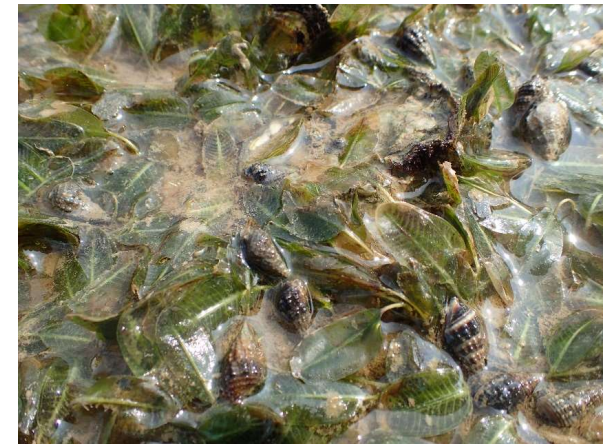
(f) Seagrass *Halophila ovalis* recorded at TCB3 during the Qualitative Walk-through Survey

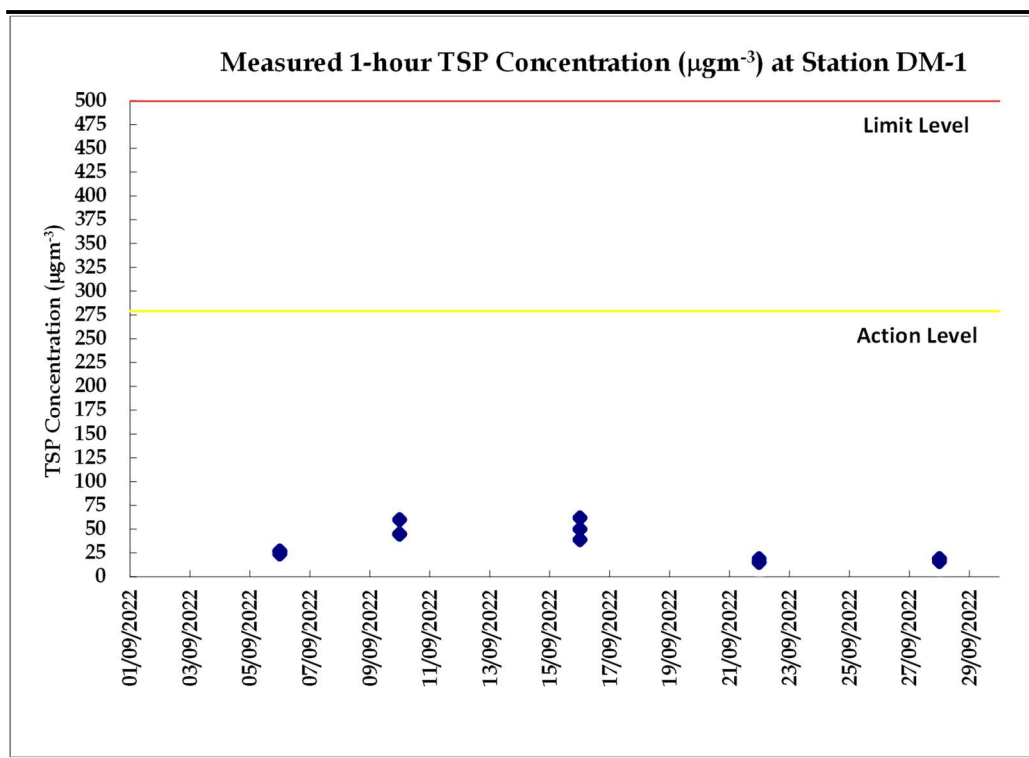
Figure E3 *Graphical Presentation for 1-hr TSP Monitoring at Station DM-1*

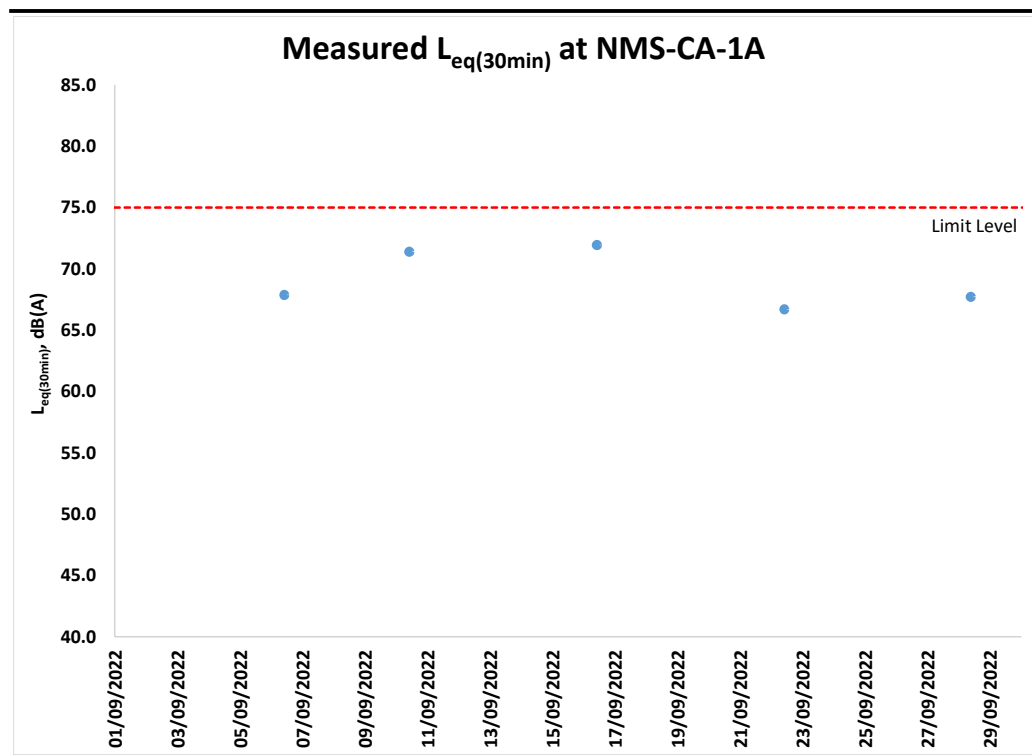
Figure F3.1 Graphical Presentation for Noise Monitoring at Station NMS-CA-1A

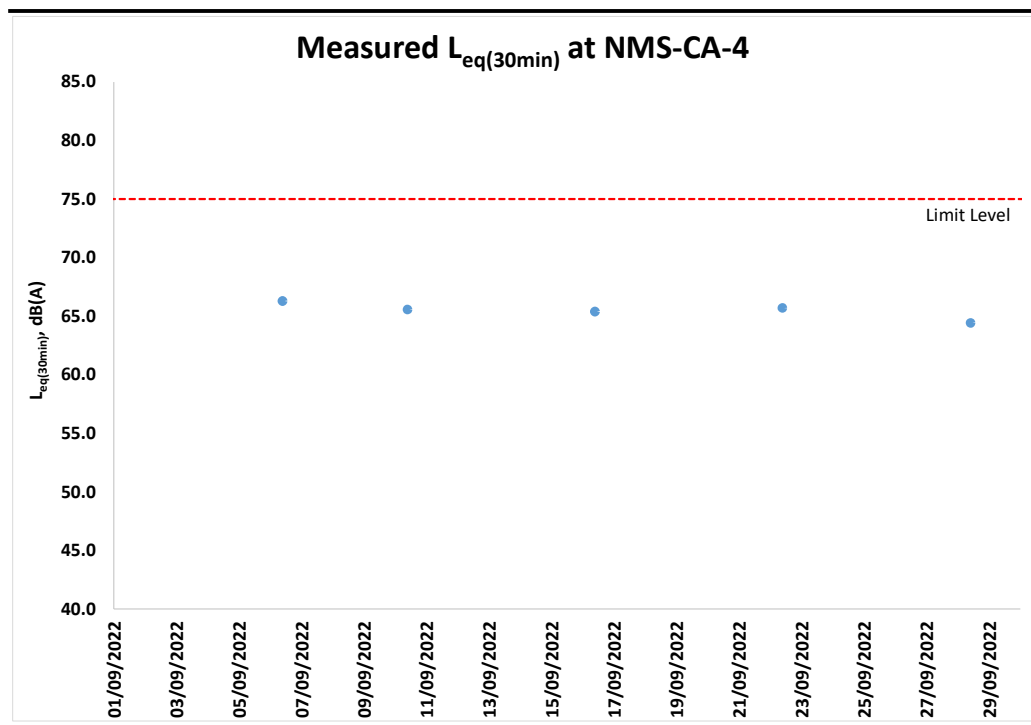
Figure F3.2 Graphical Presentation for Noise Monitoring at Station NMS-CA-4

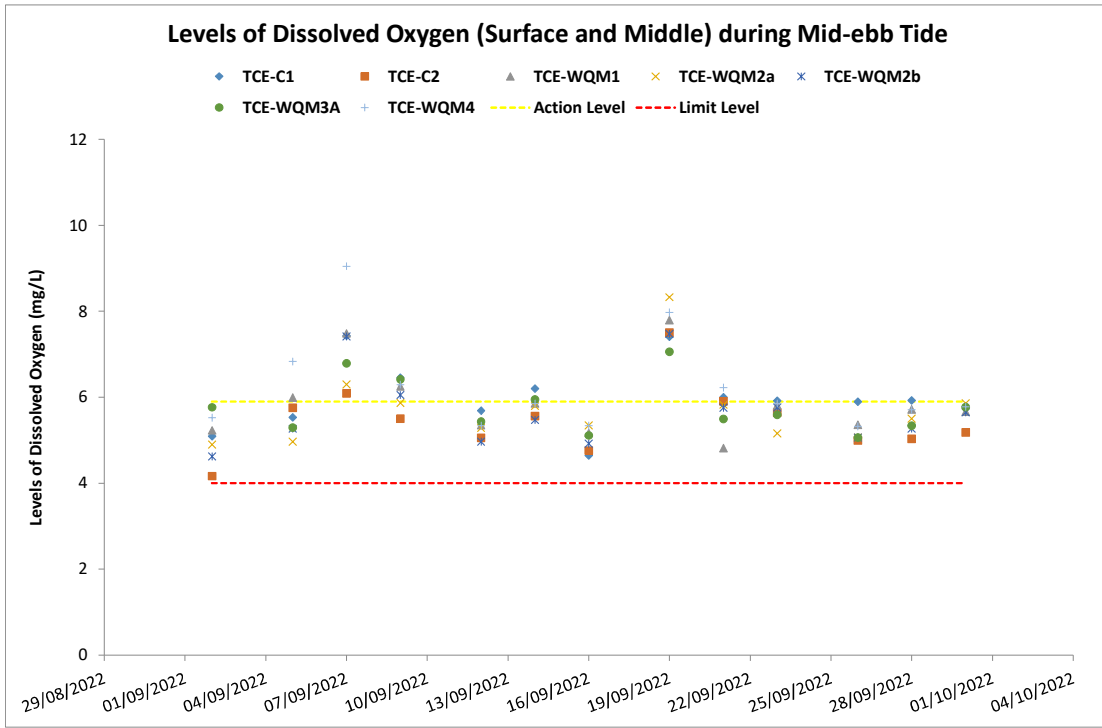
Figure 1: Levels of Dissolved Oxygen (Surface and Middle) (mg/L) recorded at Mid-ebb Tide during the Water Quality Monitoring between 1 to 30 September 2022

Based on the investigations conducted for each of the monitoring day with exceedances, the exceedances of DO and SS were not likely caused by the work activities related to the Project.

In addition, low levels of DO were recorded during previous three summer periods. This further suggested that exceedances of DO are likely caused by seasonal fluctuation and a similar trend of lower levels of DO would likely occur again during this summer period.
