**Civil Engineering and
Development Department**

Agreement No. CE 60/2017 (EP)

Environmental Team for Tung Chung New Town Extension (East) - Design and Construction

**Monthly Environmental Monitoring & Audit Report
for September 2022**

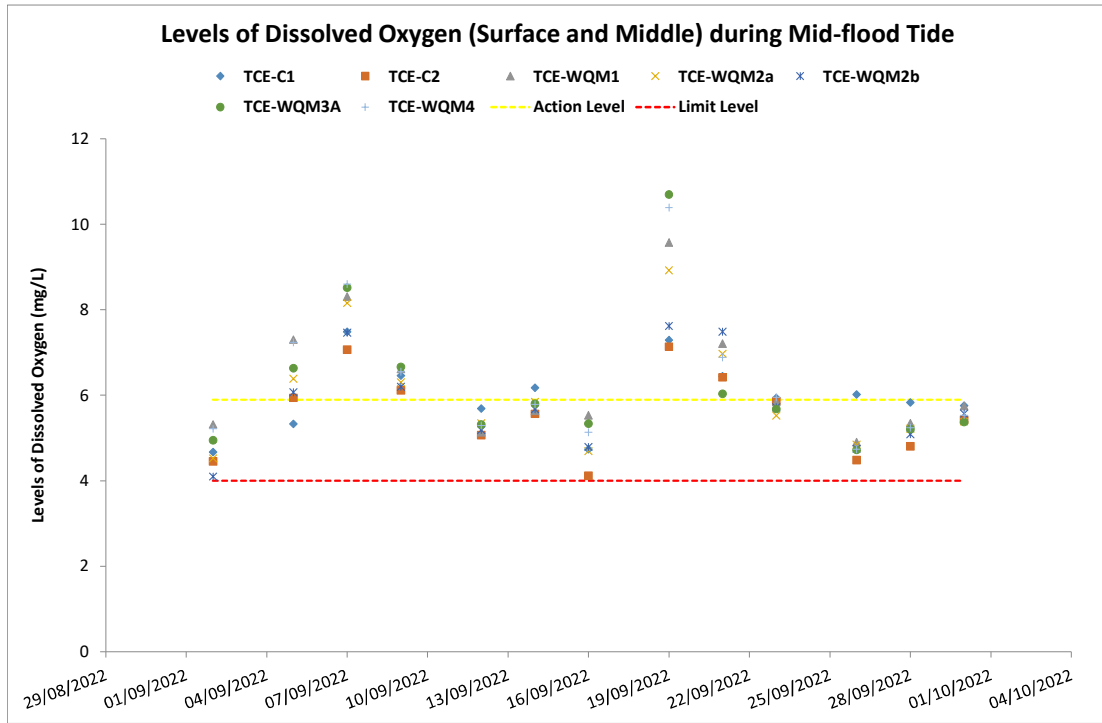
Figure 2: Levels of Dissolved Oxygen (Surface and Middle) (mg/L) recorded at Mid-flood Tide during the Water Quality Monitoring between 1 to 30 September 2022

Based on the investigations conducted for each of the monitoring day with exceedances, the exceedances of DO and SS were not likely caused by the work activities related to the Project.

In addition, low levels of DO were recorded during previous three summer periods. This further suggested that exceedances of DO are likely caused by seasonal fluctuation and a similar trend of lower levels of DO would likely occur again during this summer period.

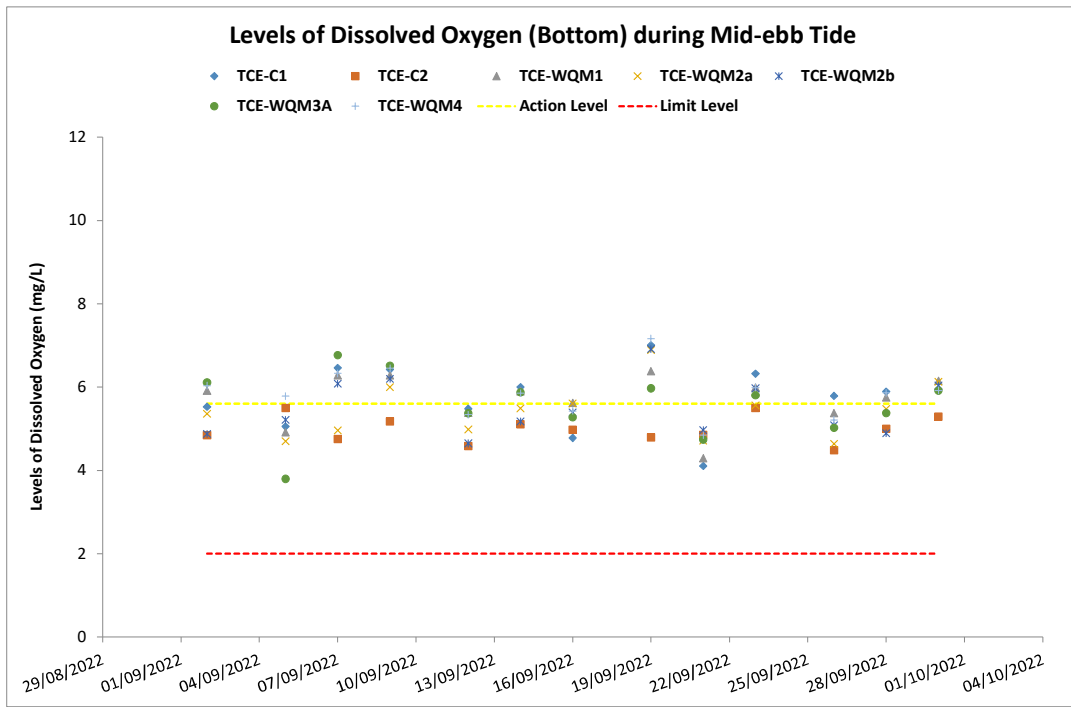
Figure 3: Levels of Dissolved Oxygen (Bottom) (mg/L) recorded at Mid-ebb Tide during the Water Quality Monitoring between 1 to 30 September 2022

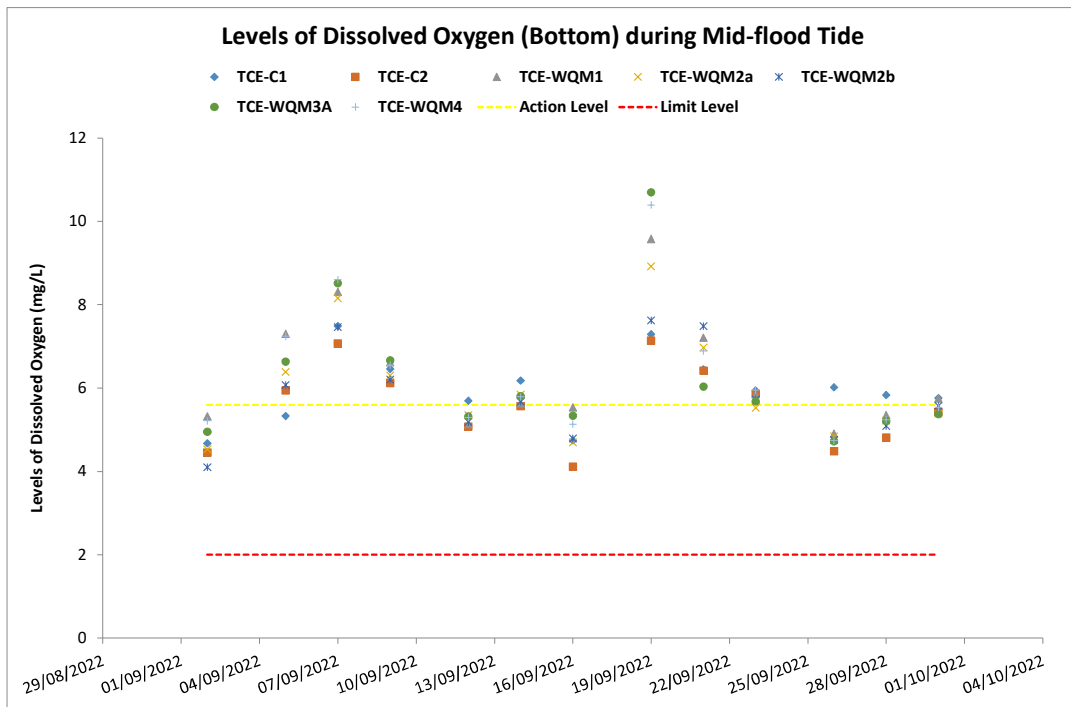
Figure 4: Levels of Dissolved Oxygen (Bottom) (mg/L) recorded at Mid-flood Tide during the Water Quality Monitoring between 1 to 30 September 2022

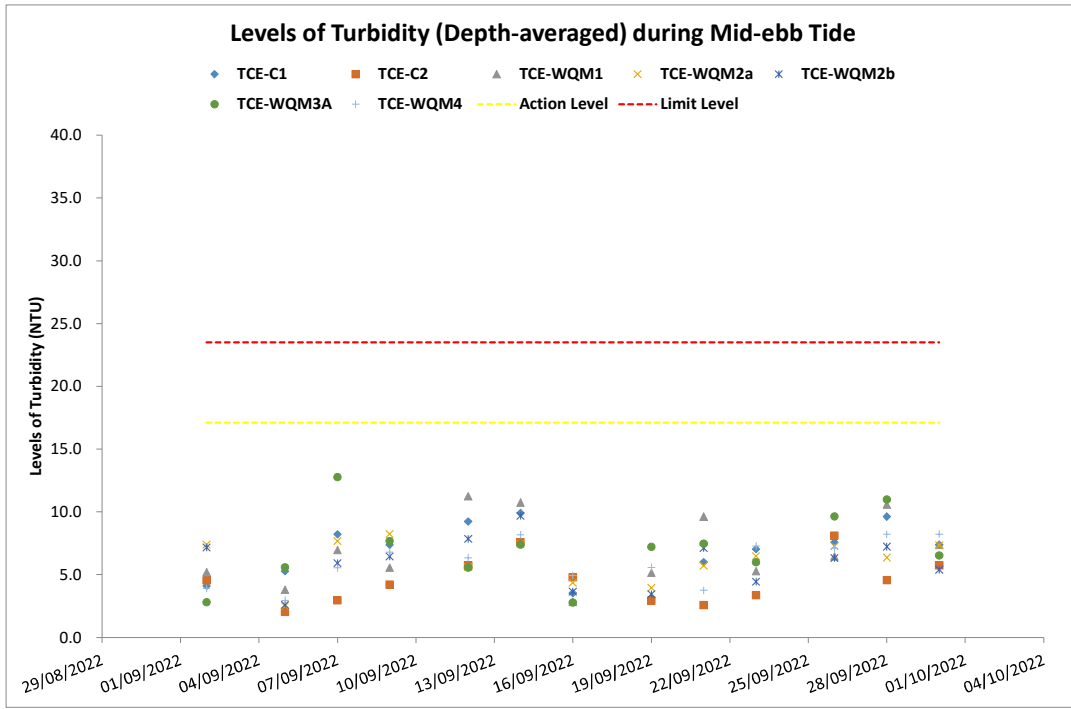
Figure 5: Levels of Turbidity (Depth-averaged) (NTU) recorded at Mid-ebb Tide during the Water Quality Monitoring between 1 to 30 September 2022

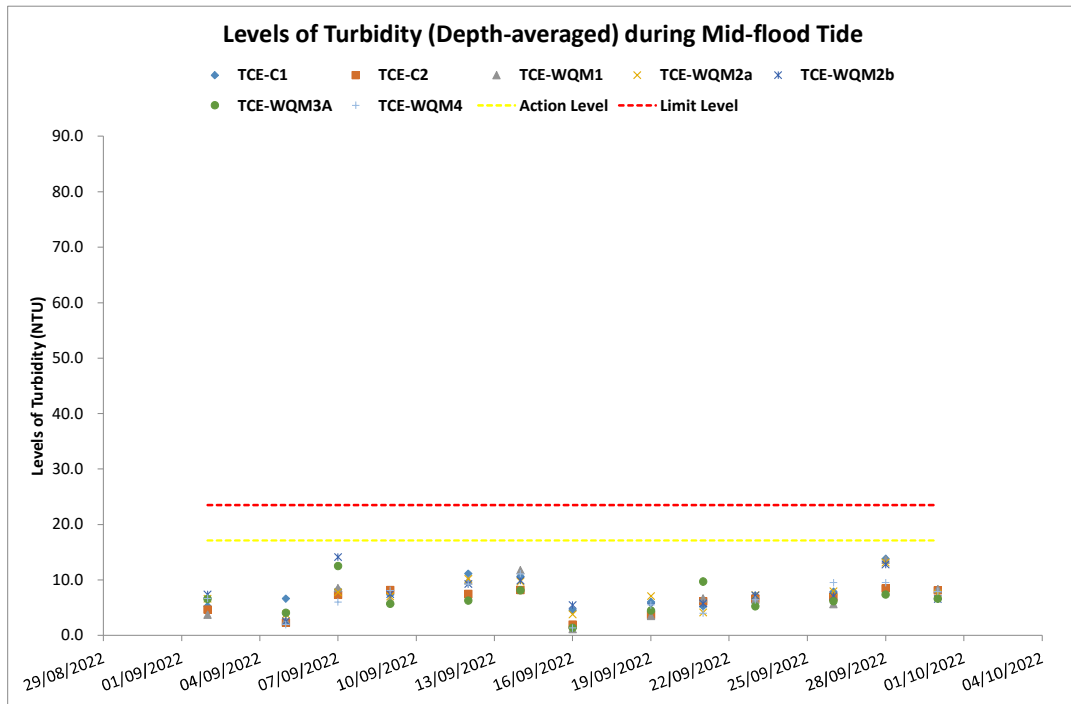
Figure 6: Levels of Turbidity (Depth-averaged) (NTU) recorded at Mid-flood Tide during the Water Quality Monitoring between 1 to 30 September 2022

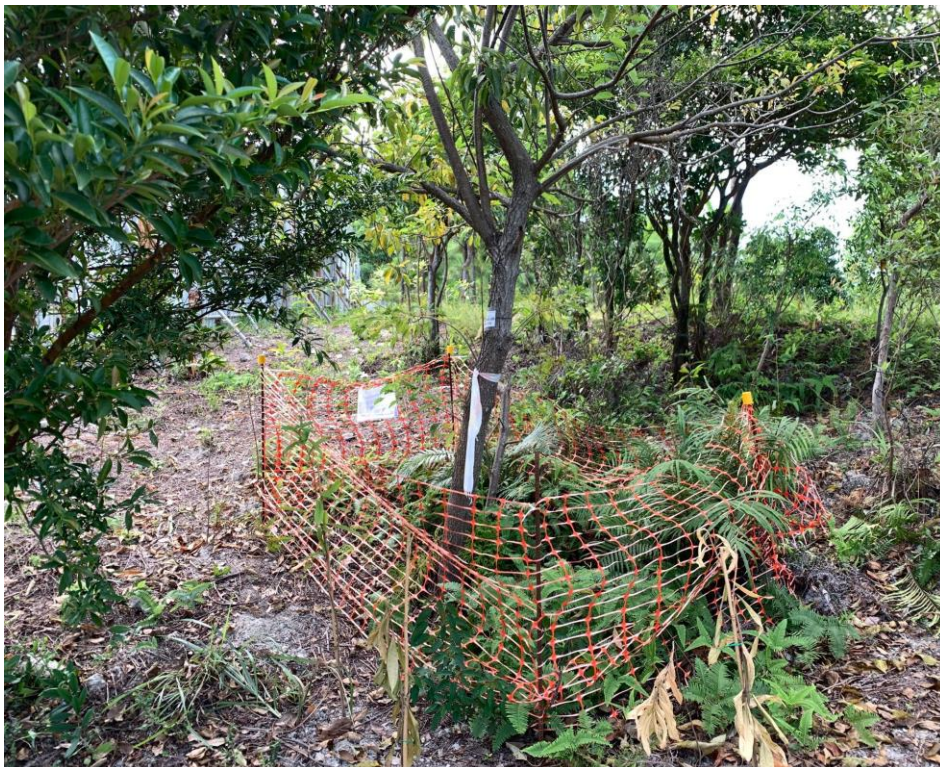
Photo 1 – General view of tree protection zone for preserved plant species of conservation importance

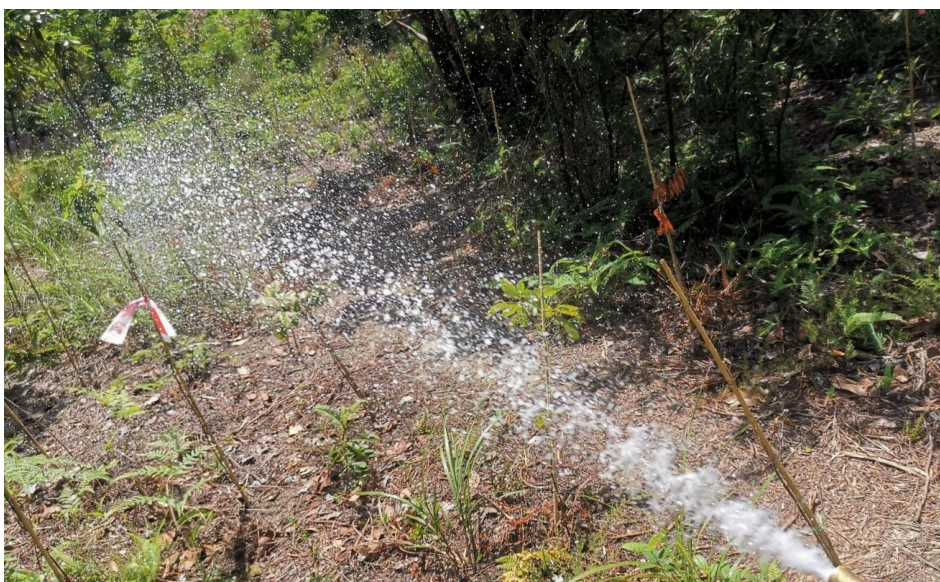
Photo 2 – Regular watering of compensation woodland
