Agreement No. CE 60/2017 (EP) Environmental Team for Tung Chung New Town Extension (East) – Design and Construction
Monthly Environmental Monitoring & Audit Report for March 2025

Agreement No. CE 60/2017 (EP) Environmental Team for Tung Chung New Town Extension (East) – Design and Construction

Monthly Environmental Monitoring & Audit Report for March 2025

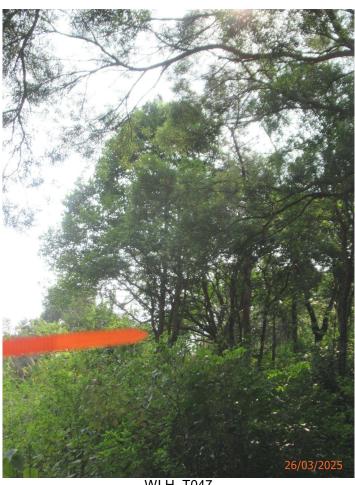
WLH_T047 Aquilaria sinensis
Observed since November 2023
