# **Tung Chung New Town Extension – Salt Water Supply System**

## **Detailed Preservation and/or Translocation Plan for Plant Species of Conservation Importance for Tung Chung East**

November 2021

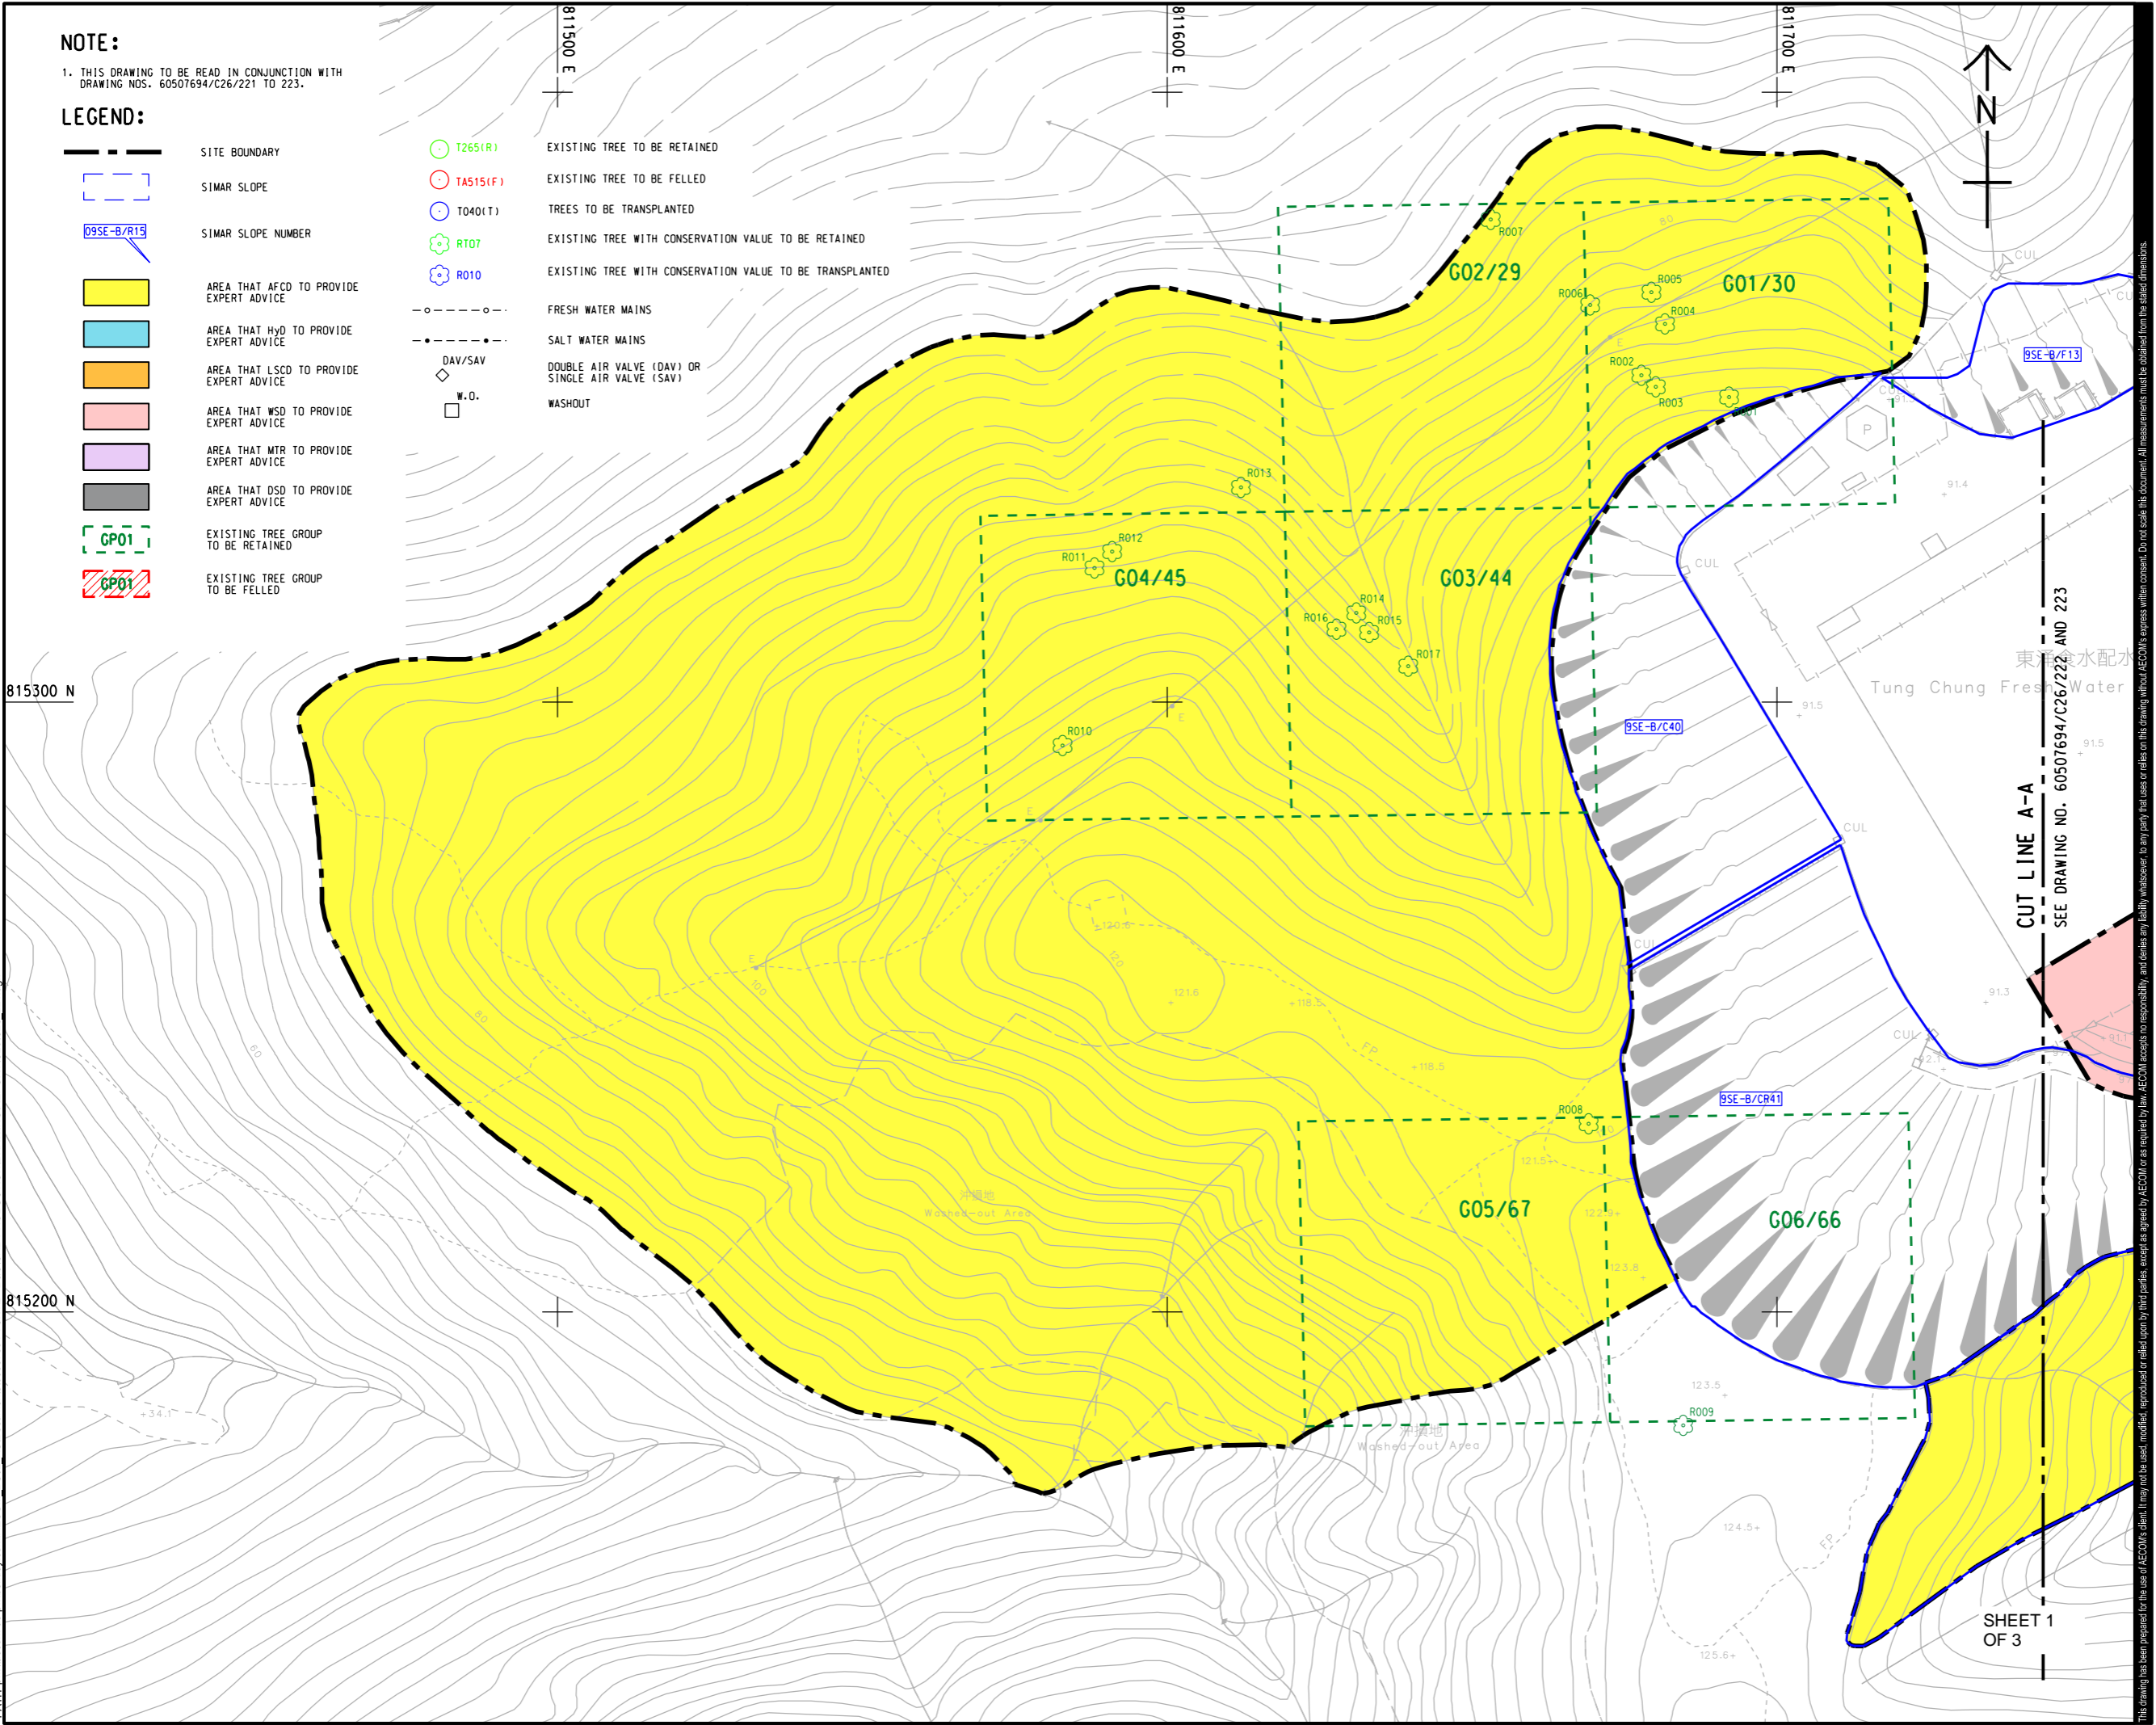
**SHEET TITLE**  
 LOCATION AND RECOMMENDATION  
 OF RECORDED PLANTS OF  
 CONSERVATION IMPORTANCE  
 SHEET 1 OF 3

- 3.1.2 Under the group vegetation survey conducted in August 2020, 35 no. of *Gmelina chinensis* and 3 no. of *Aquilaria sinensis* were identified, in which 2 no. of *Gmelina chinensis*, RT03 and RT06 were missing during the tree inspection conducted in August 2021 respectively, as plant species with conservation importance at or adjoining the Project Site. Detailed information and locations of each of the recorded individuals are presented in **Appendix B** and **Figure 2.1 to Figure 2.3** respectively.

- 3.1.3 Based on the layout of the SWSR, none of the *Aquilaria sinensis* and only two of the *Gmelina chinensis* individuals (i.e. RT07 and RT08) are located within the area that would be affected by the proposed works (refer to **Figure 2.1 to Figure 2.3**). The photographic record, abstract of the detailed tree survey reporting regarding the findings of the two affected *Gmelina chinensis* is shown in **Appendix C** and **Appendix F respectively**. The affected individuals are in fair health condition, so it is proposed to be transplanted.

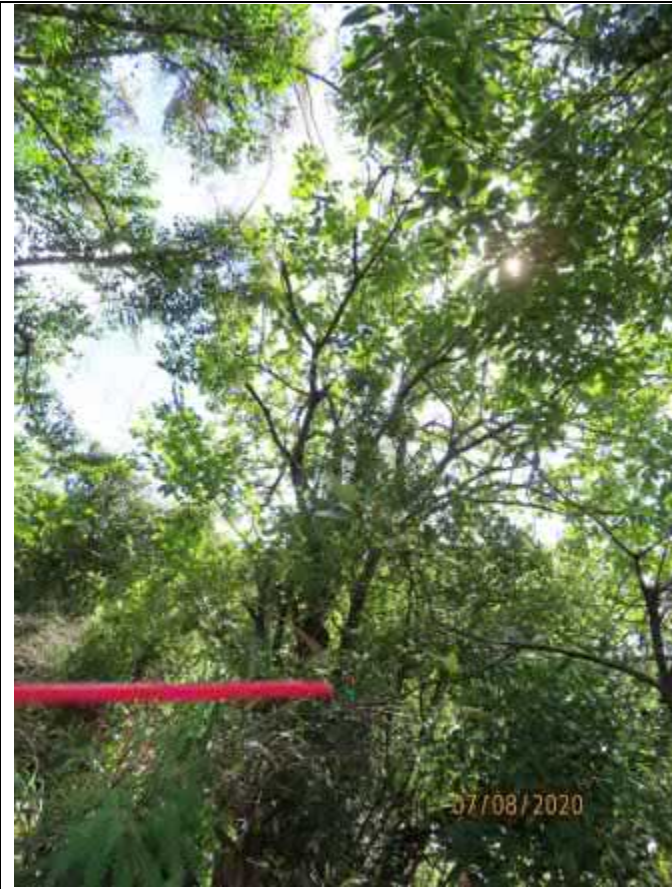
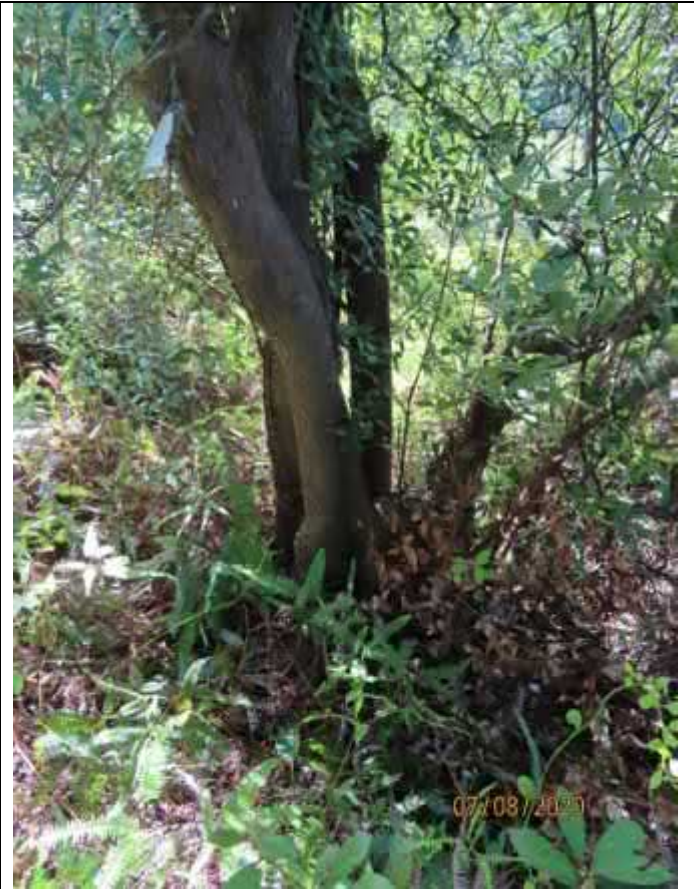
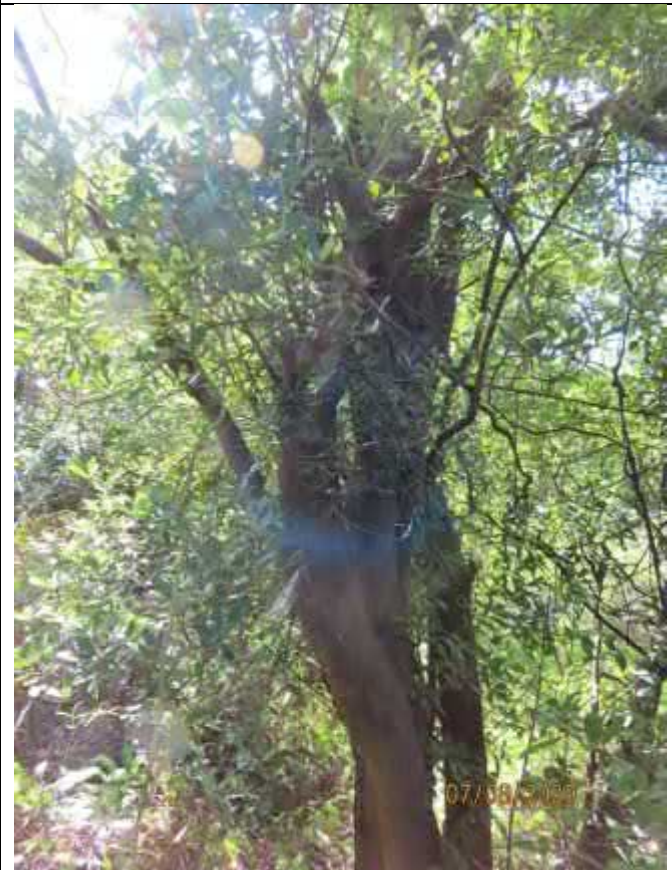
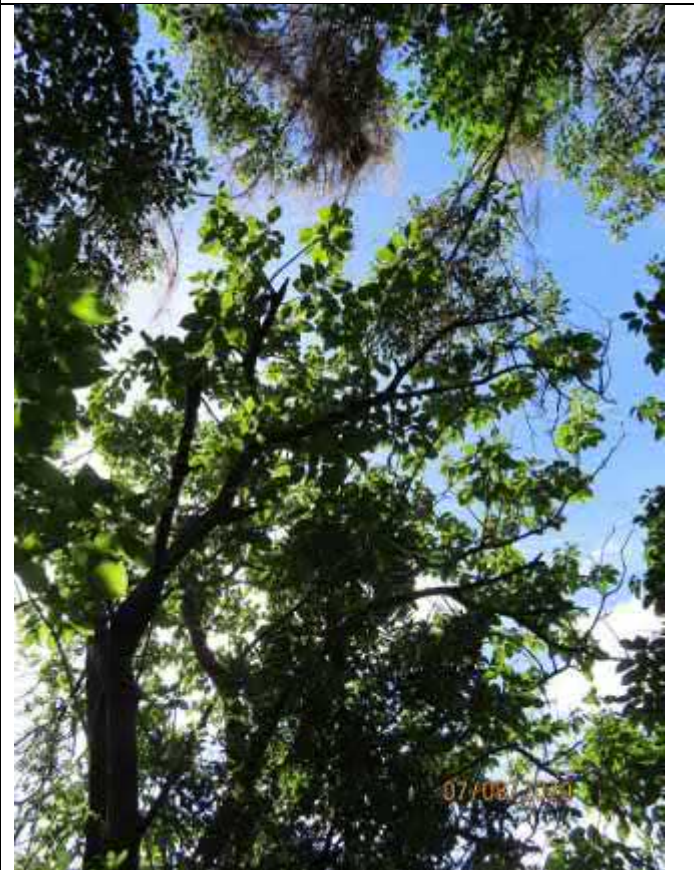
RT03 *Gmelina chinensis* (Missing while tree inspection conducted in August 2021)

2.1.3 Further to the tree inspection conducted in August 2021 by the Contractor, it was recorded that 2 no. of *Gmelina chinensis*, RT03 and RT06 proposed to be transplanted were missing. Please refer to **Appendix F** for the abstract of the detailed tree survey report regarding the findings for the captioned trees.

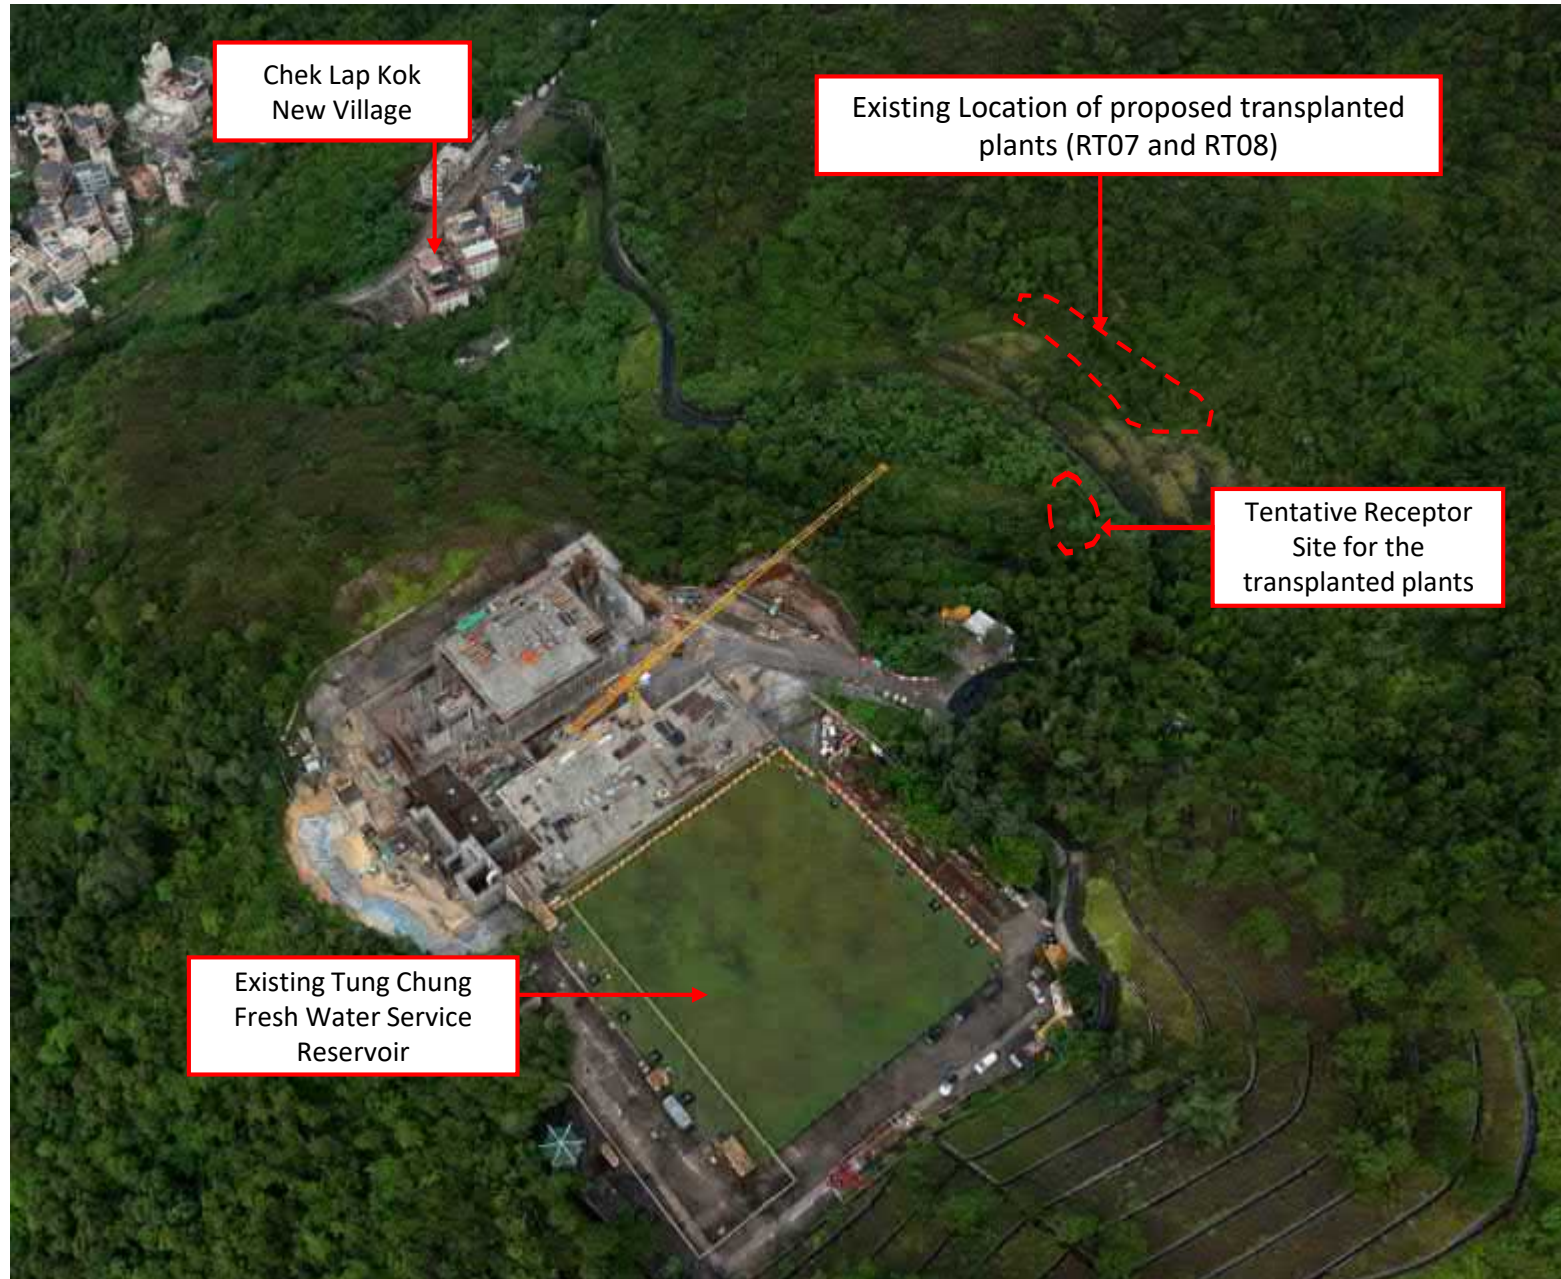
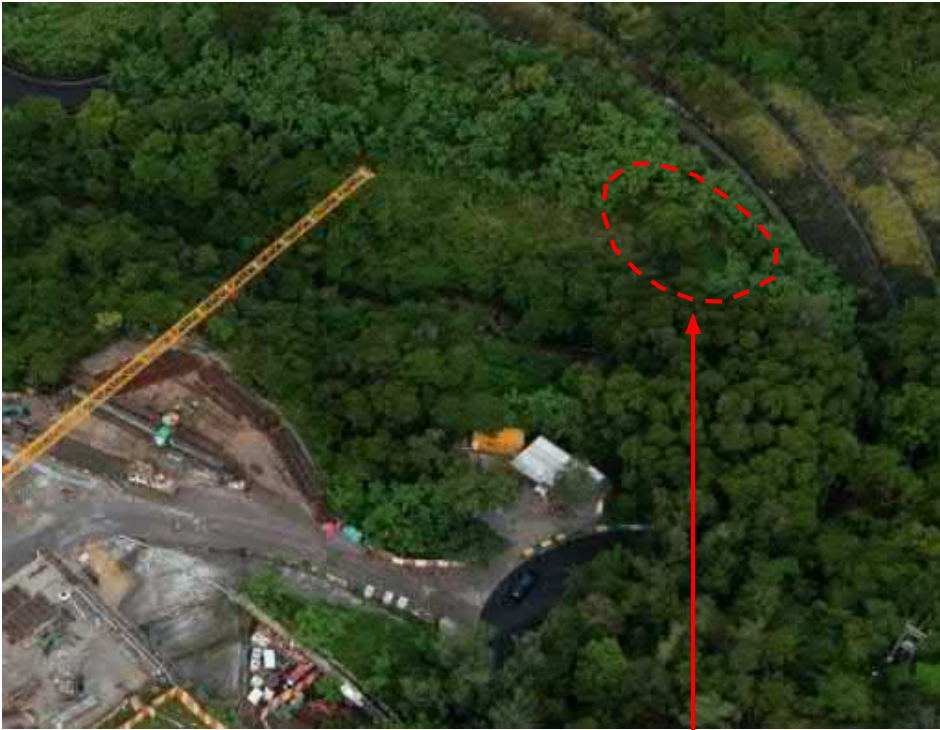
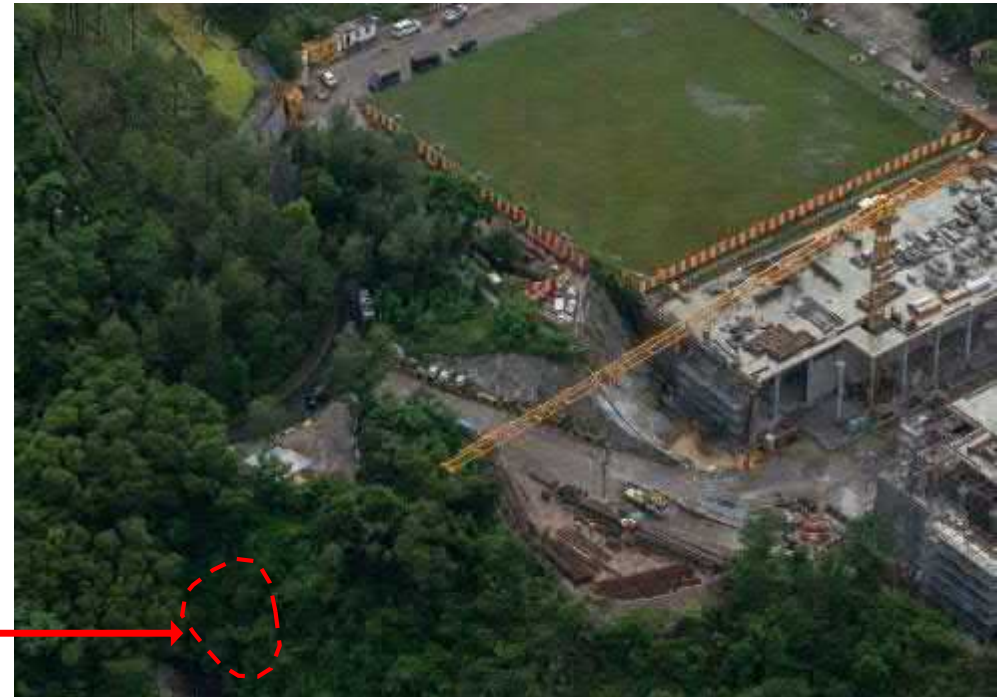
## Appendix D – Photographic Record of Tentative Receptor Site

Tentative Receptor Site for the 2 nos. transplanted plants.

The following site preparation work is required prior to actual transplanting:

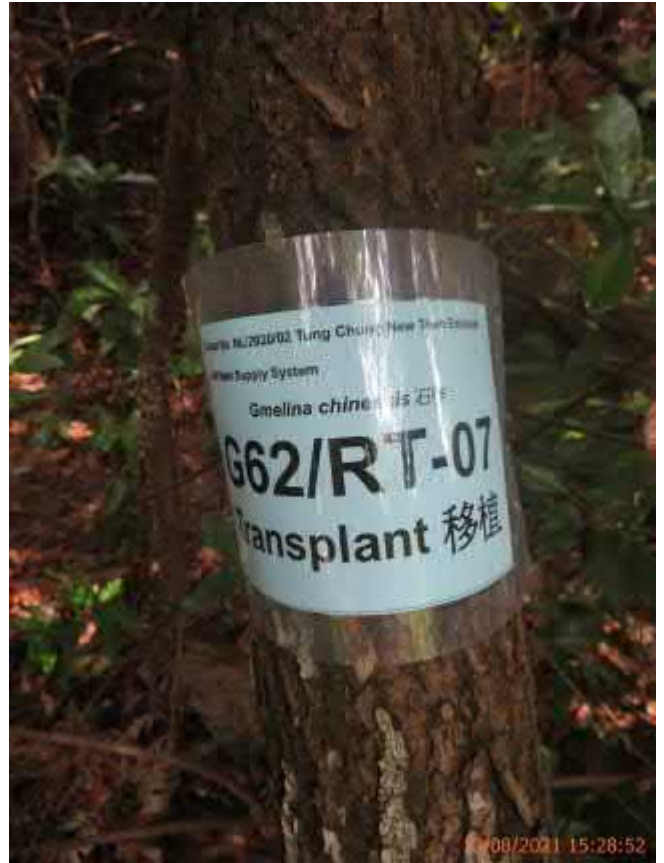
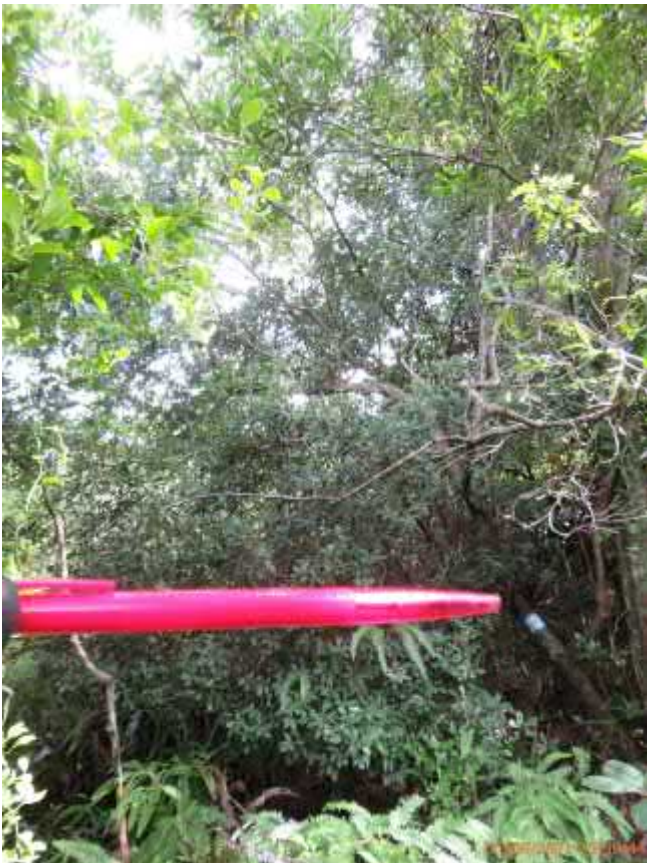
G62 RT-07\_\_Tag

G62 RT-07\_\_WholeView

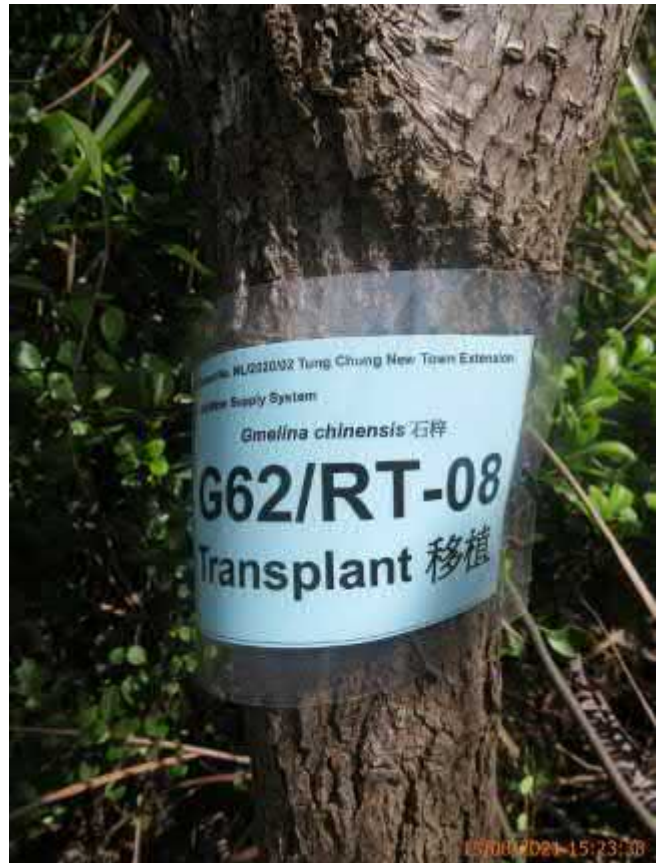
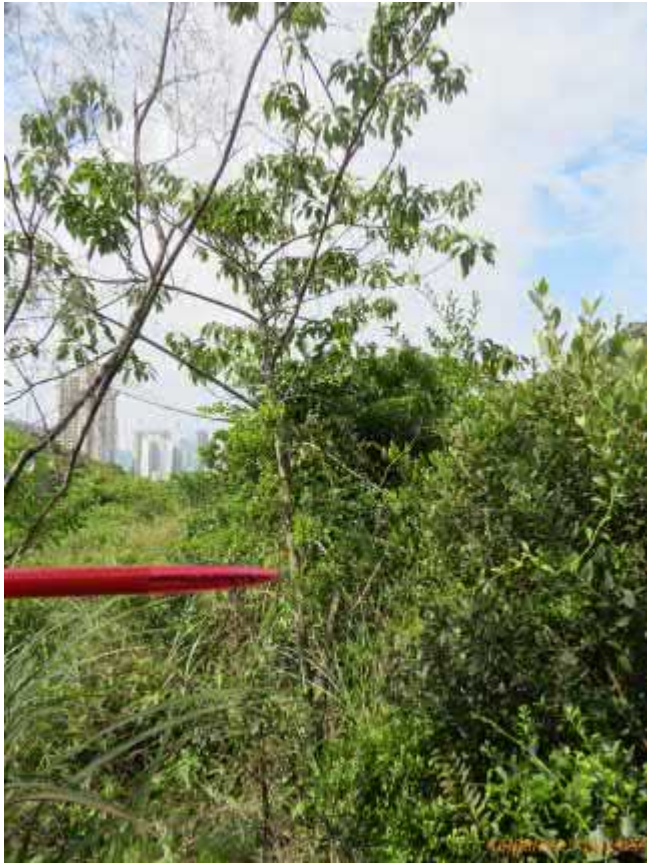
G62 RT-08\_\_Tag

G62 RT-08\_\_WholeView
