Agreement No. CE 60/2017 (EP)

# **Environmental Team for Tung Chung New Town Extension (East) - Design and Construction**

Monthly Environmental Monitoring & Audit Report for September 2018

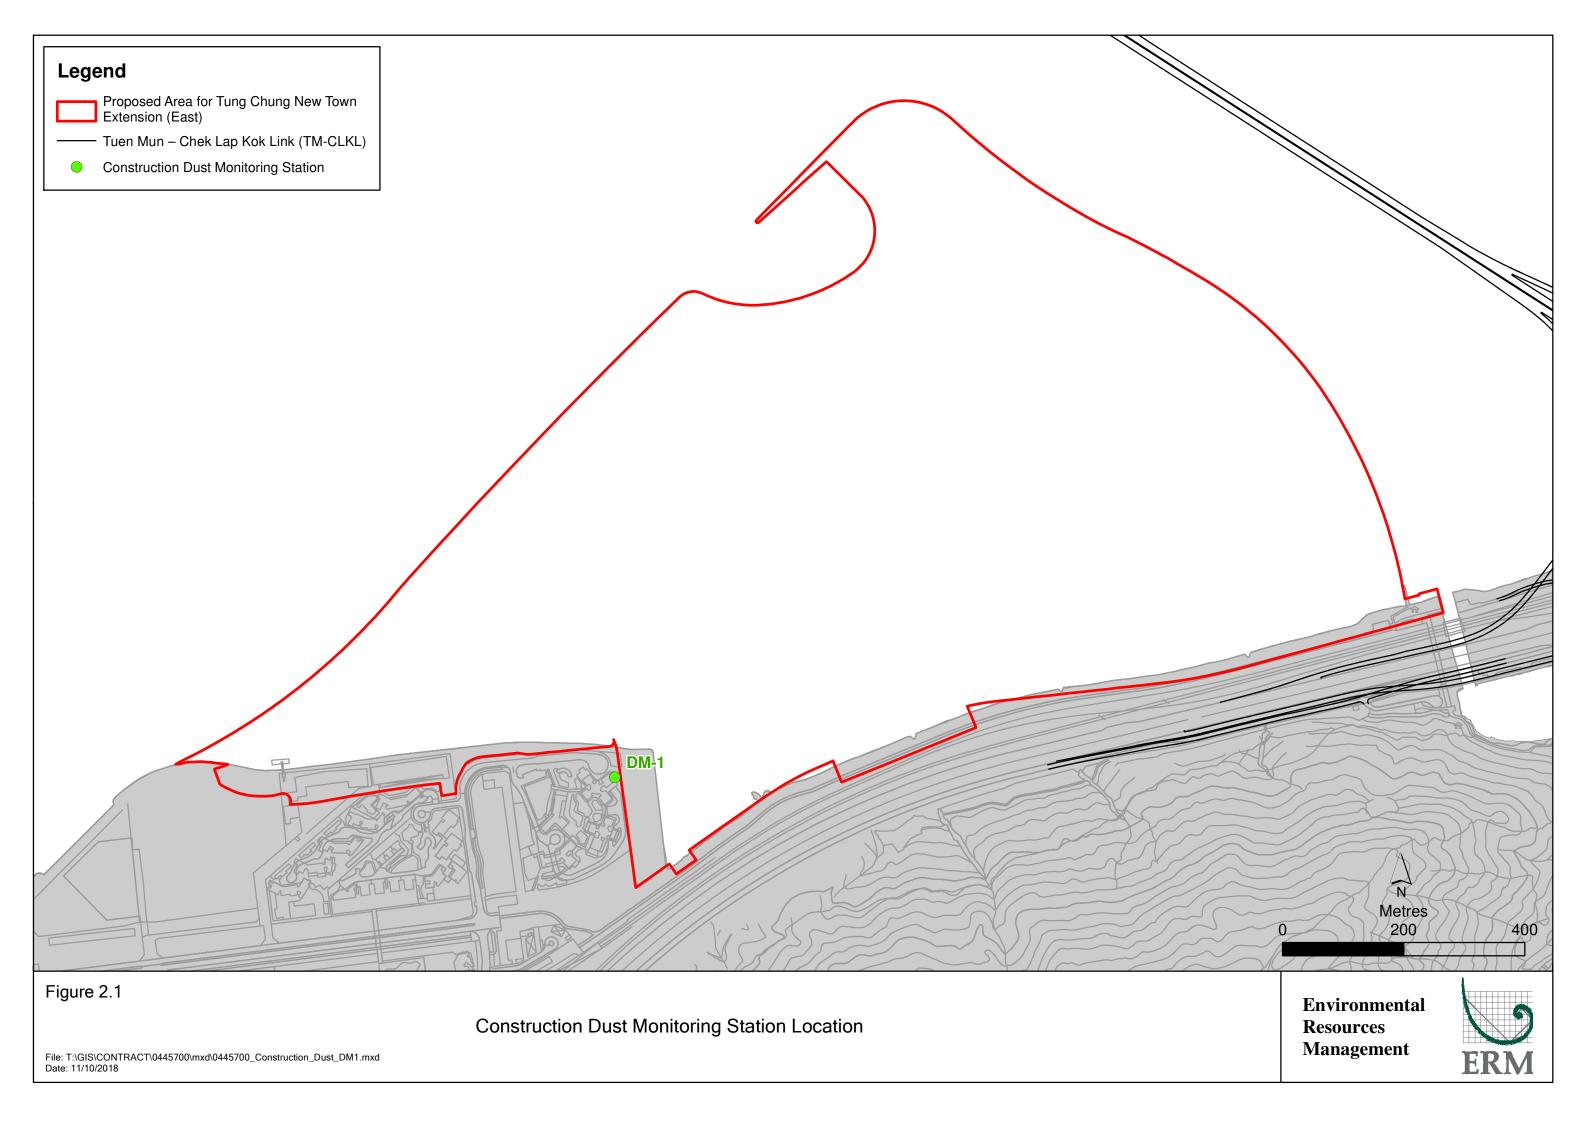
The monitoring location and equipment used in the impact air quality monitoring programme are summarized in *Table 2.2* and illustrated in *Figure 2.1*. Copies of the calibration certificates for the equipment are presented in *Annex D1*, which showed that the portable direct reading dust meter is capable of providing comparable results with that provided by a HVS.

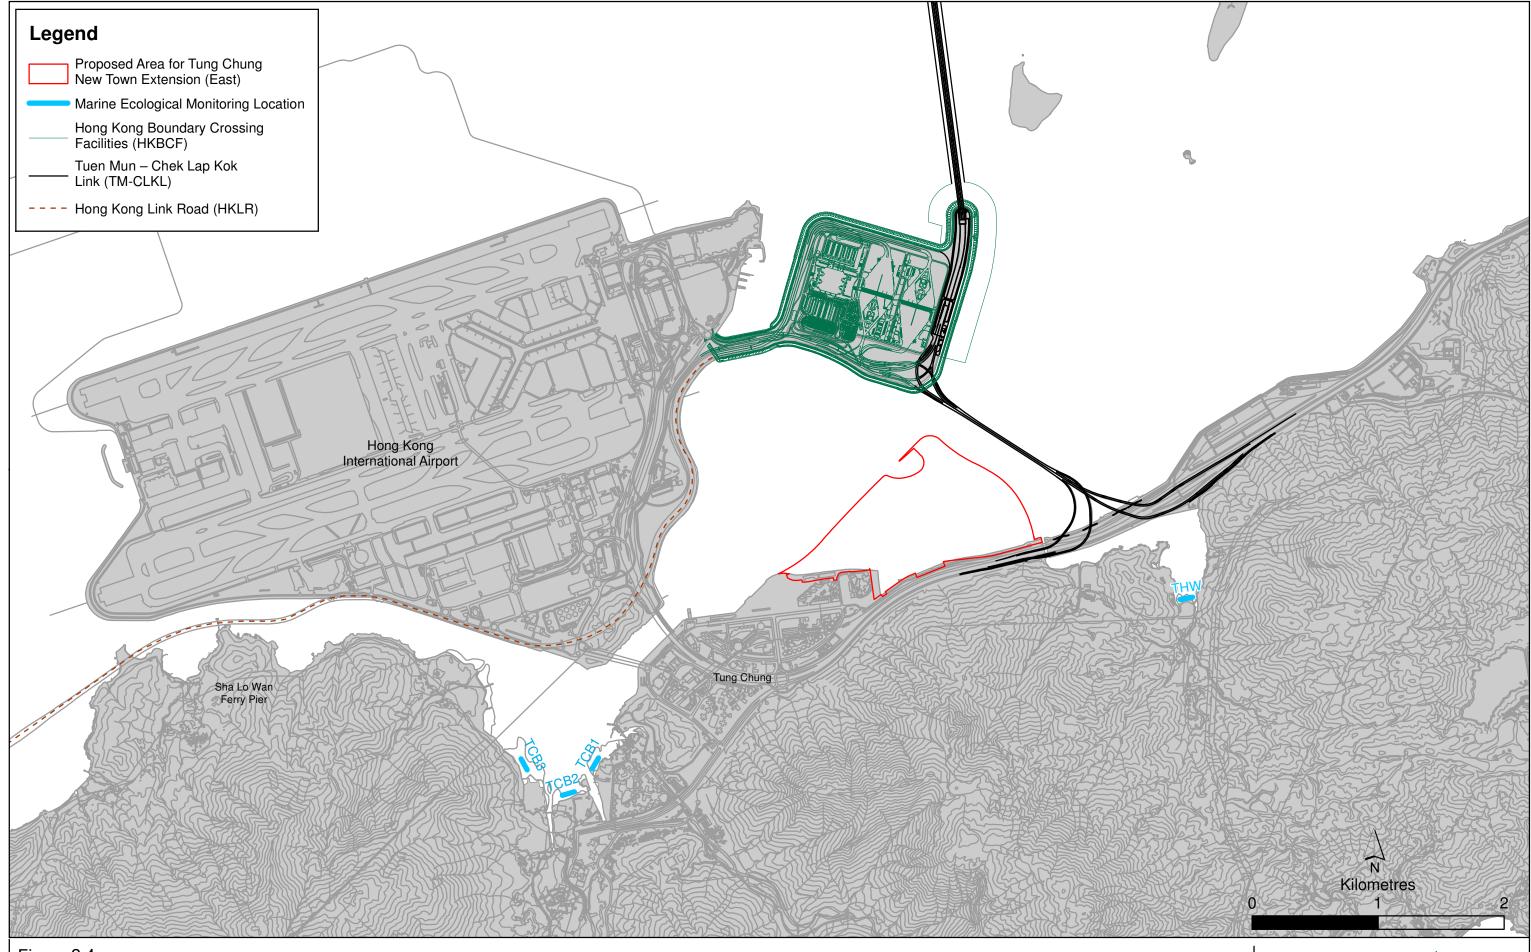
Figure 2.4

Marine Ecological Monitoring (Intertidal Soft-shore Habitats)

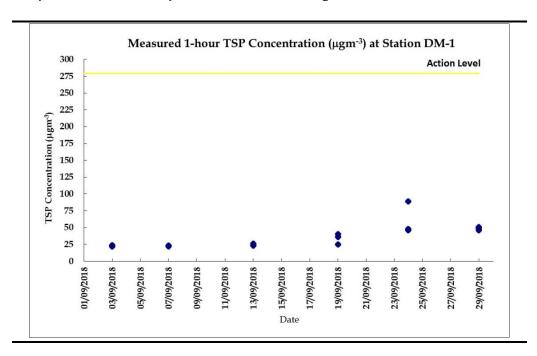
Figure D3 Graphical Presentation for 1-hr TSP Monitoring at Station DM-1

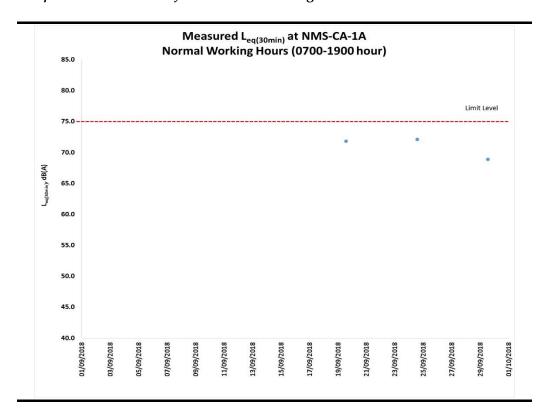
Figure E3.1 Graphical Presentation for Noise Monitoring at Station NMS-CA-1A

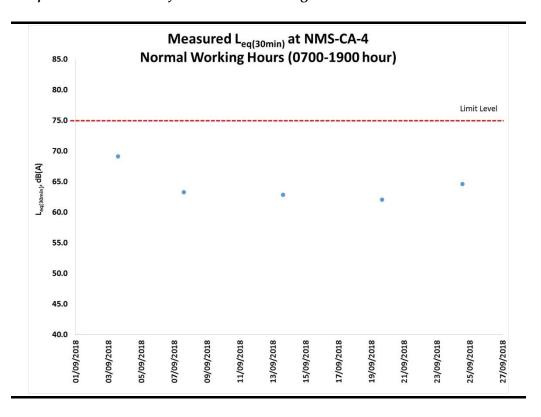
Figure E3.2 Graphical Presentation for Noise Monitoring at Station NMS-CA-4

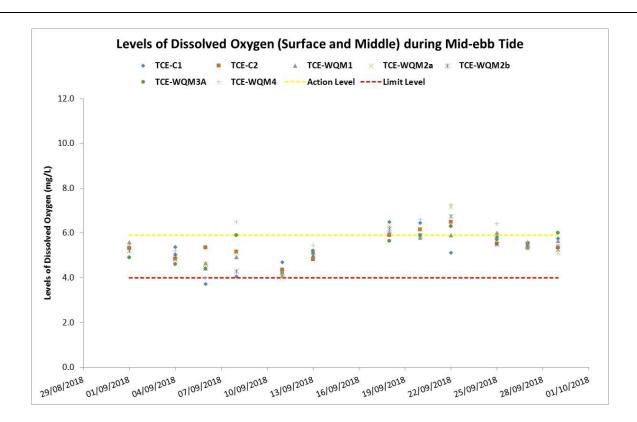
Figure 1: Levels of Dissolved Oxygen (Surface and Middle) (mg/L) recorded at Mid-ebb Tide during the Water Quality Monitoring between 1 and 30 September 2018

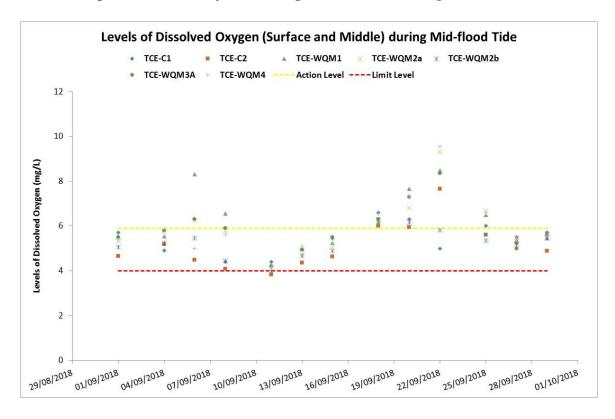
Figure 2: Levels of Dissolved Oxygen (Surface and Middle) (mg/L) recorded at Mid-flood Tide during the Water Quality Monitoring between 1 and 30 September 2018

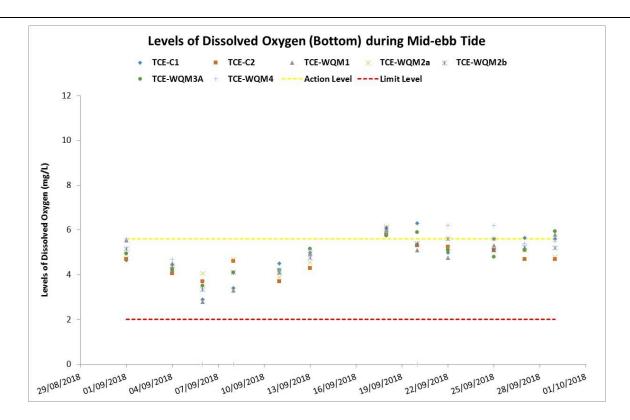
Figure 3: Levels of Dissolved Oxygen (Bottom) (mg/L) recorded at Mid-ebb Tide during the Water Quality Monitoring between 1 and 30 September 2018

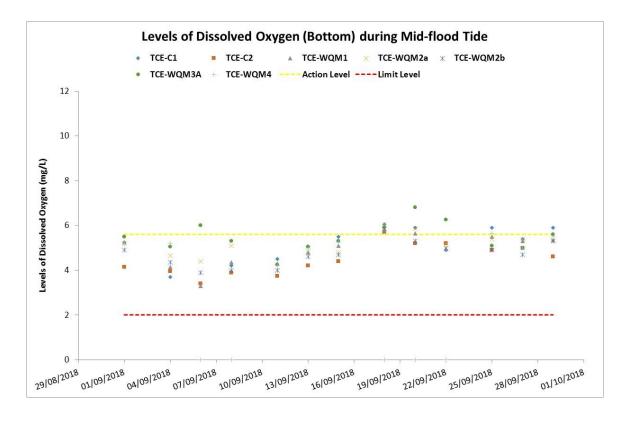
Figure 4: Levels of Dissolved Oxygen (Bottom) (mg/L) recorded at Mid-flood Tide during the Water Quality Monitoring between 1 and 30 September 2018

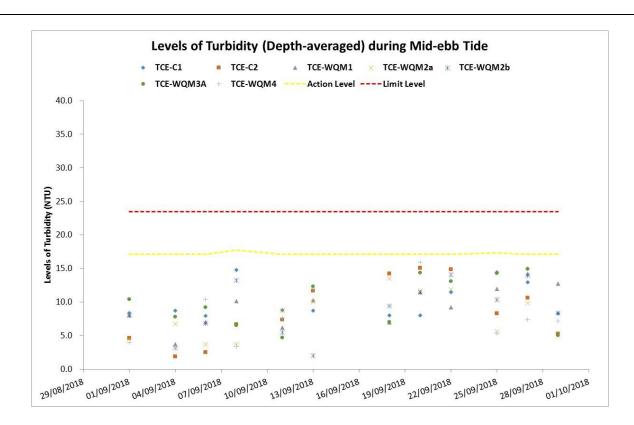
Figure 5: Levels of Turbidity (Depth-averaged) (NTU) recorded at Mid-ebb Tide during the Water Quality Monitoring between 1 and 30 September 2018

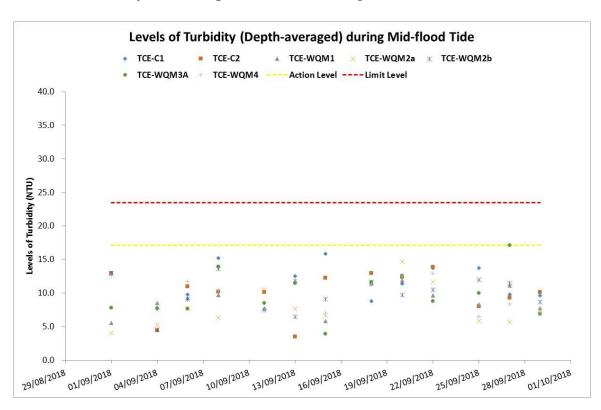
Figure 6: Levels of Turbidity (Depth-averaged) (NTU) recorded at Mid-flood Tide during the Water Quality Monitoring between 1 and 30 September 2018

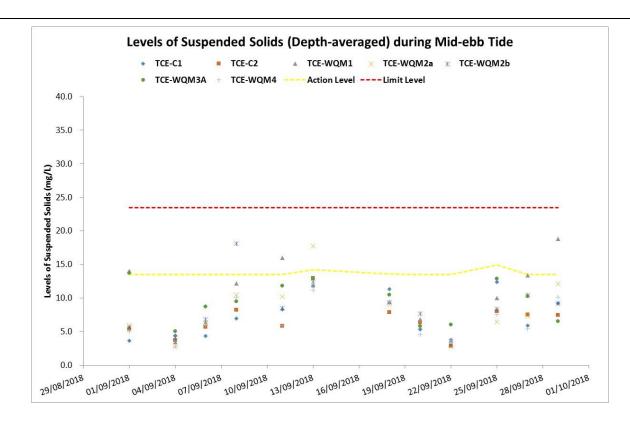
Figure 7: Levels of Suspended Solids (Depth-averaged) (mg/L) recorded at Mid-ebb Tide during the Water Quality Monitoring between 1 and 30 September 2018

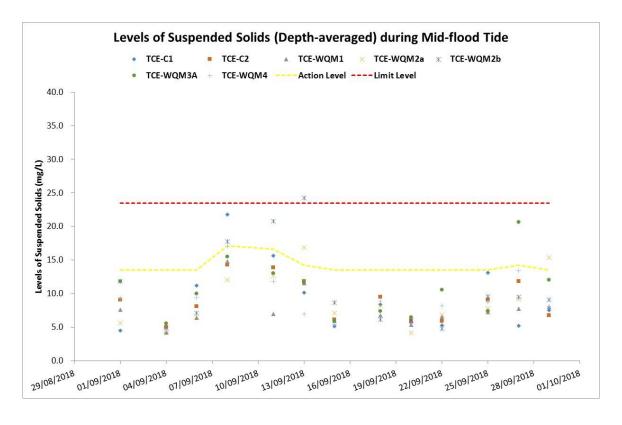
Figure 8: Levels of Suspended Solids (Depth-averaged) (mg/L) recorded at Mid-flood Tide during the Water Quality Monitoring between 1 and 30 September 2018
