Agreement No. CE 60/2017 (EP)

Environmental Team for Tung Chung New Town Extension (East) -Design and Construction

Monthly Environmental Monitoring & Audit Report for April 2022

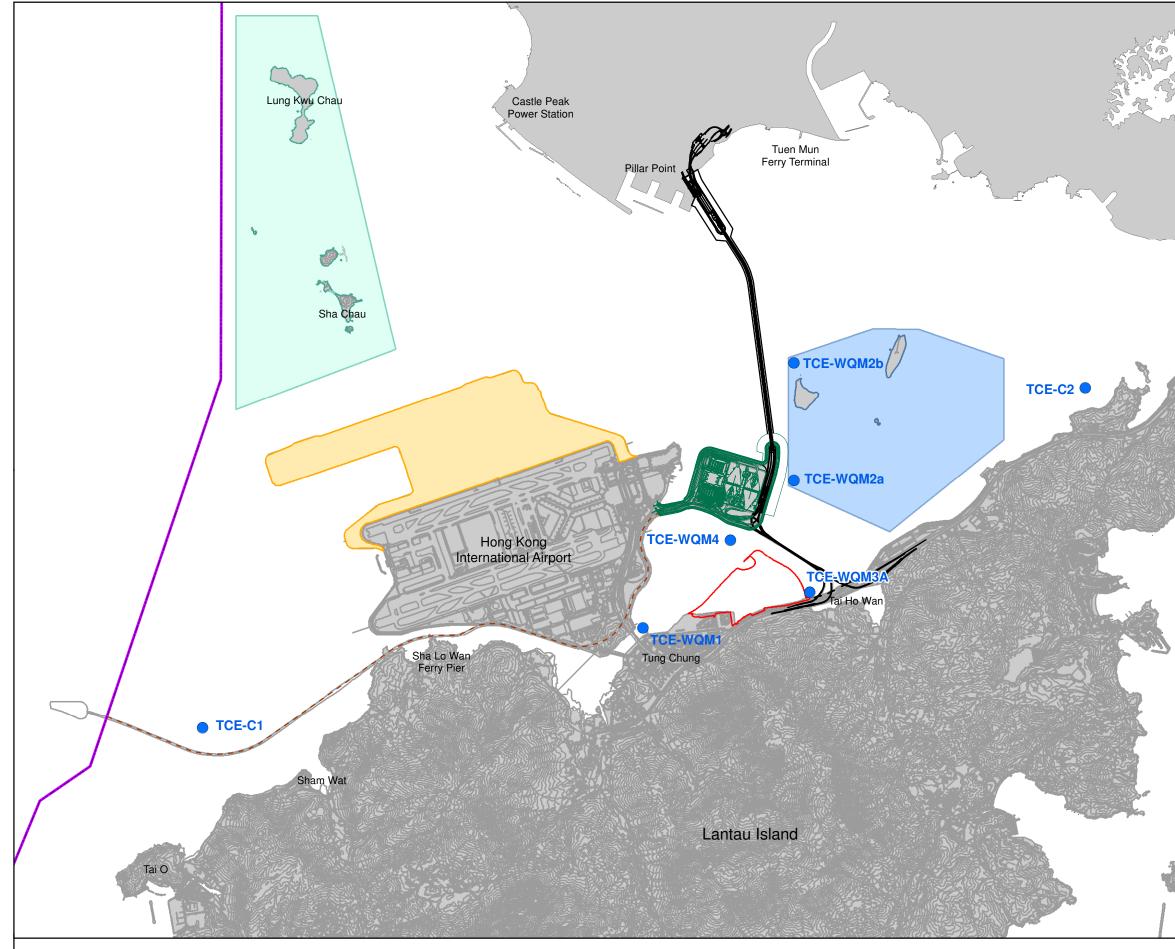
Figure 2.3

Water Quality Monitoring Locations
