Agreement No. CE 60/2017 (EP)

Environmental Team for Tung Chung New Town Extension (East) - Design and Construction

Monthly Environmental Monitoring & Audit Report for June 2022

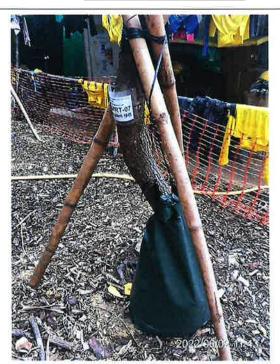
2 June 2022 ⁽¹⁾	Portion 3 • The health condition of the transplanted plant species of conservation importance was poor (RT-07 and RT-08).	Portion 3 • The Contractor was reminded to provide mitigation measures (i.e. daily watering, use of mulch and pruning/weeding) when necessary, keep close monitoring of the plants in terms of their health condition and report to relevant parties in the event of deterioration immediately.

Photo 02:Root collar of G62/RT-07

Photo 03:Crown condition of G62/RT-07

Photo 04: Whole view of G62/RT-07

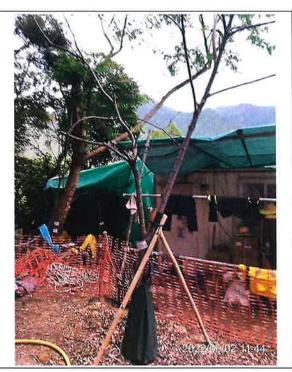
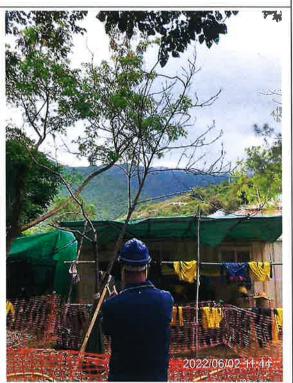
Photo 06: Root collar of G62/RT-08

Photo 07: Crown condition of G62/RT-08

Photo 08: Whole view for G62/RT-08
