Agreement No. CE 60/2017 (EP)

Environmental Team for Tung Chung New Town Extension (East) - Design and Construction

**Monthly Environmental Monitoring & Audit Report
for March 2019**

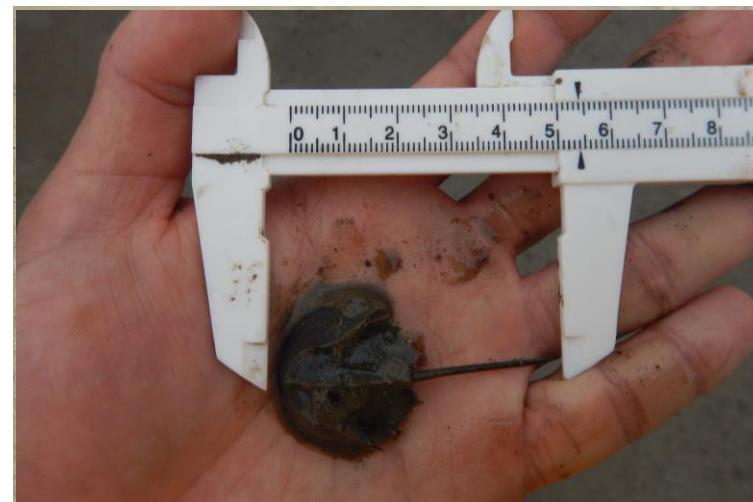
(e) Horseshoe crab *Tachypleus tridentatus* recorded at THW during Qualitative Walk-through Survey

For qualitative walk-through surveys, the March 2019 monitoring results were similar to those recorded in the baseline monitoring conducted in April - June 2018. Horseshoe crabs and intertidal soft shore communities were recorded while seagrass beds were not observed. The survey results for each monitoring location are summarized in *Table 2.11* below and detailed in *Annex H2*.
