**Civil Engineering and
Development Department**

Agreement No. CE 60/2017 (EP)

Environmental Team for Tung Chung New Town Extension (East) - Design and Construction

**Monthly Environmental Monitoring & Audit Report
for March 2020**

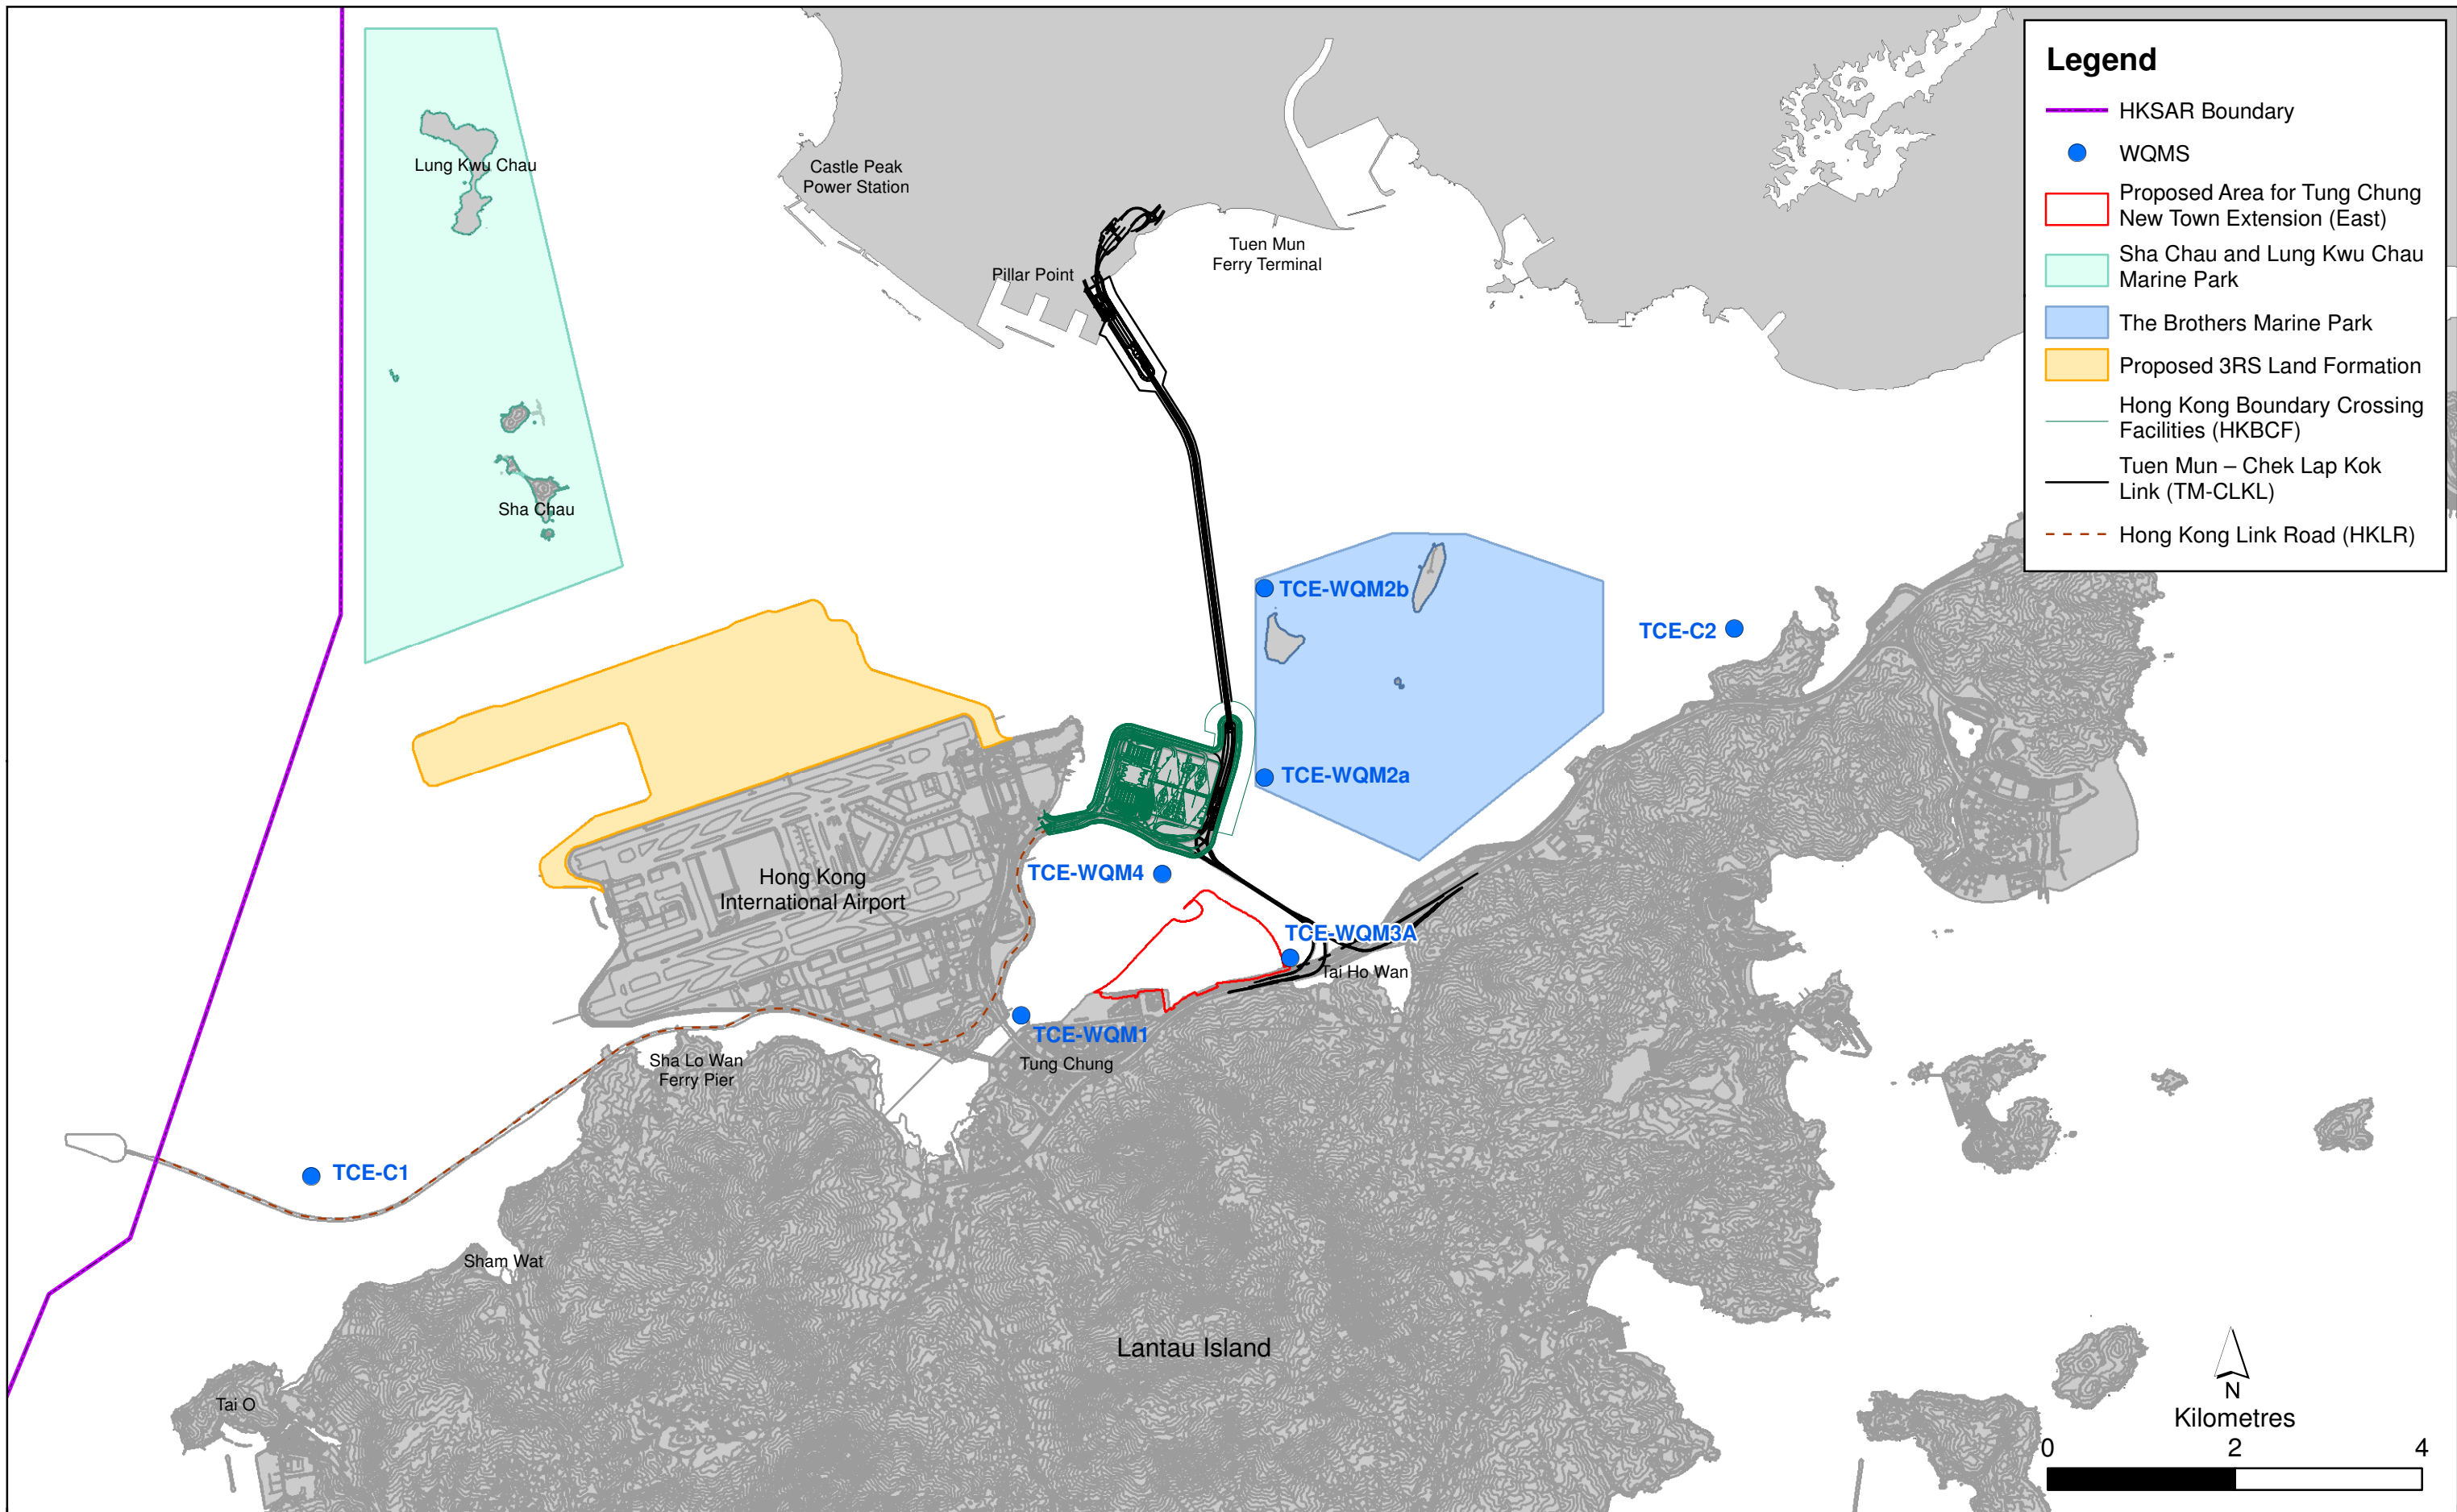
The locations of the monitoring stations under the Project are shown in Figure 2.3 and Table 2.8.

Water Quality Monitoring Locations

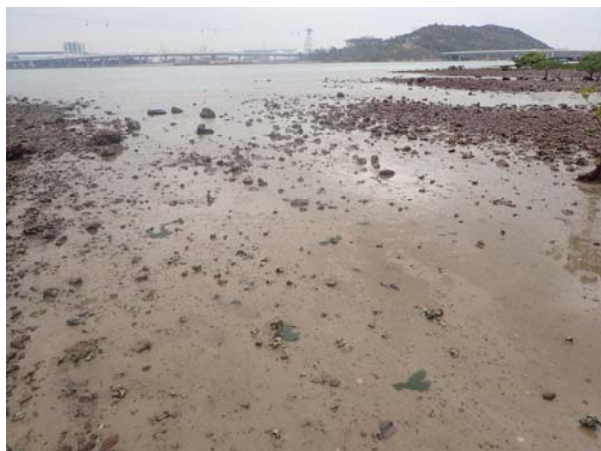
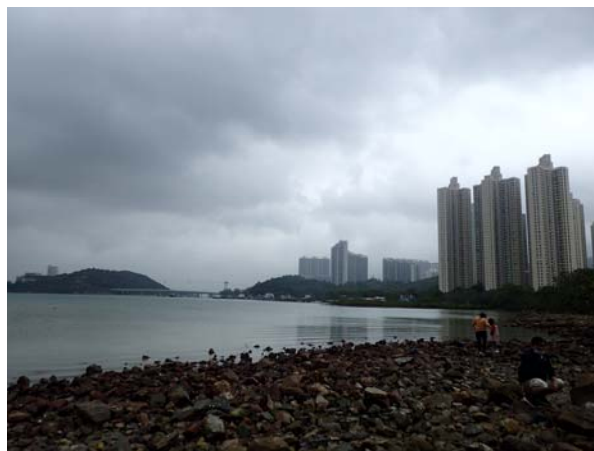
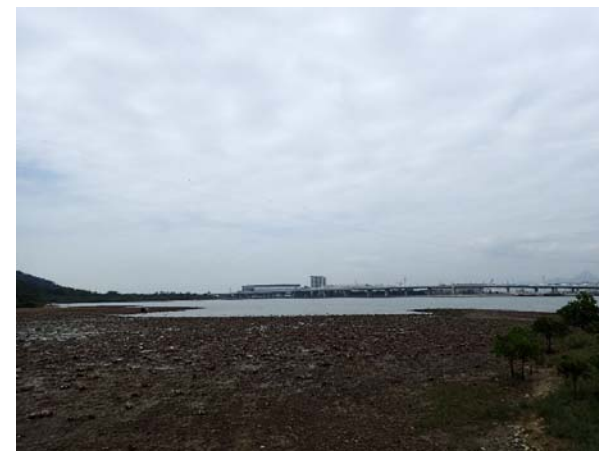
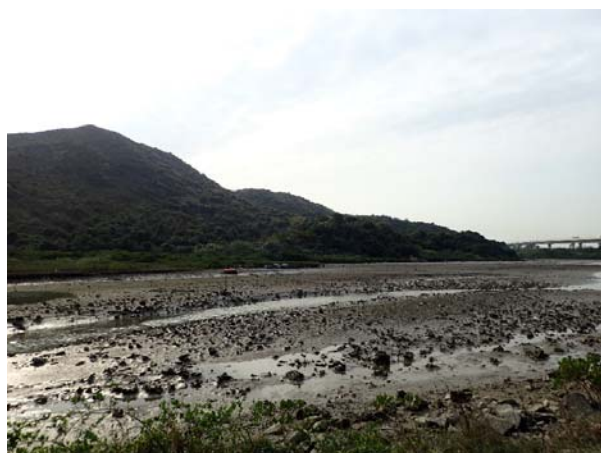
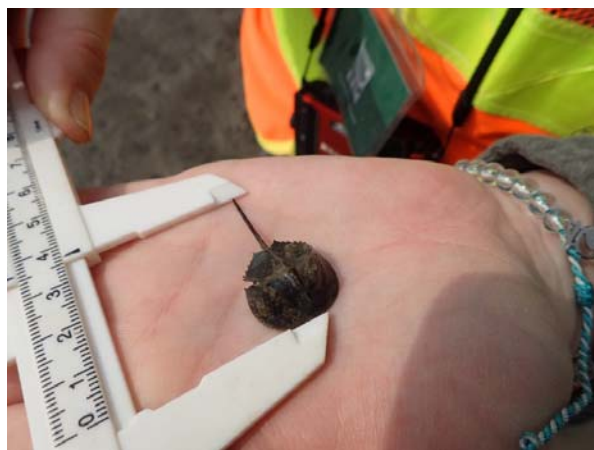
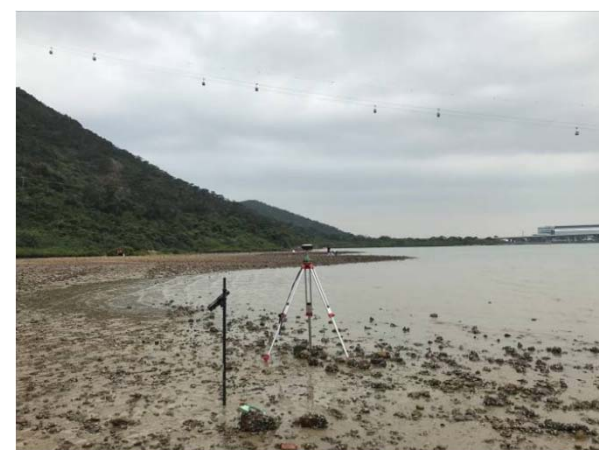
Figure 2.5

(a) Survey Location at TCB1

(b) Survey Location at TCB2

(c) Survey Location at TCB3

(d) Survey Location at THW

(e) Horseshoe crab *Tachypleus tridentatus* recorded at THW during Qualitative Walk-through Survey

(f) Sedimentation Rate Monitoring
