Civil Engineering and
Development Department

Agreement No. CE 60/2017 (EP)

Environmental Team for Tung Chung New Town Extension (East) - Design and Construction

**Monthly Environmental Monitoring & Audit Report
for June 2020**

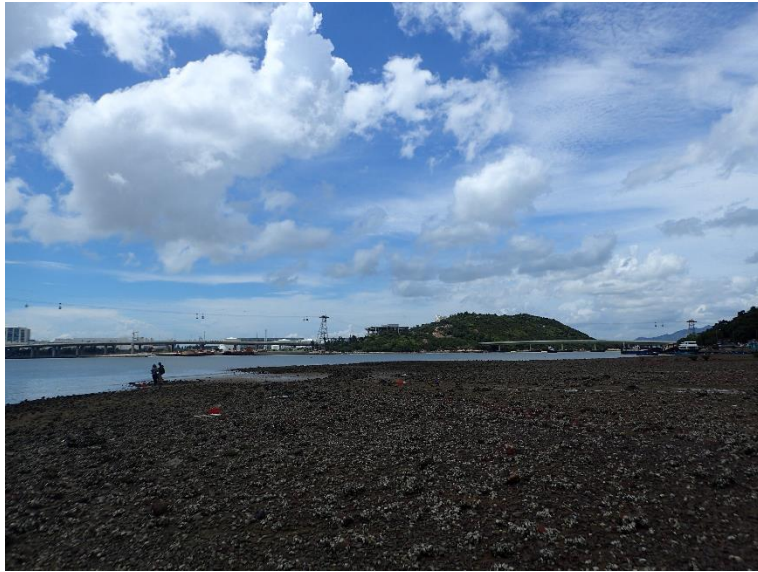
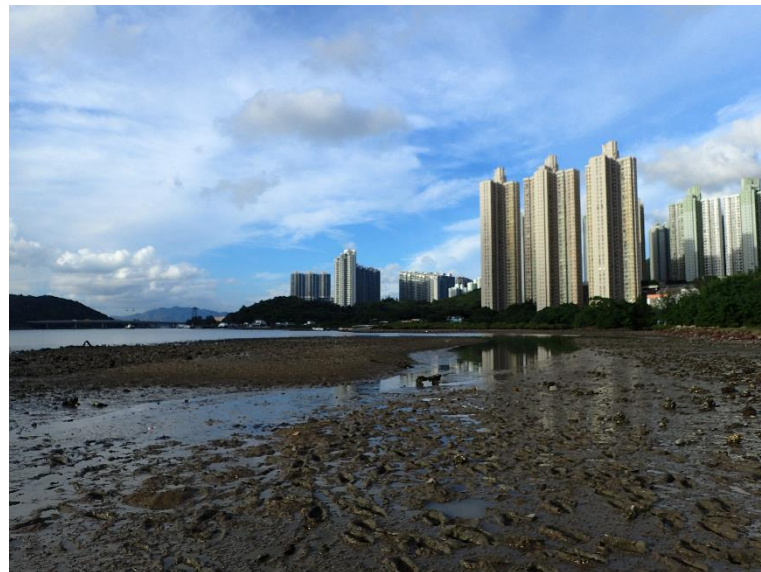
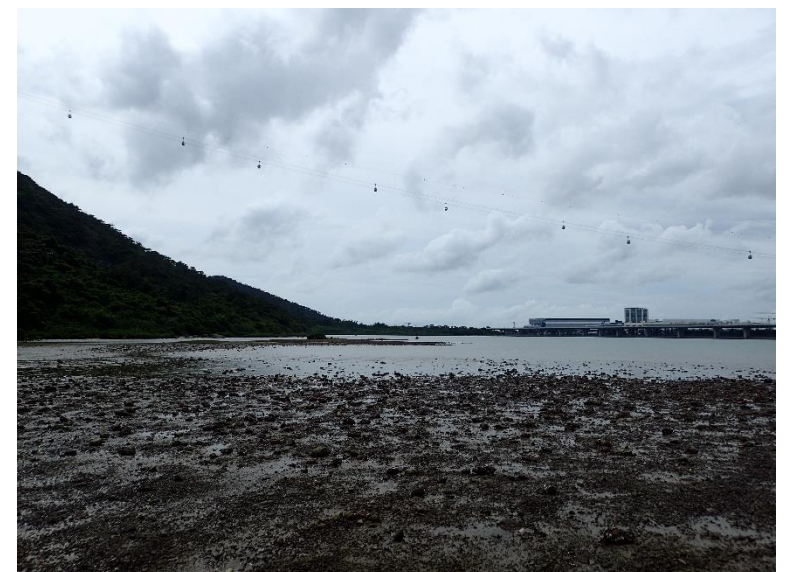
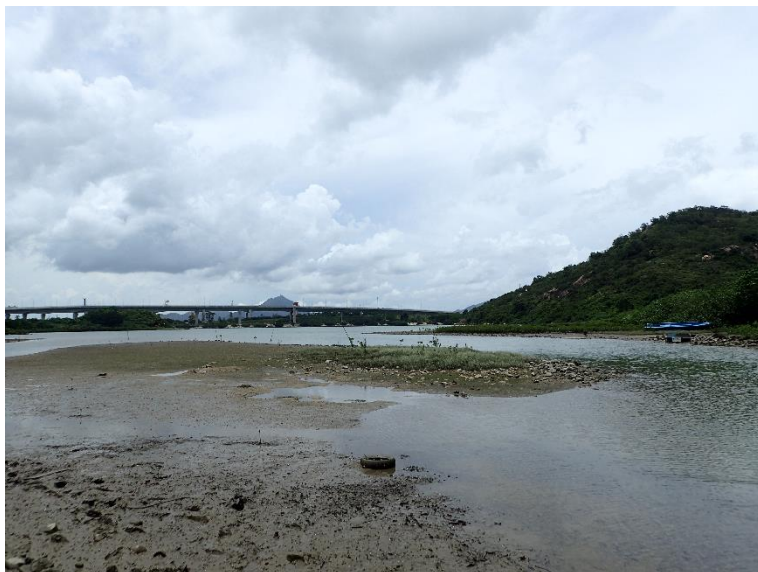
Figure 2.4

Marine Ecological Monitoring (Intertidal Soft-shore Habitats)

(a) Survey Location at TCB1

(b) Survey Location at TCB2

(c) Survey Location at TCB3

(d) Survey Location at THW

For quantitative transect survey, one 50 – 100 m horizontal (belt) transect (actual length subject to the site conditions) was surveyed at each of the three shore heights: 2 m, 1.5 m and 1 m above Chart Datum of each survey location. On each transect, five quadrats (50 cm x 50 cm) were placed randomly in each transect to assess the abundance and distribution of flora and fauna. For each quadrat, surface layer to 5 cm depth was sieved and microbenthic organisms (e.g. crustaceans) were recorded and identified. Density of organisms was expressed as individuals / m². Areas with seagrass were also recorded and identified and other information, such as the percentage cover, were also recorded. Sessile animals such as barnacles and oysters in each quadrat were not counted but estimated as percentage cover on the rock surface. All species of algae (encrusting, foliose and filamentous) were also identified and recorded by estimating the percentage cover on the rock surface. All organisms were identified to the lowest possible taxonomic level (at least Genus level). Species encountered outside the quadrat but in the vicinity of survey transect were also recorded.

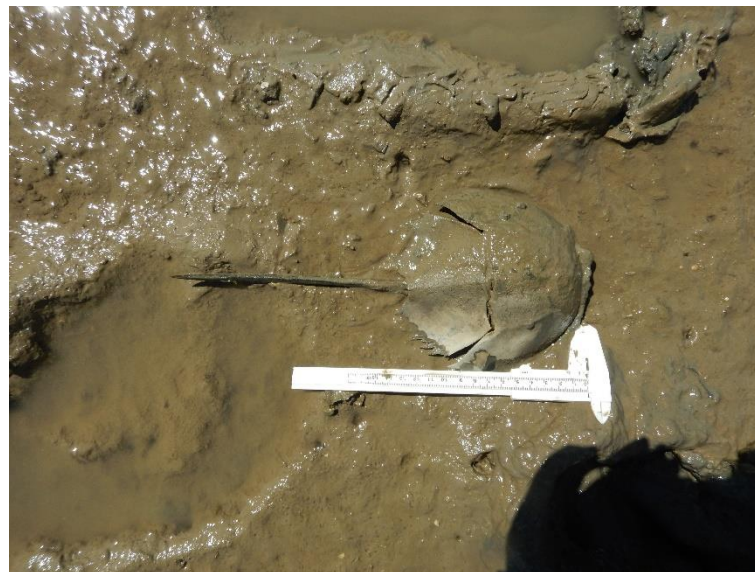
(e) Horseshoe Crab *Tachypleus tridentatus* Recorded at TCB3 During Qualitative Walk-through Survey

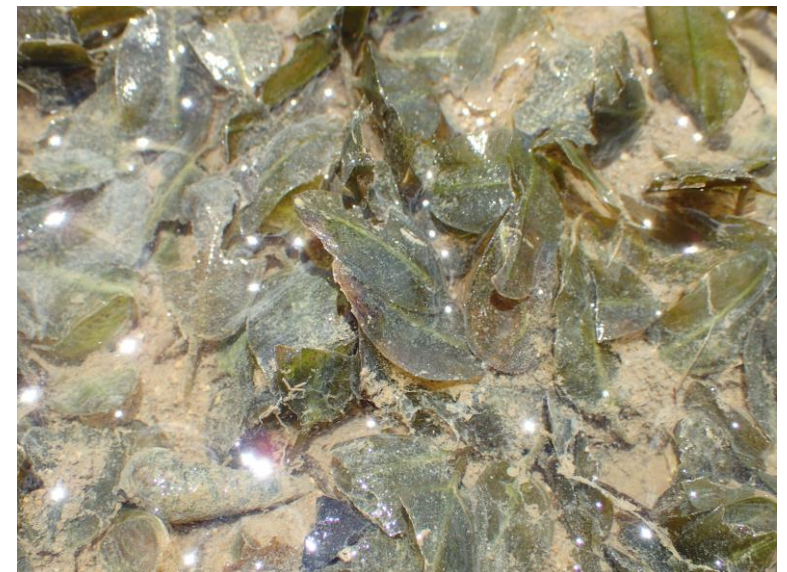
(f) Seagrass, *Halophila ovalis*, recorded at TCB3

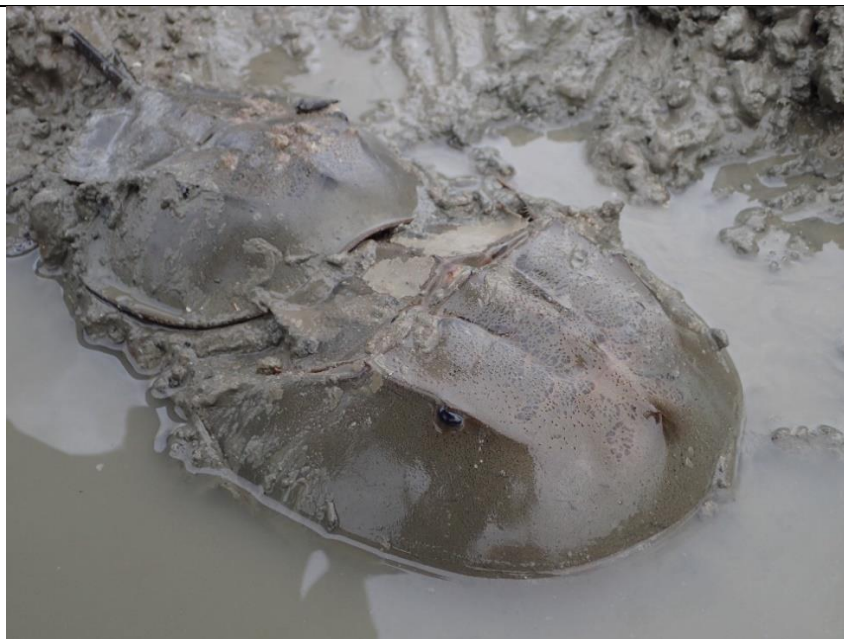
sighted outside of the sampled quadrats during the quantitative survey at TCB3 (see *Figure 2.6*).

Figure 2.6 Mating pair of *Carcinoscorpius rotundicauda* sighted at TCB3 during quantitative survey.

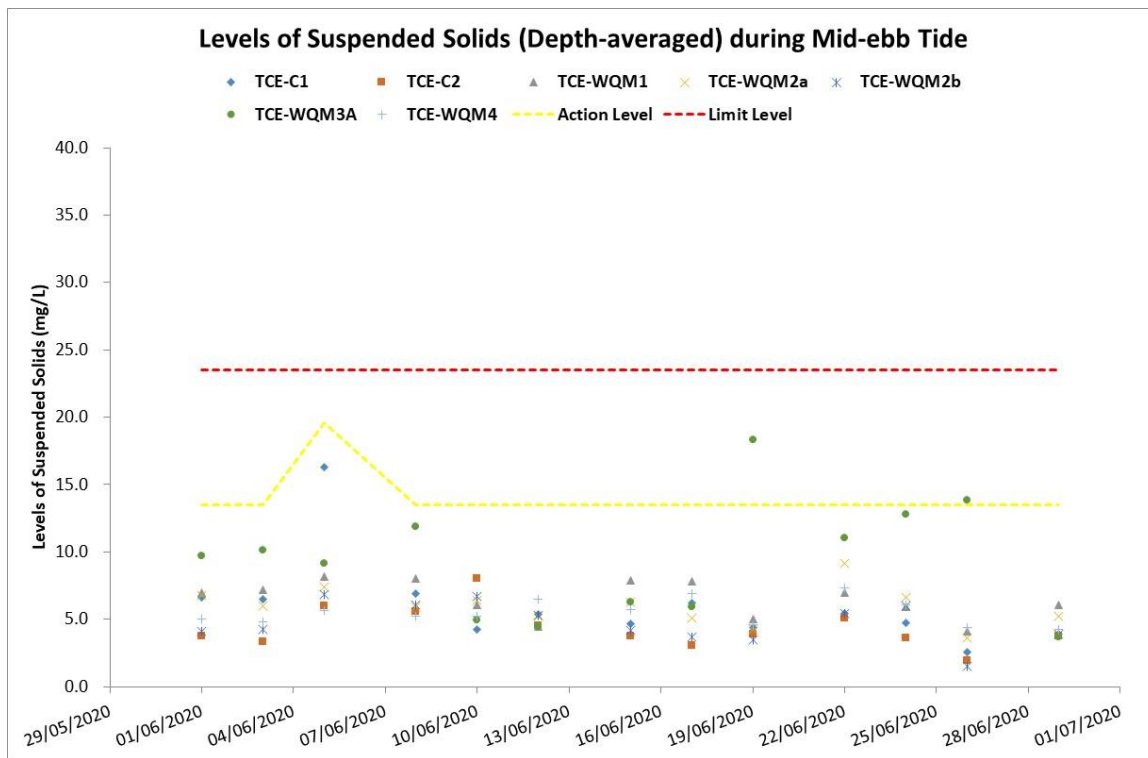
Figure 7: Levels of Suspended Solids (Depth-averaged) (mg/L) recorded at Mid-ebb Tide during the Water Quality Monitoring between 1 and 30 June 2020

Based on the investigations conducted for each of the monitoring day with exceedances, the exceedances of DO and SS are not likely caused by the work activities related to the Project. However, the exceedance of turbidity and SS on 1 June 2020 was likely contributed by propeller wash caused by marine vessel operation. Advised by the Contractor, mitigation measures such as turn off engine of the barge within 15 minutes after berthing was implemented to minimize the disturbance.
