**Civil Engineering and  
Development Department**

*Agreement No. CE 60/2017 (EP)*

## **Environmental Team for Tung Chung New Town Extension (East) - Design and Construction**

**Monthly Environmental Monitoring & Audit Report  
for September 2021**

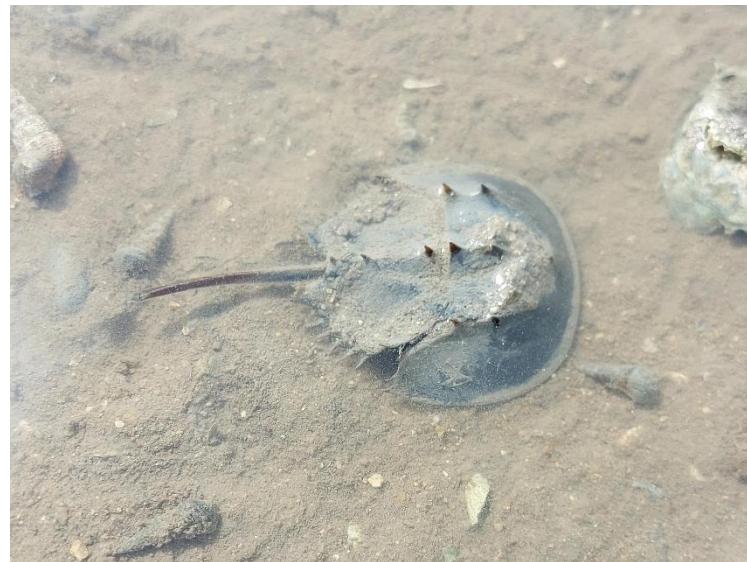
(e) Horseshoe crab *Tachypleus tridentatus* recorded at TCB3 during the Qualitative Walk-through Survey

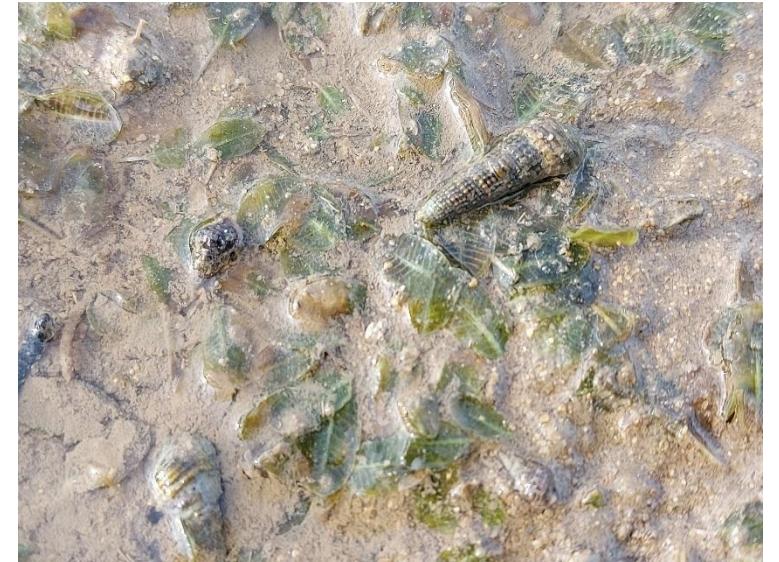
(f) Seagrass *Halophila ovalis* recorded at TCB3 during the Qualitative Walk-through Survey
