**Civil Engineering and
Development Department**

Agreement No. CE 60/2017 (EP)

Environmental Team for Tung Chung New Town Extension (East) - Design and Construction

**Monthly Environmental Monitoring & Audit Report
for November 2022**

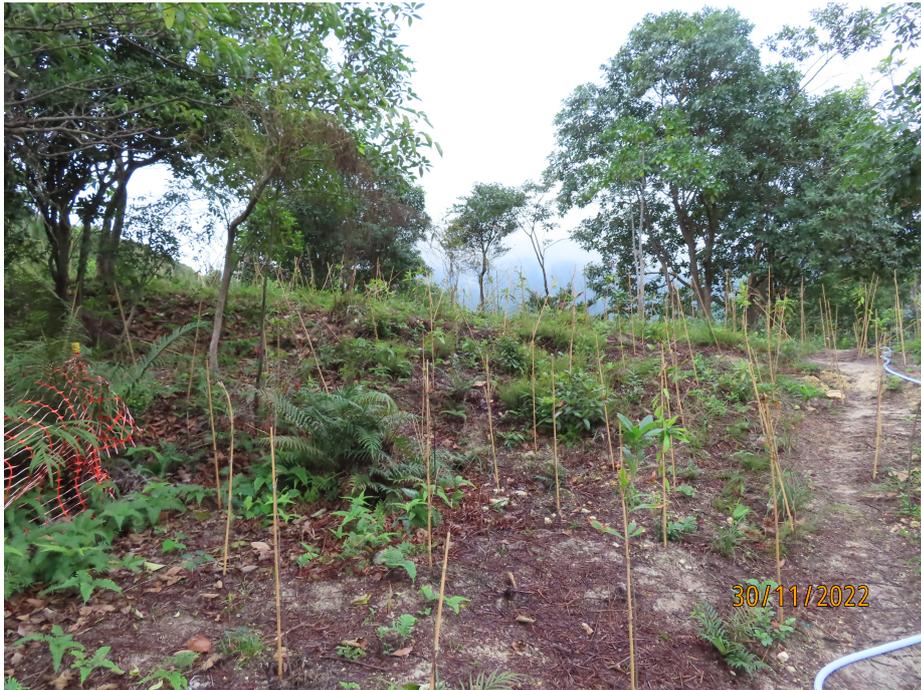
Photo 1 – General view of tree protection zone for preserved plant species of conservation importance

Tree protection zones for the *in-situ* preserved plant species of conservation importance were demarcated. No injuries and/or damages to the individuals of the *in-situ* preserved plant species of conservation importance were reported by the QP since the previous monitoring events. Photographic record and tree schedule of the preserved plant species of conservation importance monitoring are provided in *Annex I*.

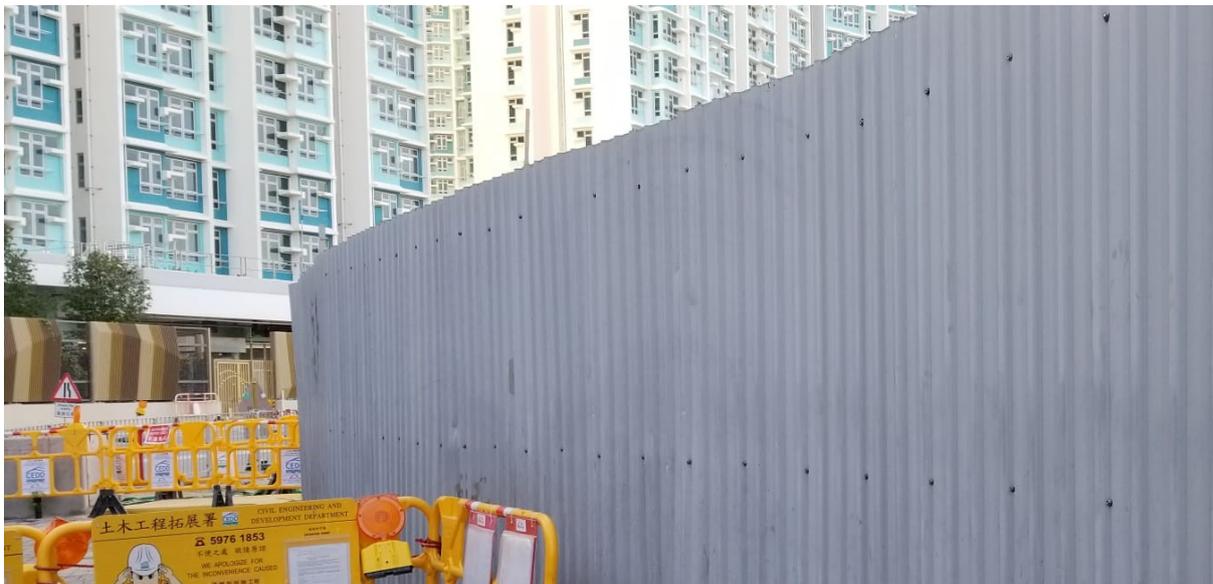
Photo 2 – Erection of site hoardings in unobtrusive colours

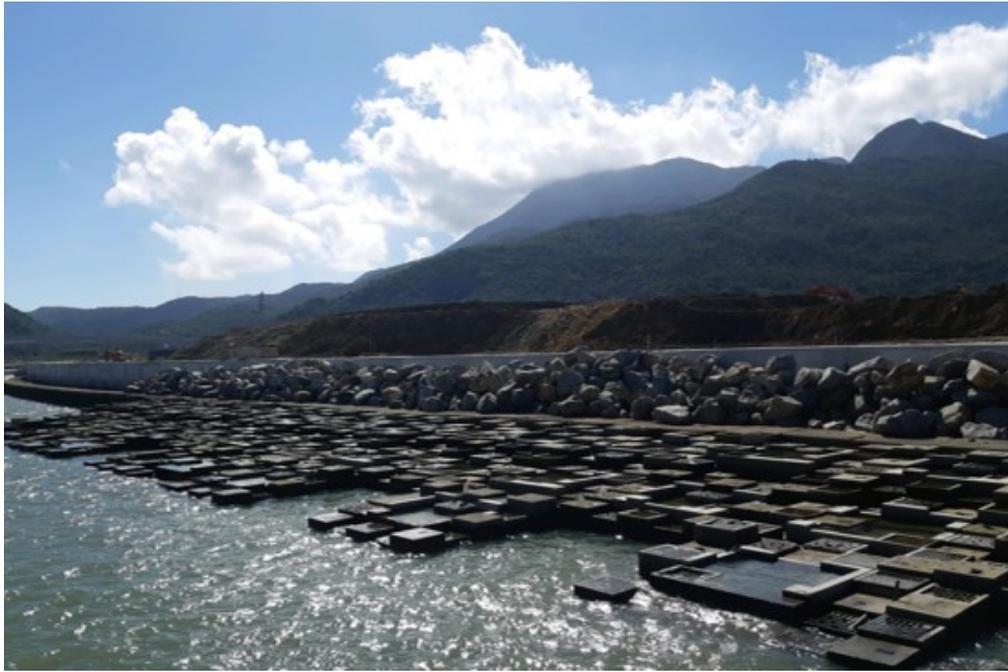
Photo 3 - Natural Rock Material/ Planting for Artificial Seawall
