Annex I1

Preserved Plant Species of Conservation Importance

Tung Chung New Town Extension - Salt Water Supply System

Monthly Report (18 August 2023) In-situ Plant Species of Conserva-on Importance - Photographic Records

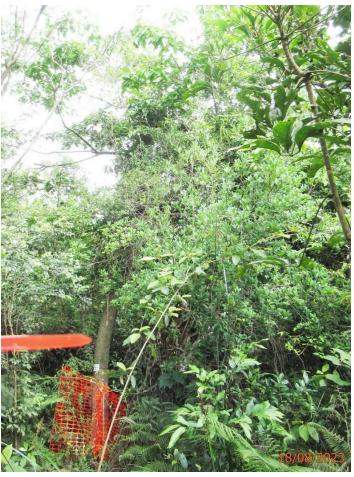
G01_81-RT-01

Drawing no.	Tree group no.	Tree No.	Botanical Name	Chinese Name	SIZE		Amenity Value	Form	Health	Structural Condition	Conservation Status	Recommendation in Detailed Preservation and/or Translocation Plan for Plant Species of Conservation	Justification	Remarks	
					Height (m)	DBH (mm)	Spread (m)		(Good/ F	(Good/ Fair/ Poor)		1	Importance for Tung Chung East (Retain/ Transplant/ Fell)		
60507694/C2/1721	G01/39	R01	Gmelina chinensis	石梓	-	-	-	-	-	-	-	Yes	Retain	-	On Slope, Inaccessible
		R02	Gmelina chinensis	石梓	-	-	-	-	-	-	-	Yes	Retain	-	On Slope, Inaccessible
	G06/59	R018	Gmelina chinensis	石梓	-	-	-	-	-	-	-	Yes	Retain	-	Missing
	G03/61	R019	Gmelina chinensis	石梓	-	-	-	-	-	-	-	Yes	Retain	-	Missing
	G05/62	RT06	Gmelina chinensis	石梓	-	-	-	-	-	-	-	Yes	Transplant	Direct conflict with proposed works	Missing
	G01/81	RT-01	Gmelina chinensis	石梓	5	160	3	Good	Poor	Fair	Fair	Yes	Retain	-	On slope, Strangled by Epiphytes

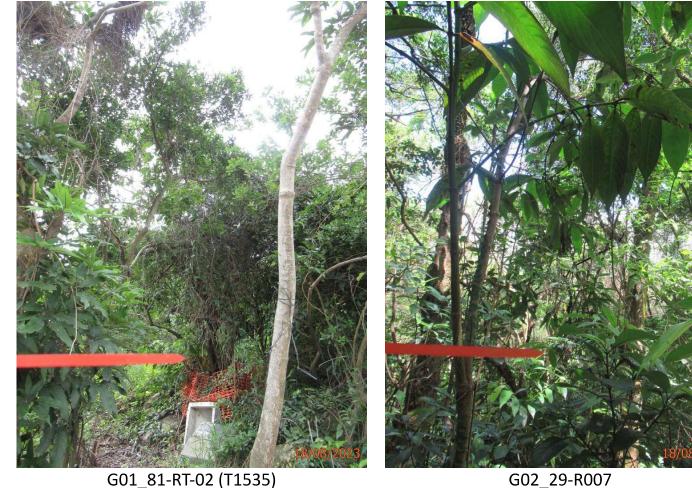
G02_29-R007

R006	Aquilaria sinensis	土沉香	-	-	-	-	-	-	-	Yes	Retain	-	Missing
	G02/29	R007	Gmelina chinensis	石梓	10	170	5	Good	Poor	Fair	Fair	Yes	Retain	-	On slope, Co-dominant Branches with Included Bark Crossed Branches. Old termite tracks on trunk
		R013	Gmelina chinensis	石梓	8	150	7	Good	Poor	Fair	Fair	Yes	Retain	-	Crossed Branches, Old termite tracks on trunk On slope, Co-dominant Branches, Epicormics at Branch Broken Leader with Epiphyte
	G03/44	R014	Gmelina chinensis	石梓	7	160	5	Good	Poor	Fair	Fair	Yes	Retain	-	On slope, Co-dominant Branches
		R015	Gmelina chinensis	石梓	6	110	2	Good	Poor	Poor	Fair	Yes	Retain	-	On slope, Broken Leader, Epiphytes
		R016	Gmelina chinensis	石梓	-	-	-	-	-	-	-	Yes	Retain	-	Missing
		R017	Gmelina chinensis	石梓	8	130	4	Good	Poor	Fair	Fair	Yes	Retain	-	On slope, Broken Leader with Epicormics
	G04/45	R010	Gmelina chinensis	石梓	-	-	-	-	-	-	-	Yes	Retain	-	Missing
		R011	Gmelina chinensis	石梓	8	140	7	Good	Poor	Fair	Fair	Yes	Retain	-	On slope, Co-dominant Branches

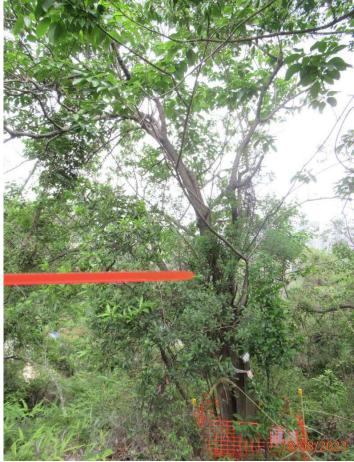
G04_83_84_85-R04 (T1788)

RT-02 (T1535)	Gmelina chinensis	石梓	8	110	3	Good	Poor	Fair	Fair	Yes	Retain	-	On slope, Co-dominant Branches, Strangled by Epiphytes.
	G02/82	RT03	Gmelina chinensis	石梓	-	-	-	-	-	-	-	Yes	Transplant	Direct conflict with proposed works	Missing
	G04/83/84/85	R04 (T1788)	Gmelina chinensis	石梓	9	260	8	Good	Poor	Fair	Fair	Yes	Retain	-	On slope, Multiple Trunks
		R05 (T1572)	Gmelina chinensis	石梓	8	120	5	Good	Poor	Fair	Fair	Yes	Retain	-	On slope, Broken branch
		R05	Gmelina chinensis	石梓	-	-	-	-	-	-	-	Yes	Retain	-	Missing
		R06	Gmelina chinensis	石梓	5	100	3	Good	Fair	Fair	Fair	Yes	Retain	-	On slope
		R07	Gmelina chinensis	石梓	8	166	5	Good	Poor	Fair	Fair	Yes	Retain	-	On slope, Co-dominant Trunks
		R08	Gmelina chinensis	石梓	7	160	5	Good	Poor	Fair	Fair	Yes	Retain	-	On slope, Broken Leader, Epicormics, Imbalanced Crown
		R09	Gmelina chinensis	石梓	5	140	4	Good	Poor	Fair	Fair	Yes	Retain	-	On slope, Broken Leader wih Epiphyte, Broken Leade with Epicomics

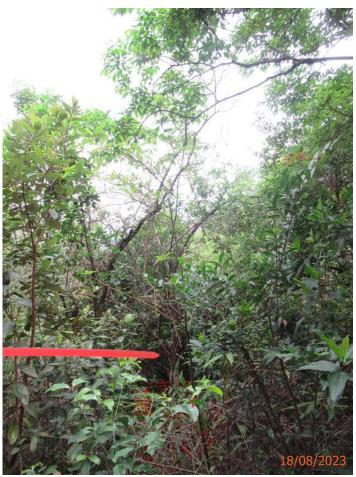
G04_83_84_85-R010

R010	Gmelina chinensis	石梓	8	110	3	Good	Poor	Fair	Fair	Yes	Retain	-	On slope, Broken Leader with Epicormics
		R011	Gmelina chinensis	石梓	9	130	4	Good	Poor	Fair	Poor	Yes	Retain	-	On slope, Multiple Branches, Leaning without Self correction
60507694/C2/1722	G04/21	R03	Gmelina chinensis	石梓	5	120	2	Good	Fair	Fair	Fair	Yes	Retain	-	Undersized, On Slope
	G05/9	R04	Gmelina chinensis	石梓	5	100	2	Good	Fair	Fair	Fair	Yes	Retain	-	On Slope
60507694/C2/1732	G01/30	R001	Gmelina chinensis	石梓	7	110	2	Good	Poor	Fair	Fair	Yes	Retain	-	On Slope
		R002	Gmelina chinensis	石梓	8	120	5	Good	Poor	Poor	Fair	Yes	Retain	-	On slope, Co-dominant Branches, Root Flare was Partially Buried, Dead Stub
		R003	Gmelina chinensis	石梓	5	140	2	Good	Poor	Poor	Fair	Yes	Retain	-	On slope, Bulge at Trunk, Root Flare was Partially Buried Climber
		R004	Aquilaria sinensis	土沉香	10	150	3	Good	Fair	Fair	Fair	Yes	Retain	-	On slope
		R005	Aquilaria sinensis	土沉香	8	130	3	Good	Fair	Fair	Fair	Yes	Retain	-	On slope

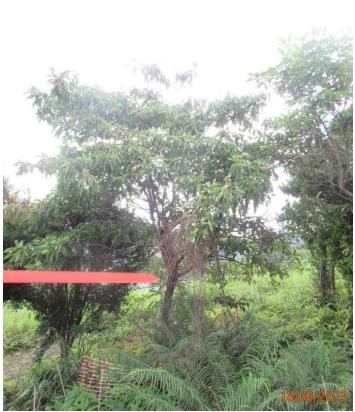
G05_67-R008

R012	Gmelina chinensis	石梓	-	-	-	-	-	-	-	Yes	Retain	-	Missing
	G05/67	R008	Gmelina chinensis	石梓	6	120	4	Good	Fair	Fair	Fair	Yes	Retain	-	On slope
	G06/66	R009	Gmelina chinensis	石梓	7	120	5	Good	Poor	Fair	Fair	Yes	Retain	-	On slope, Epicormic at Broken Stump
