Agreement No. CE 60/2017 (EP)

Environmental Team for Tung Chung New Town Extension (East) -Design and Construction

Monthly Environmental Monitoring & Audit Report for November 2018

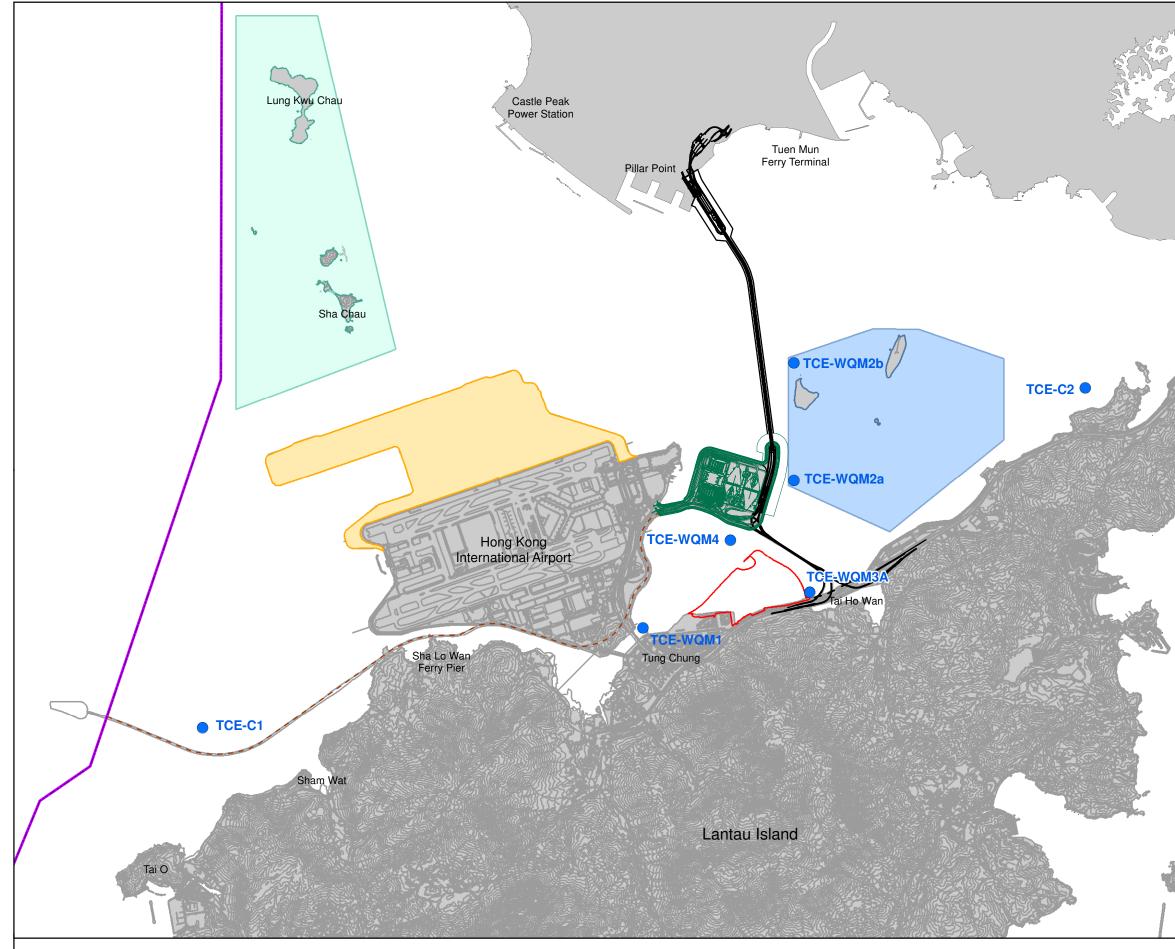
Figure 2.3

Water Quality Monitoring Locations

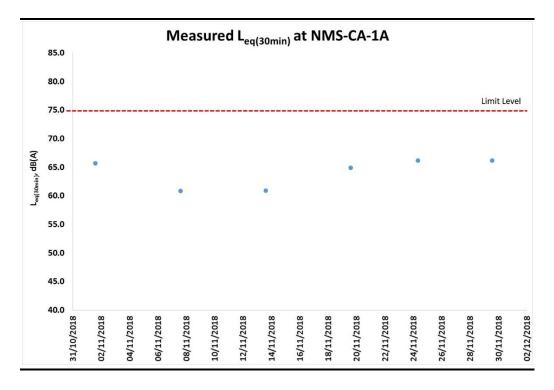
Figure E3.1 Graphical Presentation for Noise Monitoring at Station NMS-CA-1A

Table E3.1Data for Noise Monitoring at Station NMS-CA-1A during Normal Working
Hours (0700-1900 hours)

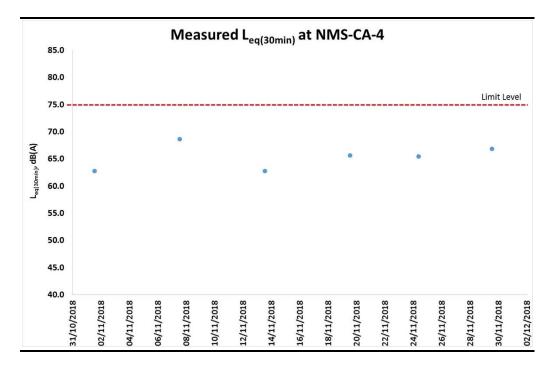
Figure E3.2 Graphical Presentation for Noise Monitoring at Station NMS-CA-4

Table E3.2Data for Noise Monitoring at Station NMS-CA-4 during Normal Working
Hours (0700-1900 hours)

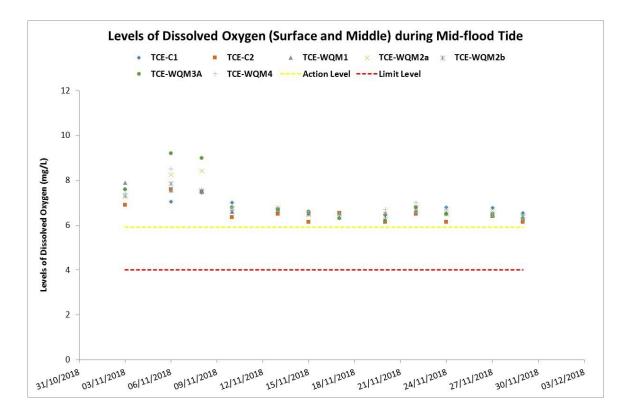
Figure 2: Levels of Dissolved Oxygen (Surface and Middle) (mg/L) recorded at Mid-flood Tide during the Water Quality Monitoring between 1 and 30 November 2018

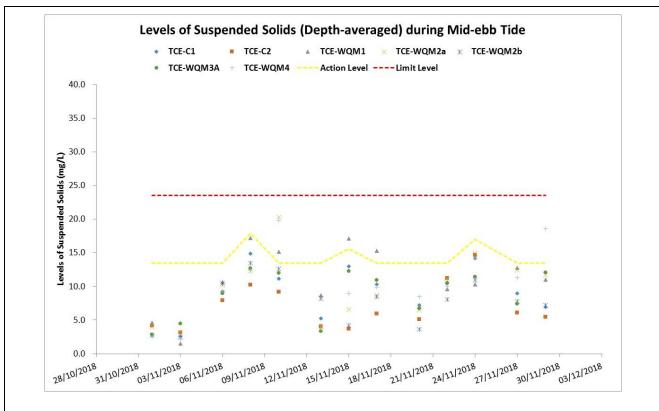
Figure 7: Levels of Suspended Solids (Depth-averaged) (mg/L) recorded at Mid-ebb Tide during the Water Quality Monitoring between 1 and 30 November 2018
