Environmental Team for Tung Chung New Town Extension (East) - Design and Construction

**Monthly Environmental Monitoring & Audit Report
for December 2018**

January 2019

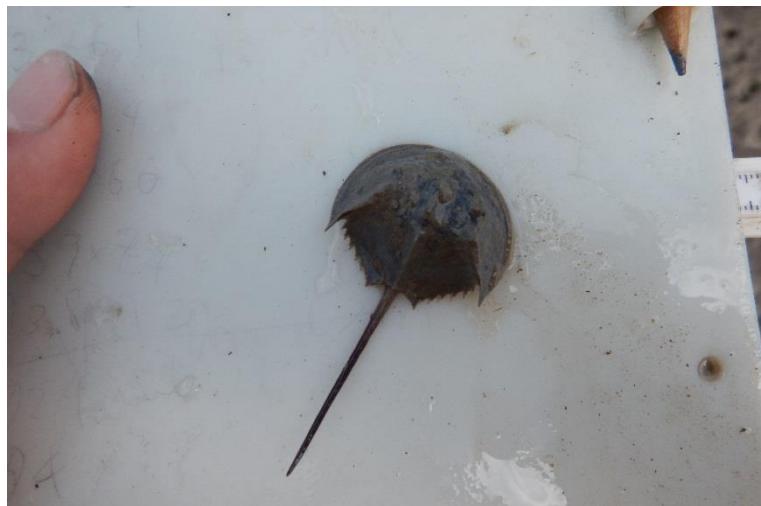
(e) Horseshoe crab *Tachypleus tridentatus* recorded at THW during Qualitative Walk-through Survey

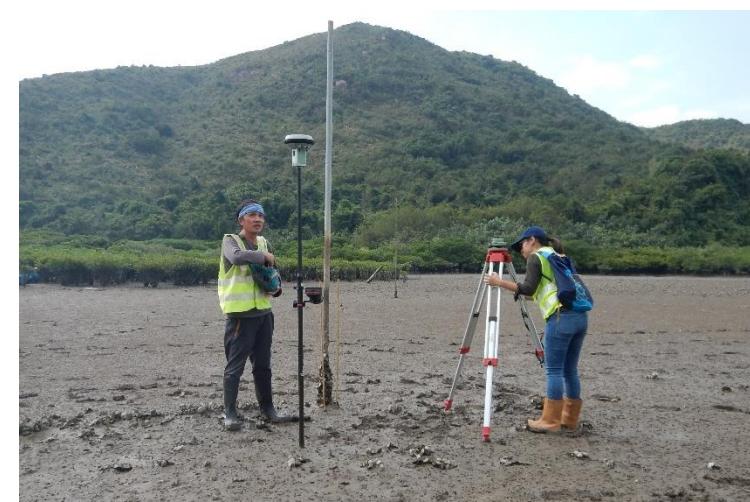
(f) Sedimentation Rate Monitoring
