Agreement No. CE 60/2017 (EP)

Environmental Team for Tung Chung New Town Extension (East) - Design and Construction

**Monthly Environmental Monitoring & Audit Report
for June 2019**

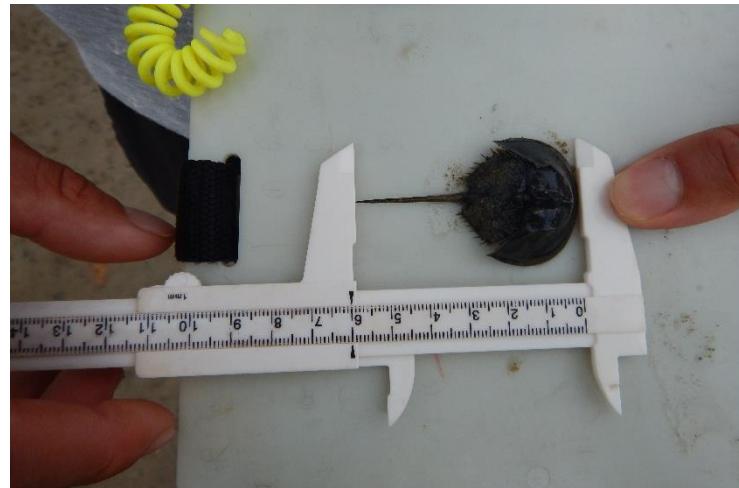
(e) Horseshoe crab *Tachypleus tridentatus* recorded at TCB3 during Qualitative Walk-through Survey

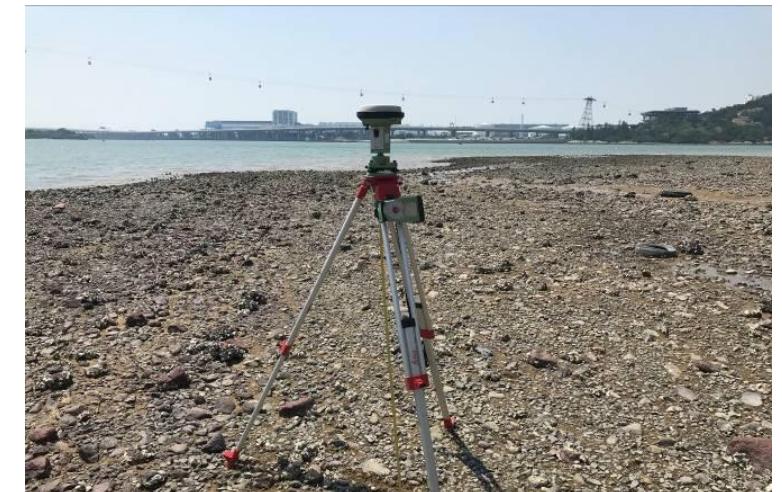
(f) Sedimentation Rate Monitoring

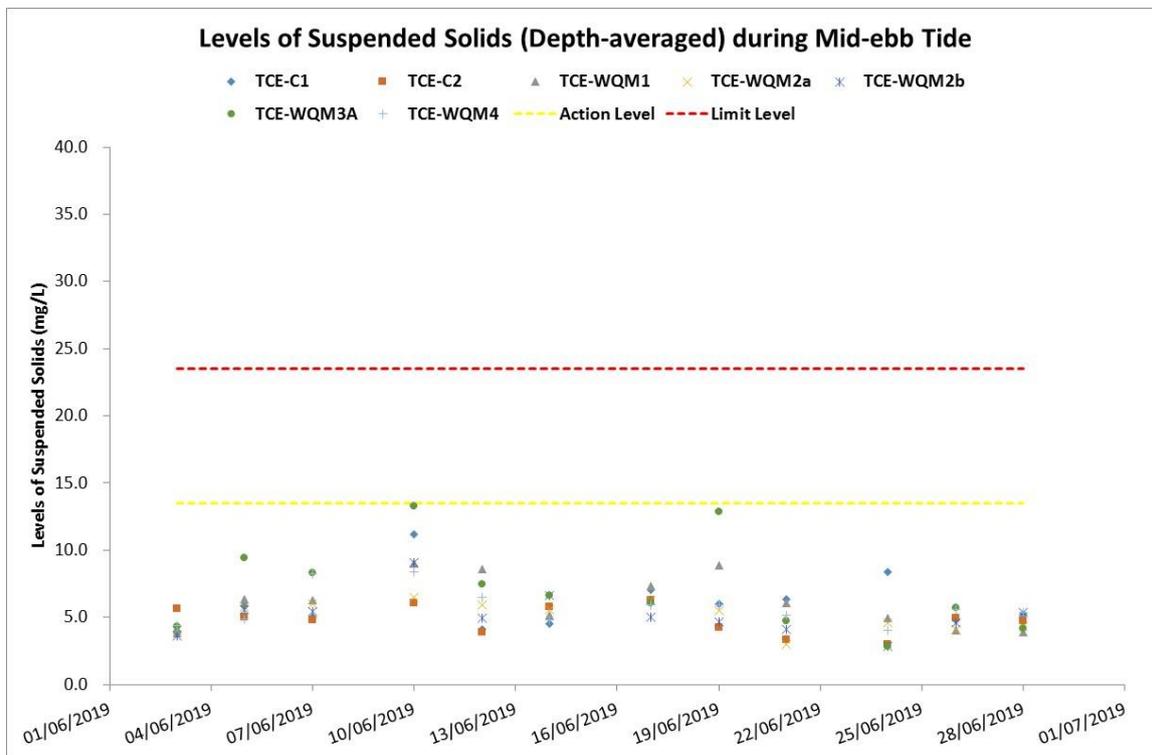
Figure 7: Levels of Suspended Solids (Depth-averaged) (mg/L) recorded at Mid-ebb Tide during the Water Quality Monitoring between 1 and 30 June 2019
