Agreement No. CE 60/2017 (EP)

Environmental Team for Tung Chung New Town Extension (East) - Design and Construction

**Monthly Environmental Monitoring & Audit Report
for December 2019**

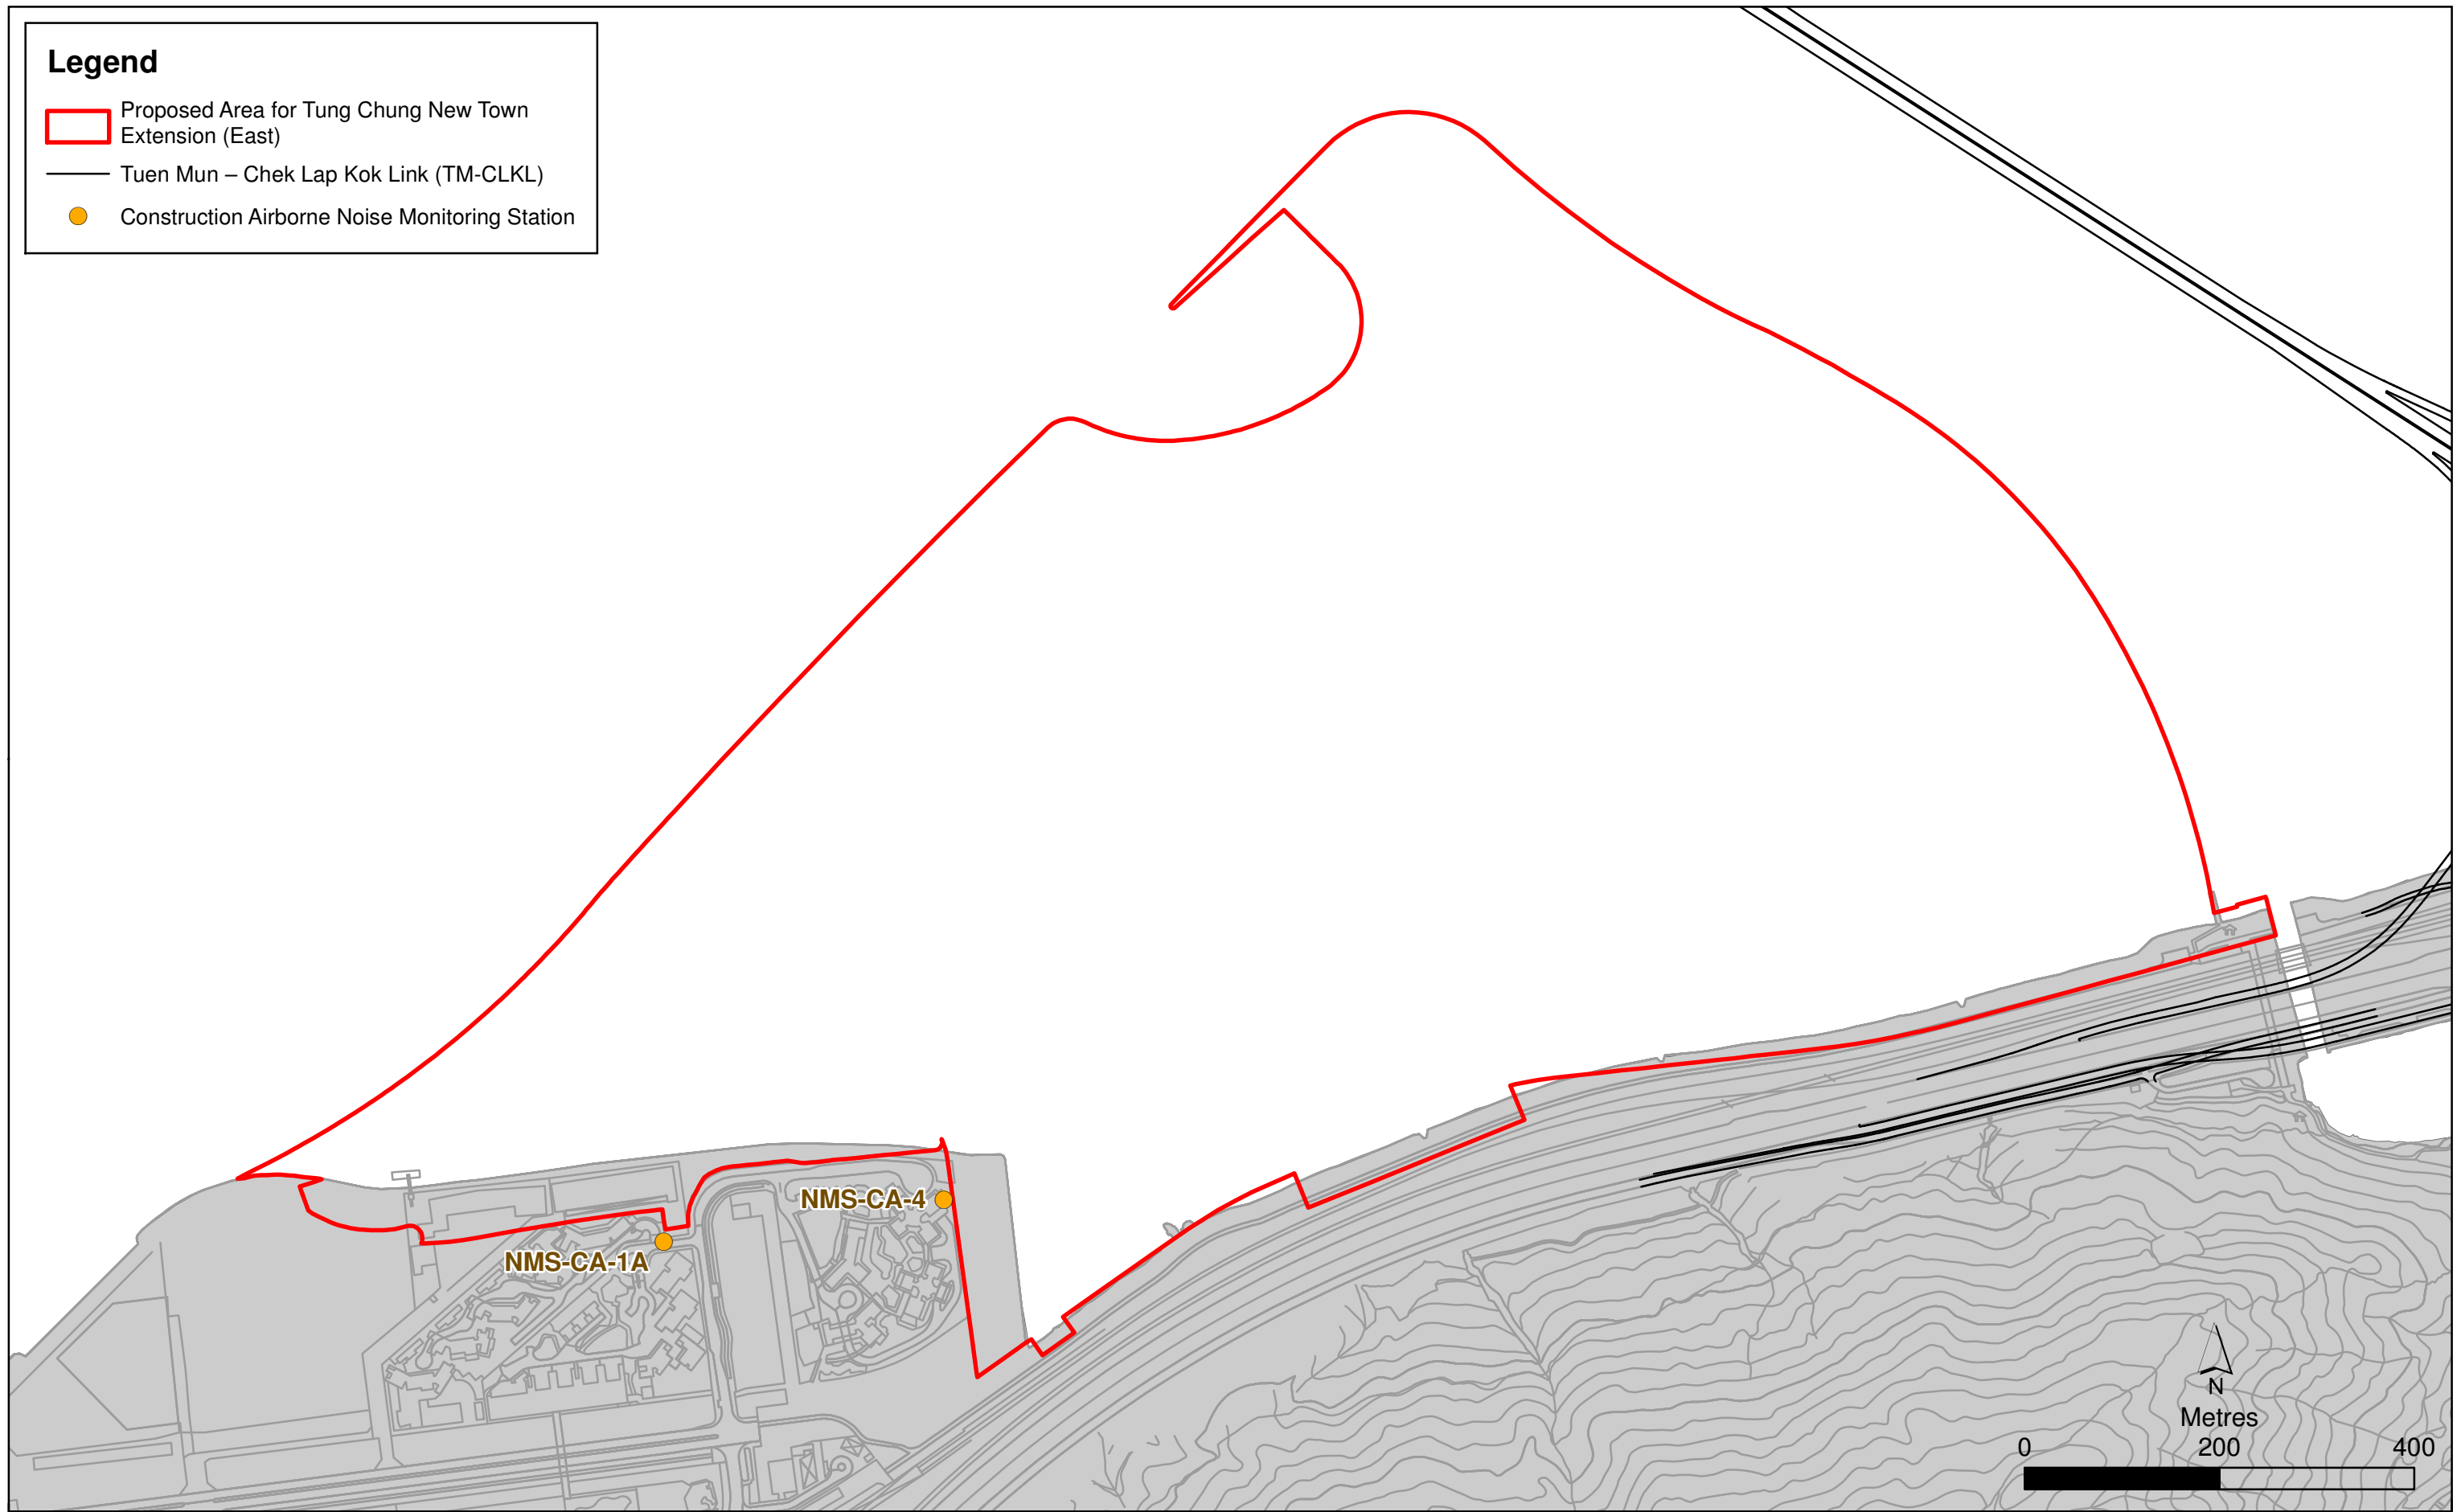
Figure 2.2

Construction Airborne Noise Monitoring Station Location

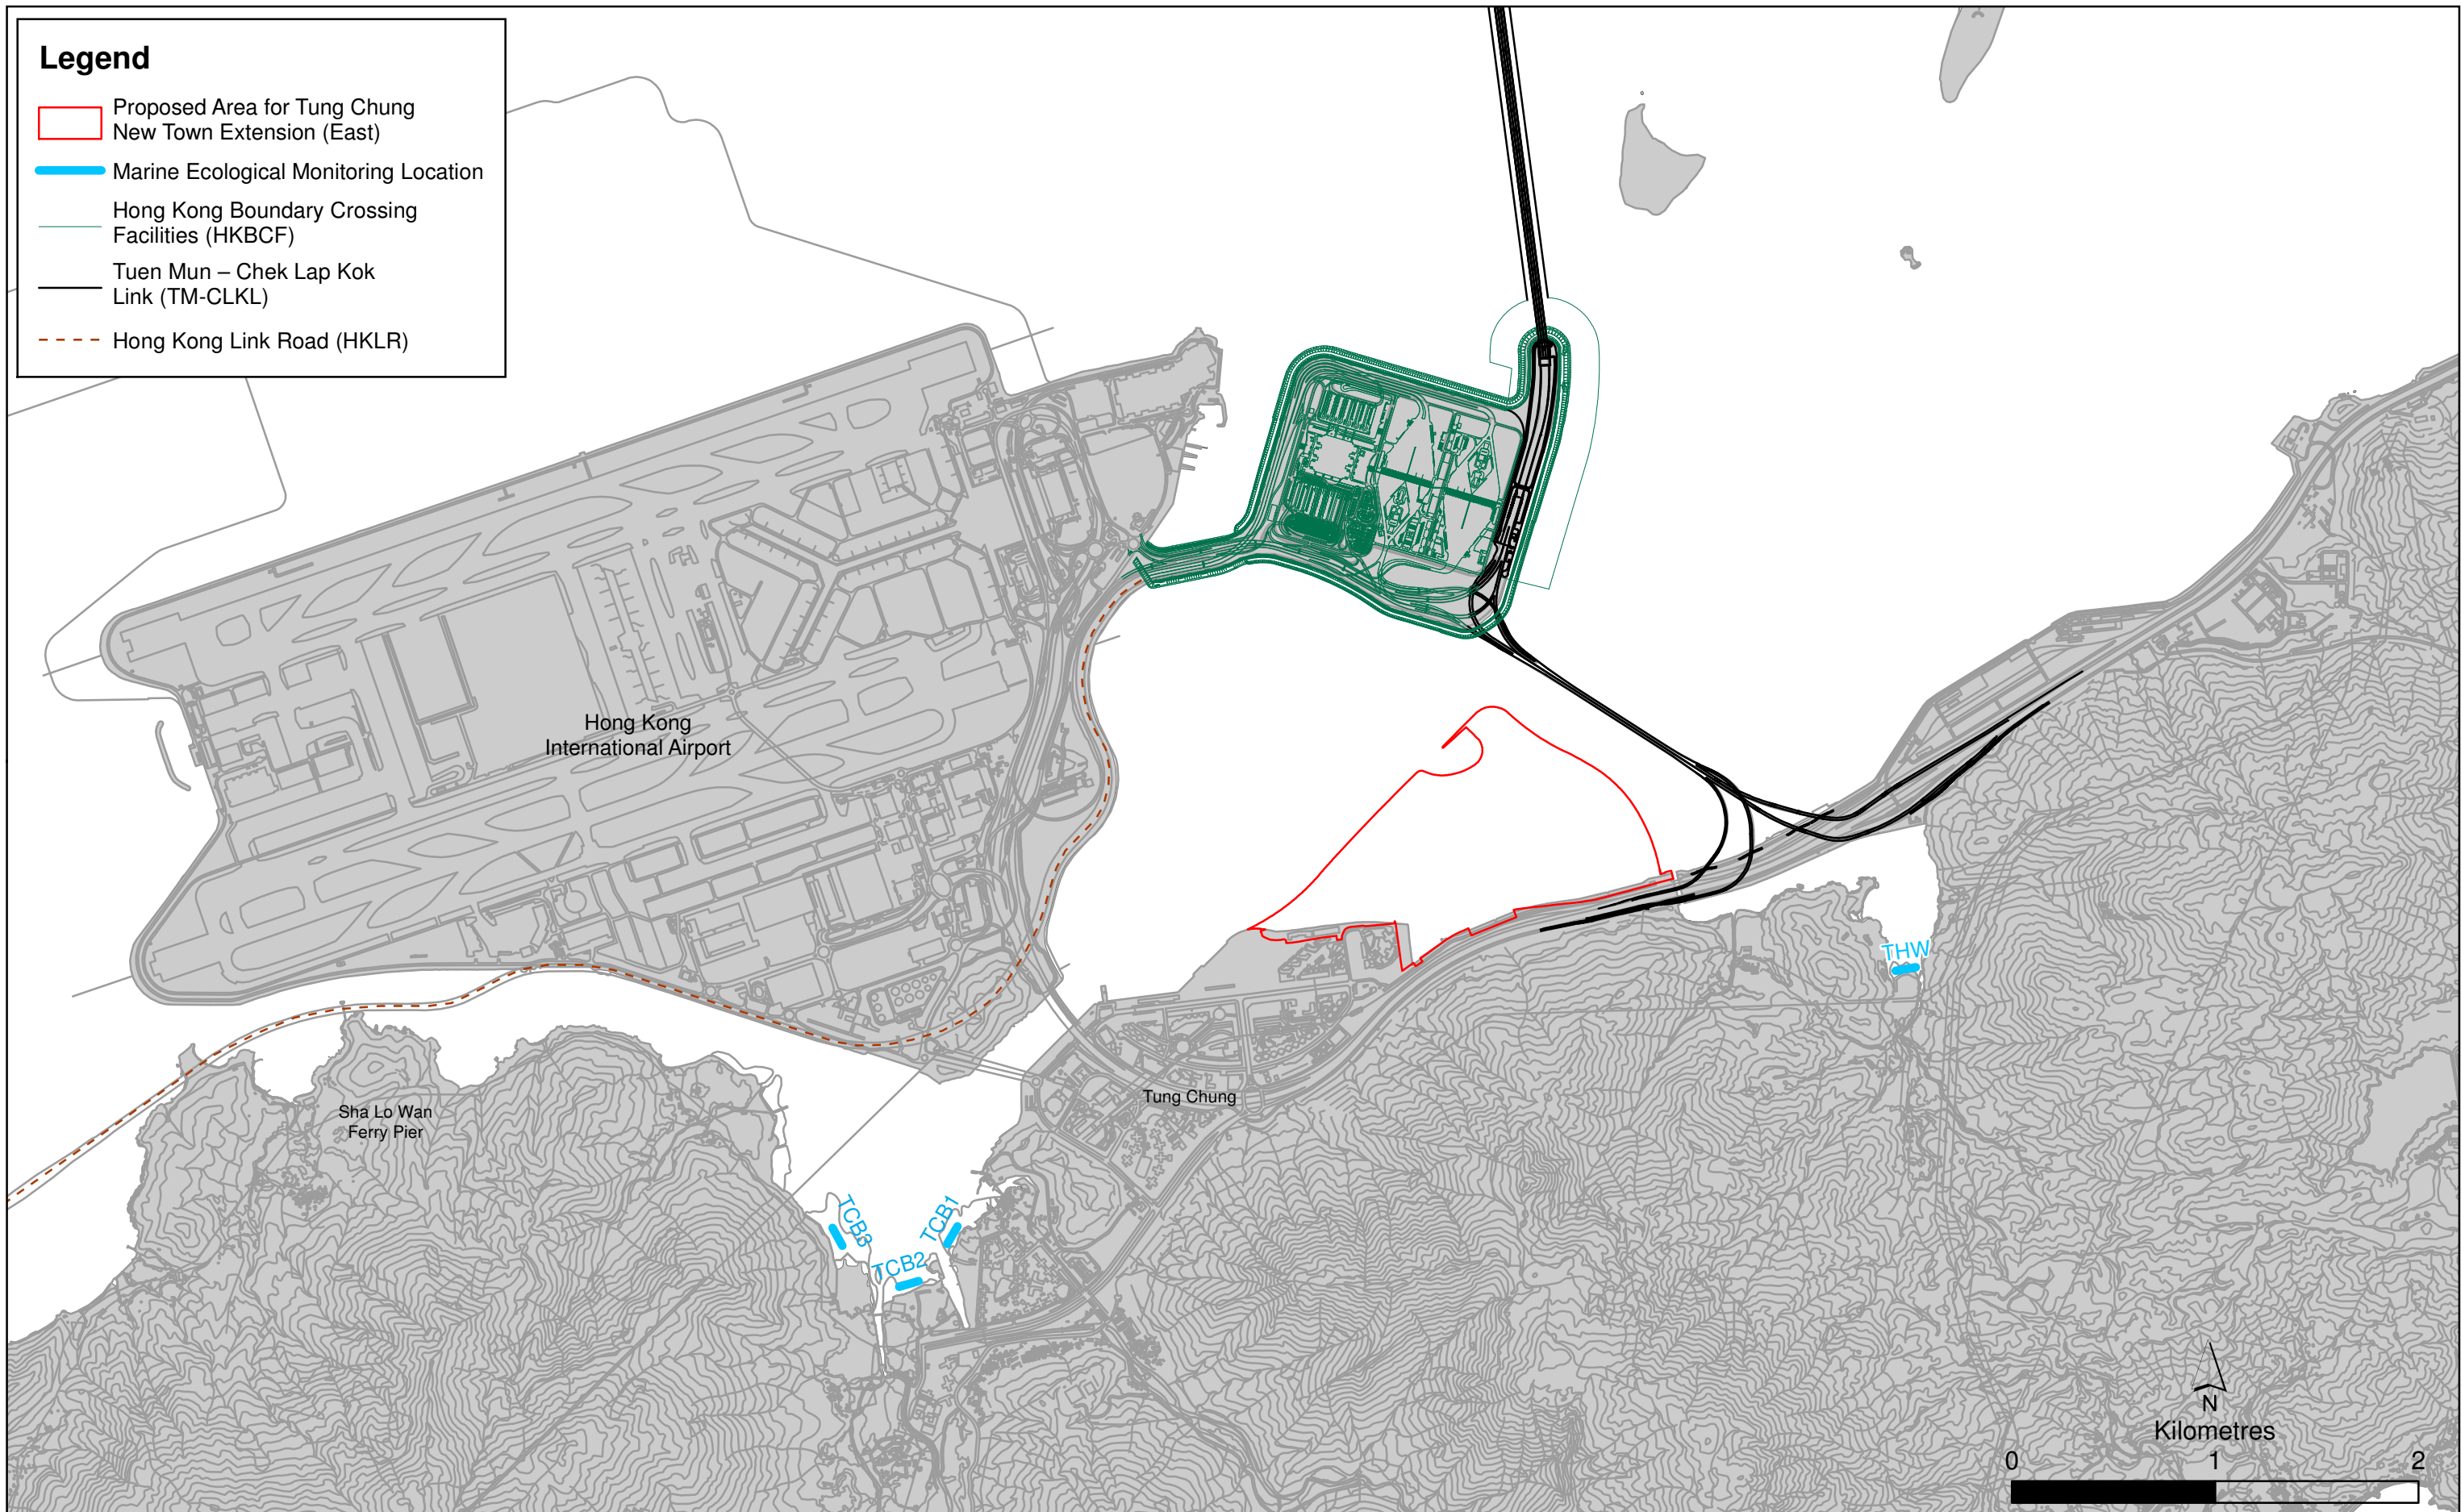
Figure 2.4

Marine Ecological Monitoring (Intertidal Soft-shore Habitats)

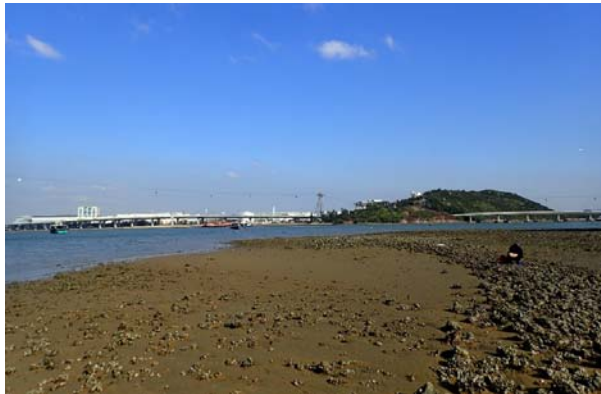
(a) Survey Location at TCB1

Figure 2.5 Representative Photographs Taken during the Impact Soft Shore Ecological Monitoring conducted in December 2019

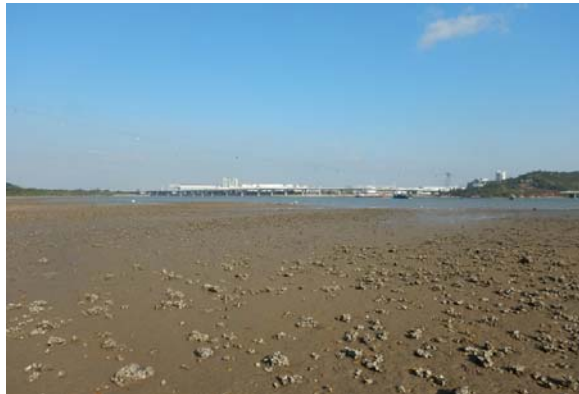
(b) Survey Location at TCB2

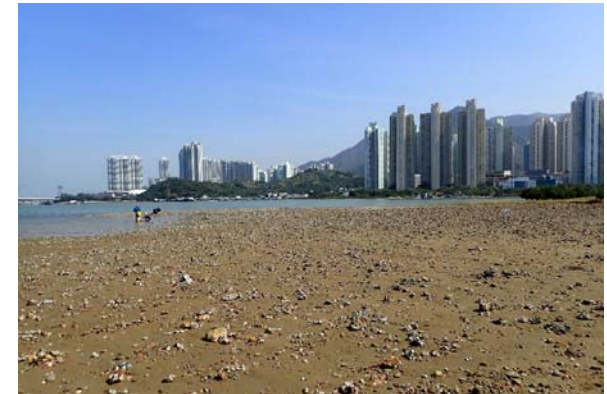
(c) Survey Location at TCB3

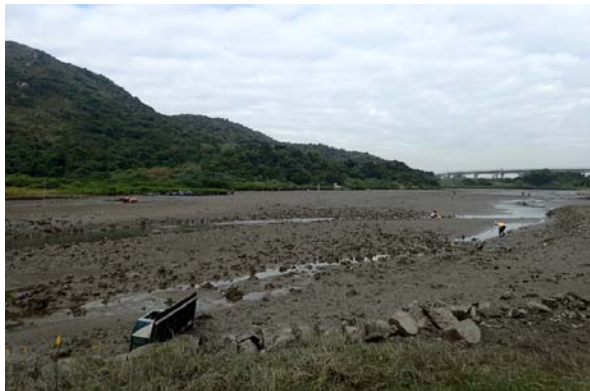
(d) Survey Location at THW

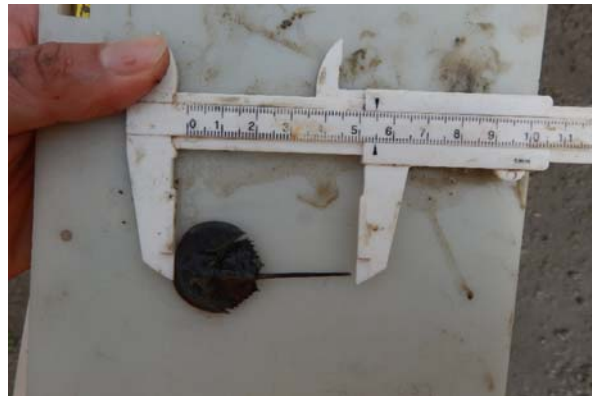
(e) Horseshoe crab *Tachypleus tridentatus* recorded at TCB2 during Qualitative Walk-through Survey

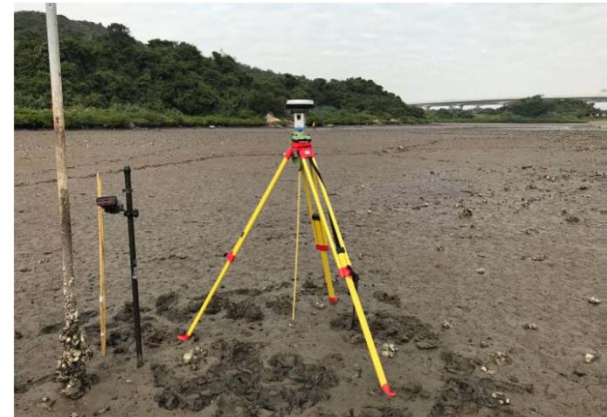
(f) Sedimentation Rate Monitoring

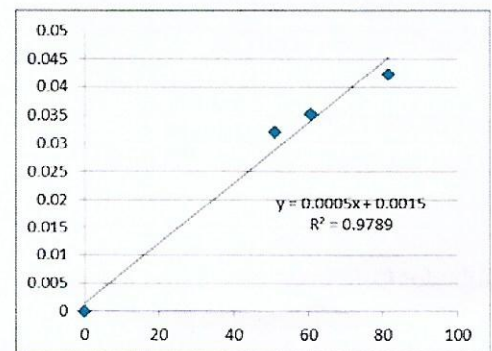
Slope (K-factor): 0.0005
Correlation Coefficient 0.9894
Date of Issue 22 October 2019

1. **Strong Correlation (R>0.8)**
2. Factor 0.0005 should be applied for TSP monitoring
