Agreement No. CE 60/2017 (EP)

### Environmental Team for Tung Chung New Town Extension (East) -Design and Construction

**Monthly Environmental Monitoring & Audit Report** for February 2022

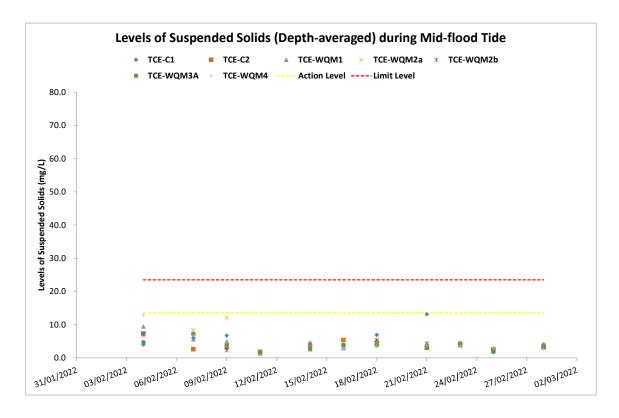
Figure 8: Levels of Suspended Solids (Depth-averaged) (mg/L) recorded at Mid-flood Tide during the Water Quality Monitoring between 1 to 28 February 2022
