Agreement No. CE 60/2017 (EP)

Environmental Team for Tung Chung New Town Extension (East) - Design and Construction

**Monthly Environmental Monitoring & Audit Report
for May 2022**

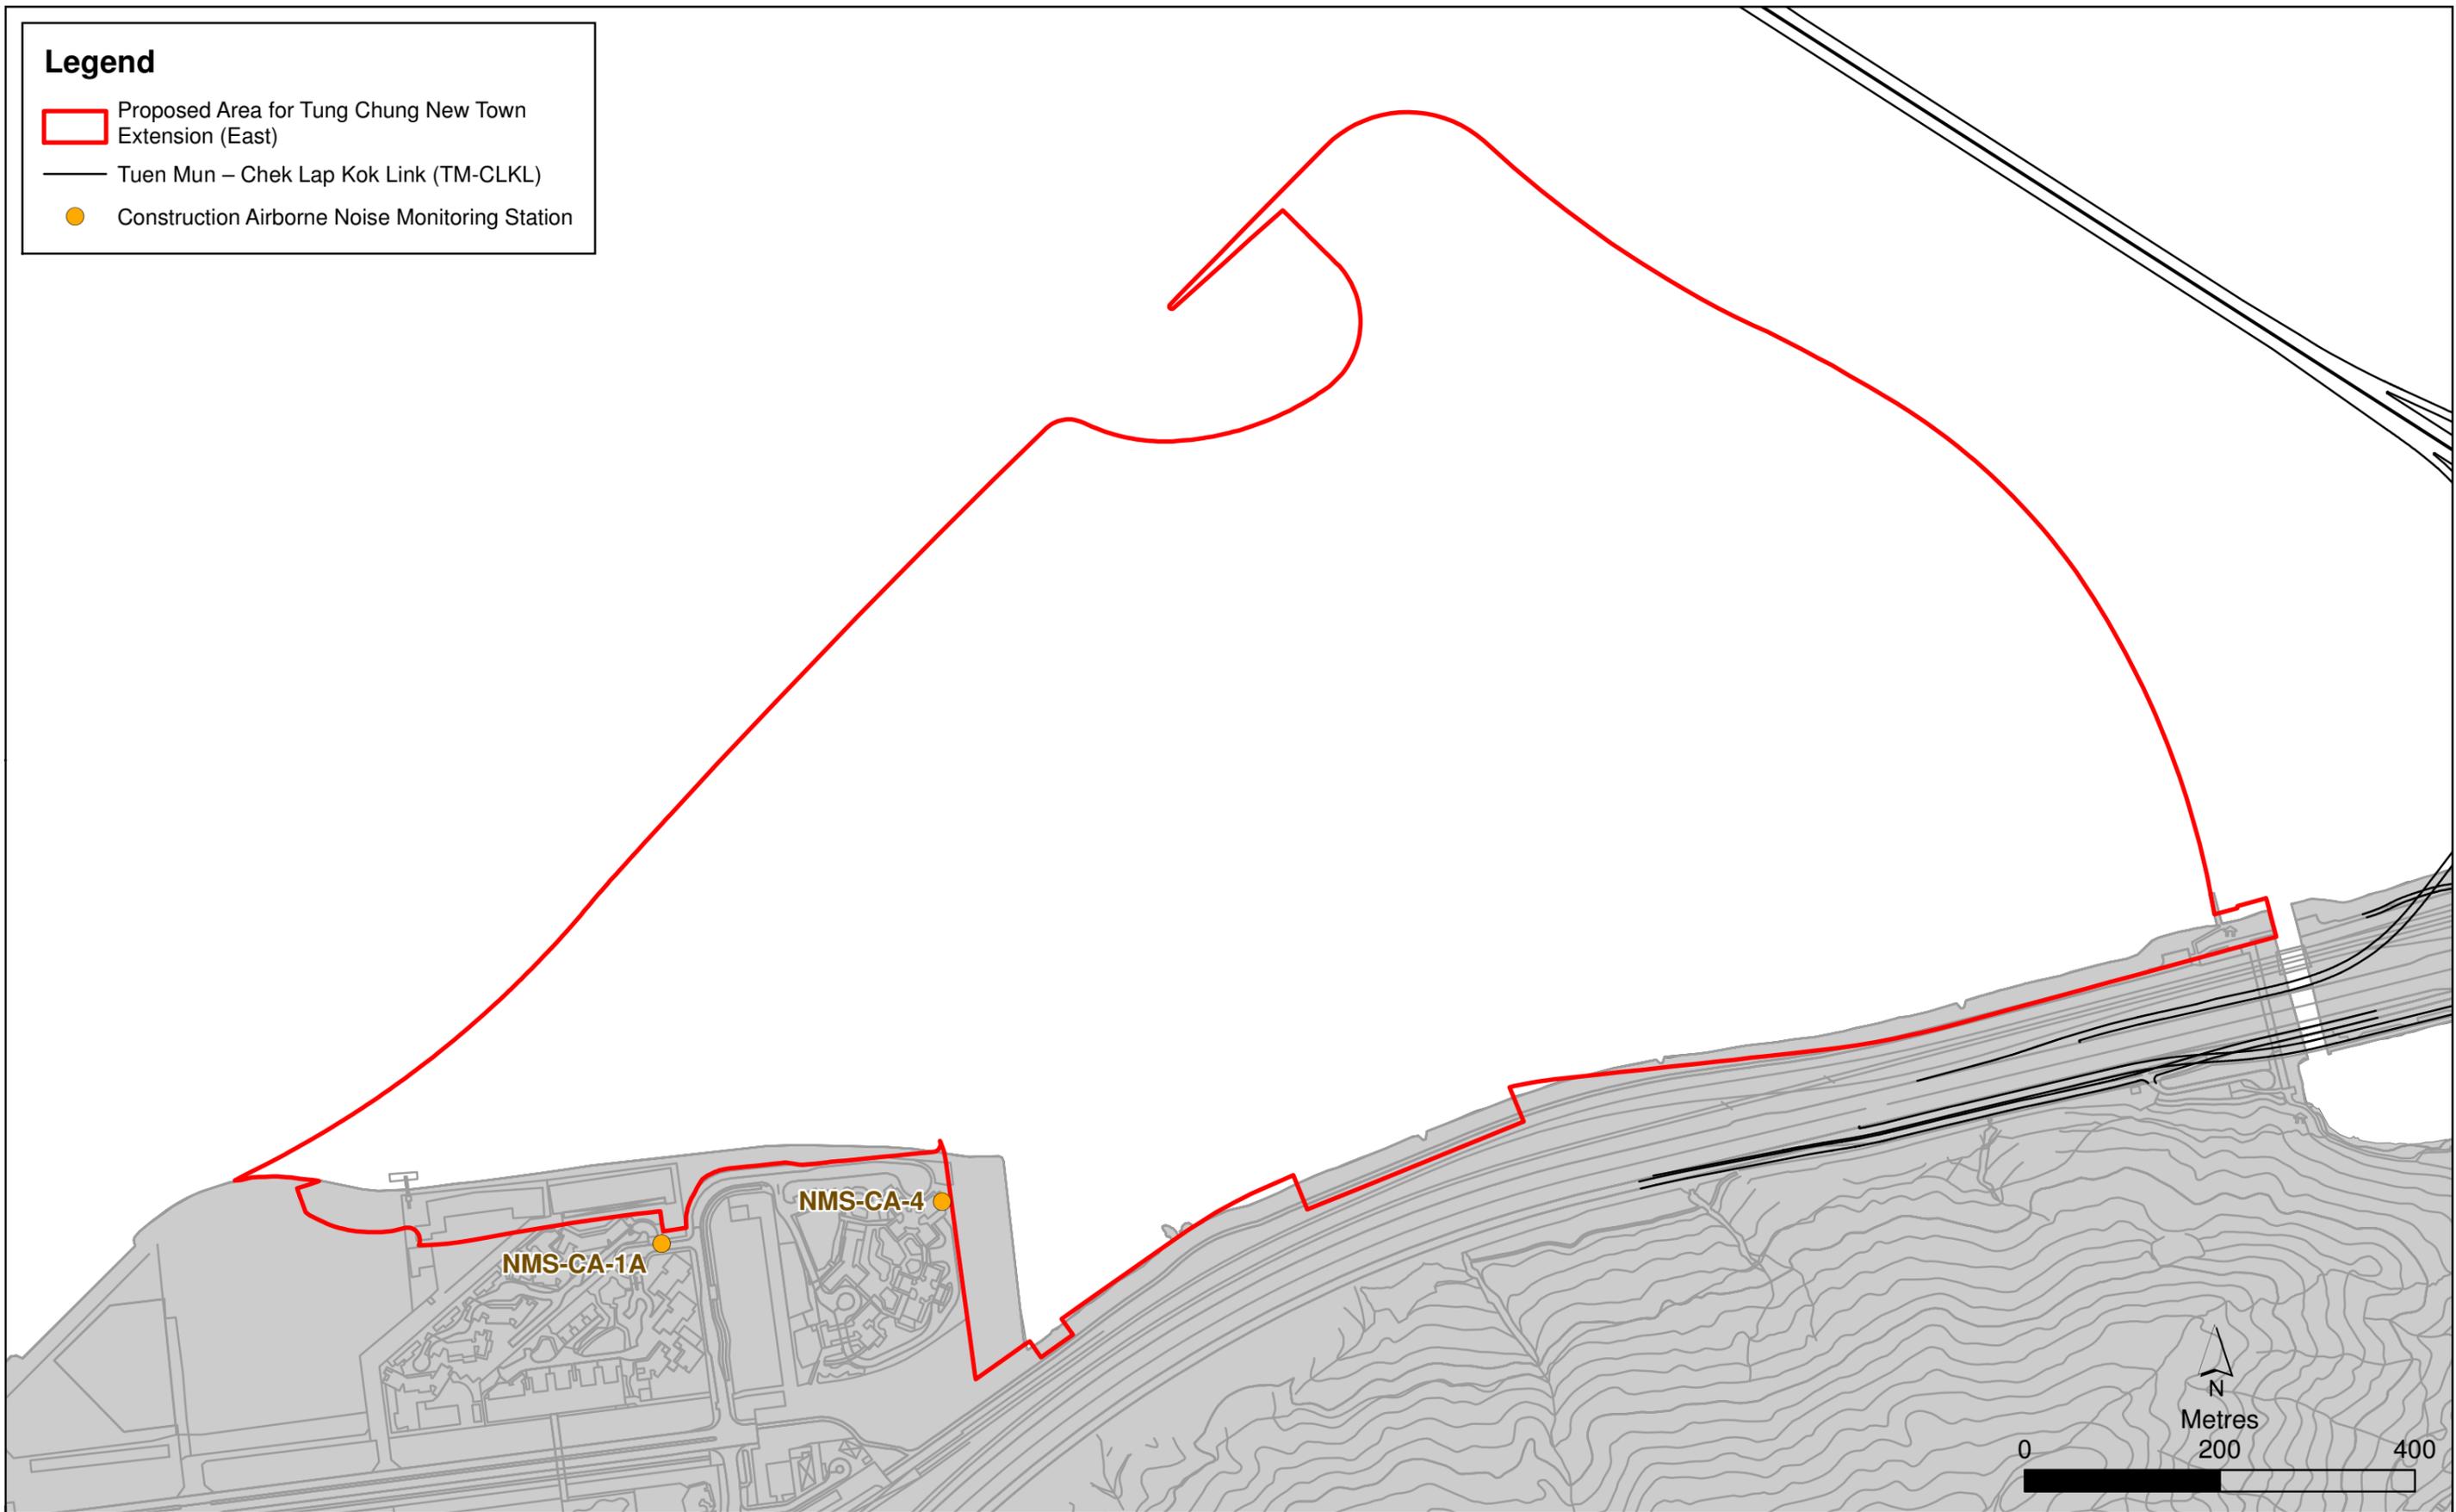
Figure 2.2

Construction Airborne Noise Monitoring Station Location

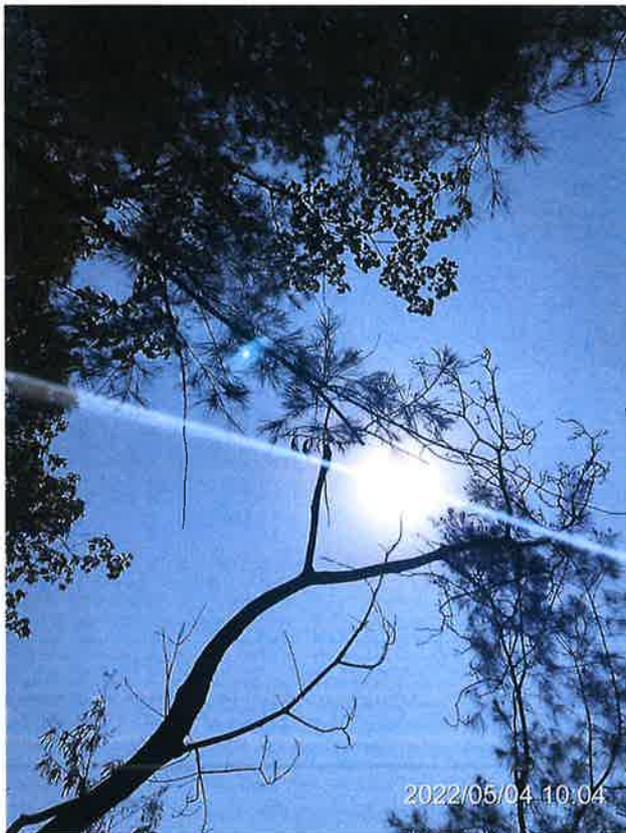
Contract 2	4 May 2022	Portion 3 <ul style="list-style-type: none"> The health condition of the transplanted plant species of conservation importance was poor (RT-07 and RT-08). 	Portion 3 <ul style="list-style-type: none"> The Contractor was reminded to provide mitigation measures (i.e. daily watering, use of mulch and pruning/weeding) when necessary, keep close monitoring of the plants in terms of their health condition and report to relevant parties in the event of deterioration immediately.
		HDD <ul style="list-style-type: none"> Environmental permit was not observed on the gate. Muddy runoff was observed. 	HDD <ul style="list-style-type: none"> The Contractor was reminded to affix environmental permit on the gate. The Contractor was urged to remove the materials and provide tree protection.

Photo 03: Crown condition of G62/RT-07

Photo 04: Whole view of G62/RT-07

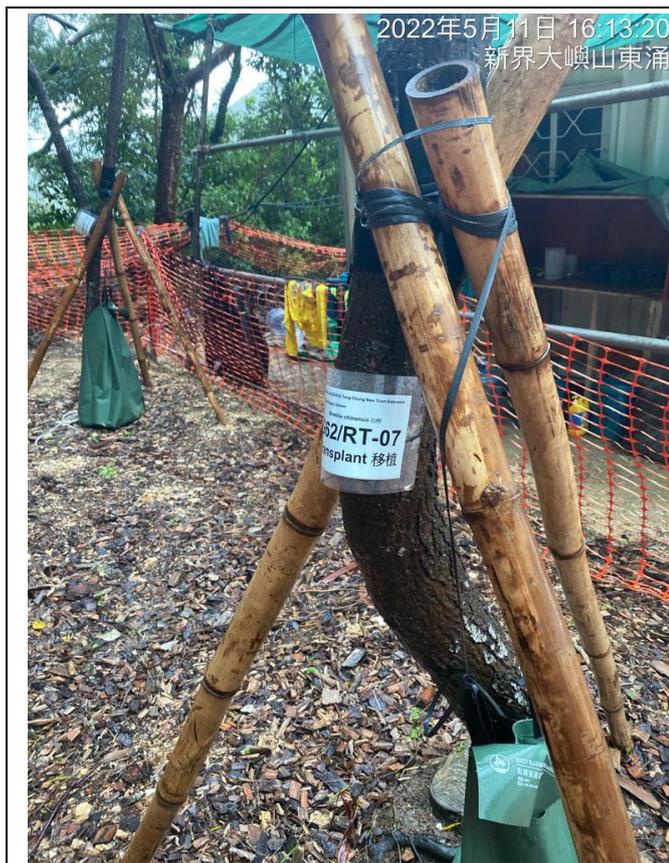
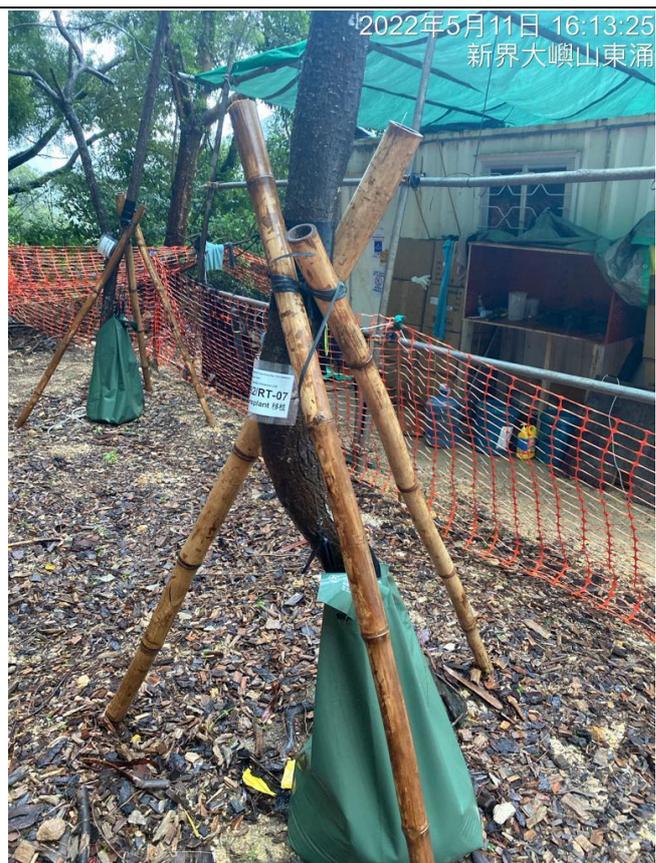
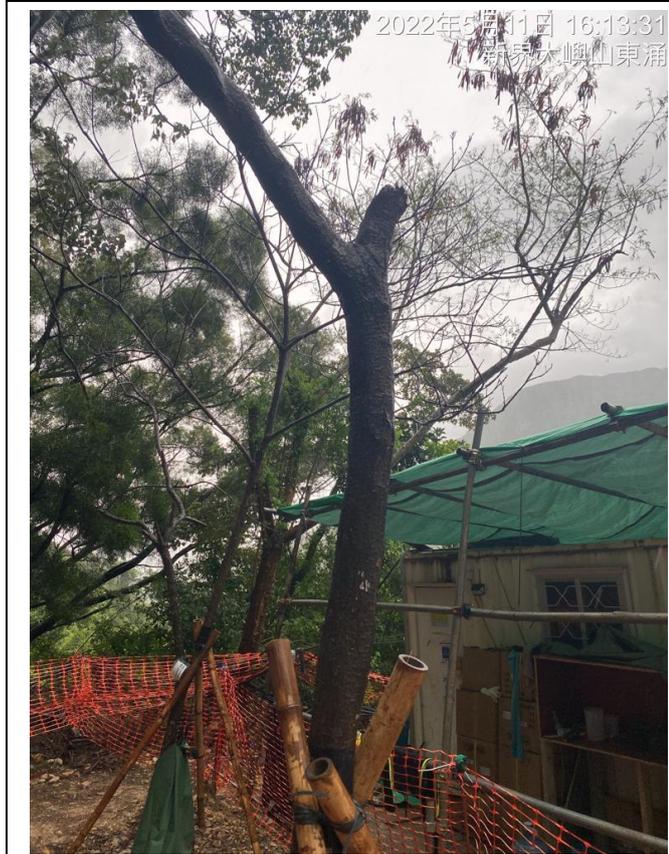
Contract No.	Inspection Date	Environmental Observations	Recommendations/ Remarks
	11 May 2022	Portion 3 <ul style="list-style-type: none"> The health condition of the transplanted plant species of conservation importance was poor (RT-07 and RT-08). Runoff was observed. 	Portion 3 <ul style="list-style-type: none"> The Contractor was reminded to provide mitigation measures (i.e. daily watering, use of mulch and pruning/weeding) when necessary, keep close monitoring of the plants in terms of their health condition and report to relevant parties in the event of deterioration immediately. The Contractor was urge to implement mitigation measures to prevent polluted site runoff from discharging into near drainage system / waterbodies, critically review the drainage system immediately.
	18 May 2022	Portion 3 <ul style="list-style-type: none"> The health condition of the transplanted plant species of conservation importance was poor (RT07 and RT-08). Cement was observed in the tree protection zone. Portion 6 <ul style="list-style-type: none"> Runoff was observed. 	Portion 3 <ul style="list-style-type: none"> The Contractor was reminded to provide mitigation measures (i.e. daily watering, use of mulch and pruning/weeding) when necessary, keep close monitoring of the plants in terms of their health condition and report to relevant parties in the event of deterioration immediately. The Contractor was urge to remove the cement and keep the tree protection zone clean. Portion 6 <ul style="list-style-type: none"> The Contractor was urge to implement mitigation measures to prevent polluted site runoff from discharging into near waterbodies, critically review the drainage system immediately.

Photo 01: Tree tag of G62/ RT-07

Photo 02: Root collar of G62/ RT-07

Photo 03: Crown condition of G62/RT-07

Photo 04: Whole view of G62/RT-07

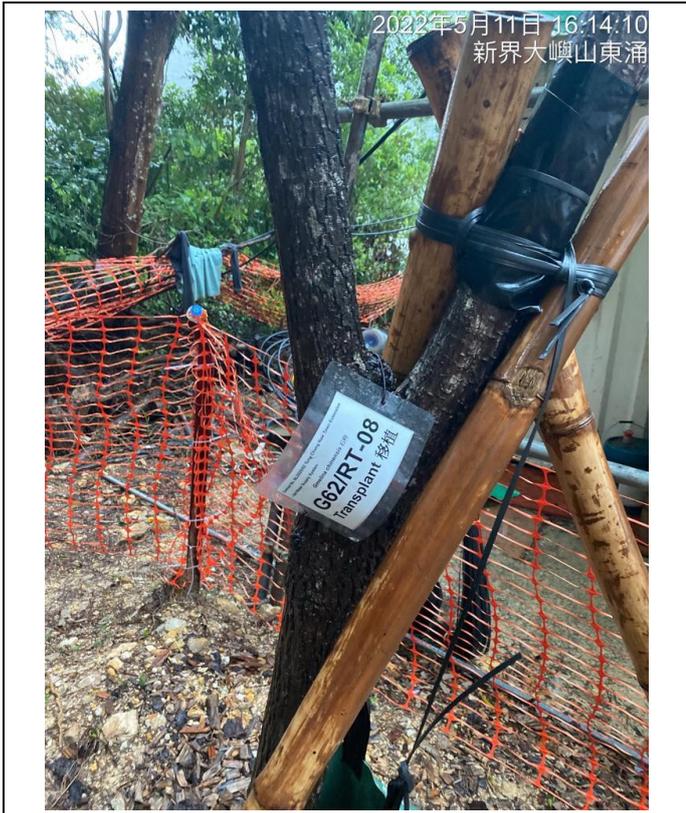
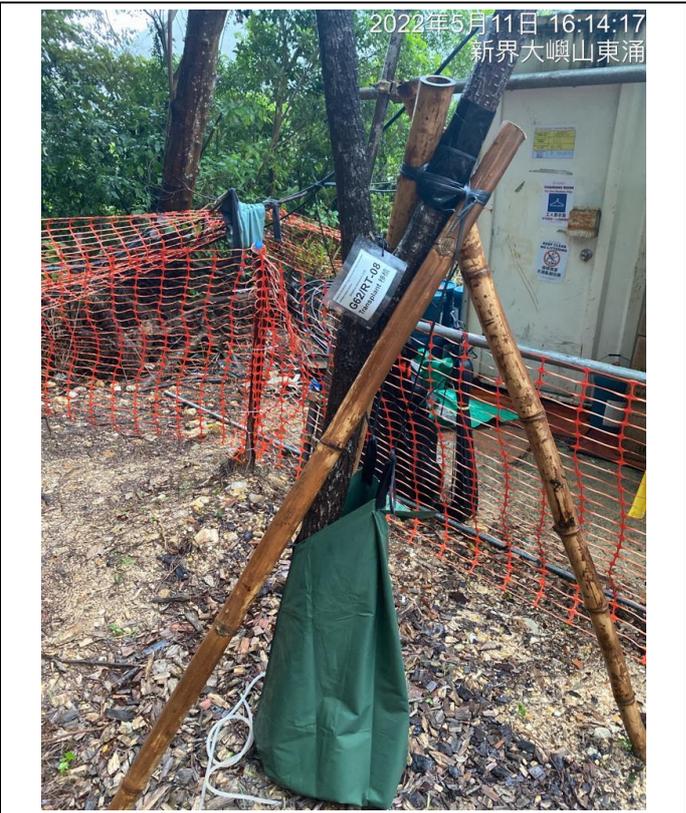
Photo 05: Tree tag of G62/ RT-08

Photo 06: Root collar of G62/RT-08

Photo 07: Crown condition of G62/RT-08

Photo 08: Whole view for G62/RT-08
